RENOVATION OF BLOCK B' FOR FRENCH SCHOOL (LYCEE LOUIS MASSIGNON)

CONCRETE REPAIRS AND STRUCTURAL REINFORCEMENT

Structure Condition Assessment (Concrete Part)

APAVE INTERNATIONAL – Abu Dhabi			
Inspector Name:	Christian LICARDO		
Inspection Date:	Dec 11 to 15, 2021	Report Number:	Auh.CI21.127-v1

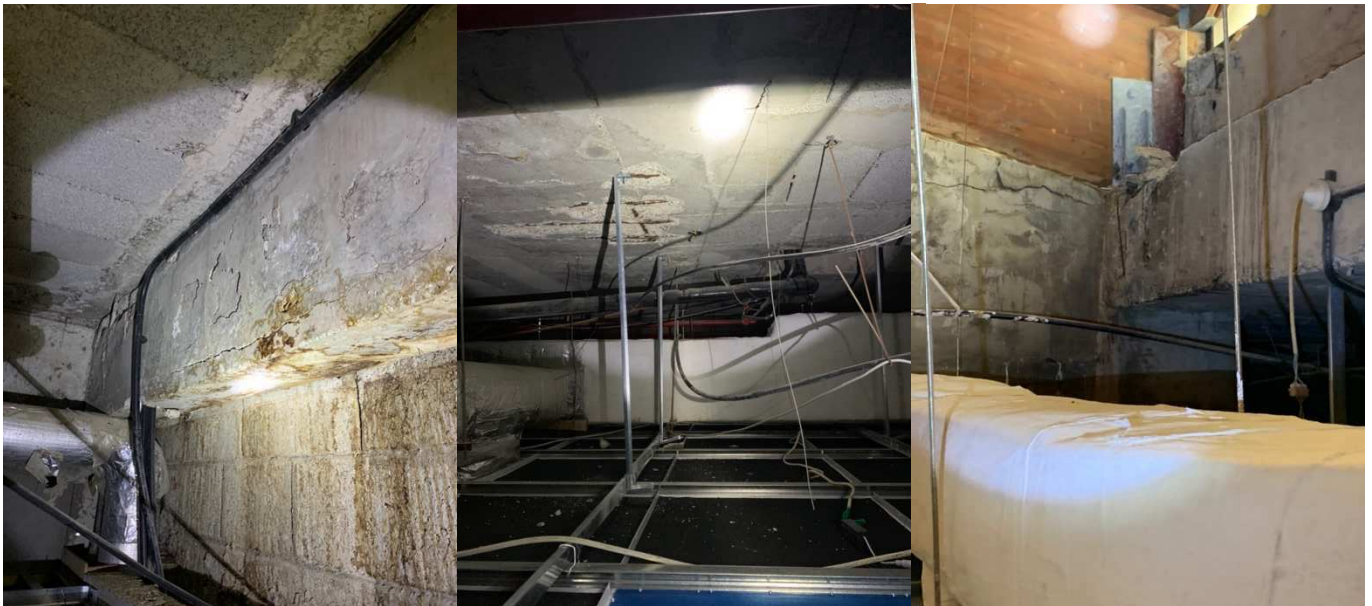
Some of Defect Photos

Some of the defects are deemed to be critical and require immediate action/attention: observation numbers: 3, 5, 6, 13, 14, 27, 29, 31, 32, 34, 35, 36, 39, 40, 44 and 51.

Some of those defects shows a degraded concrete beam / spalling slabs as show in below photographs (Refer to section 5 – Inspection Findings and recommendations for more details).

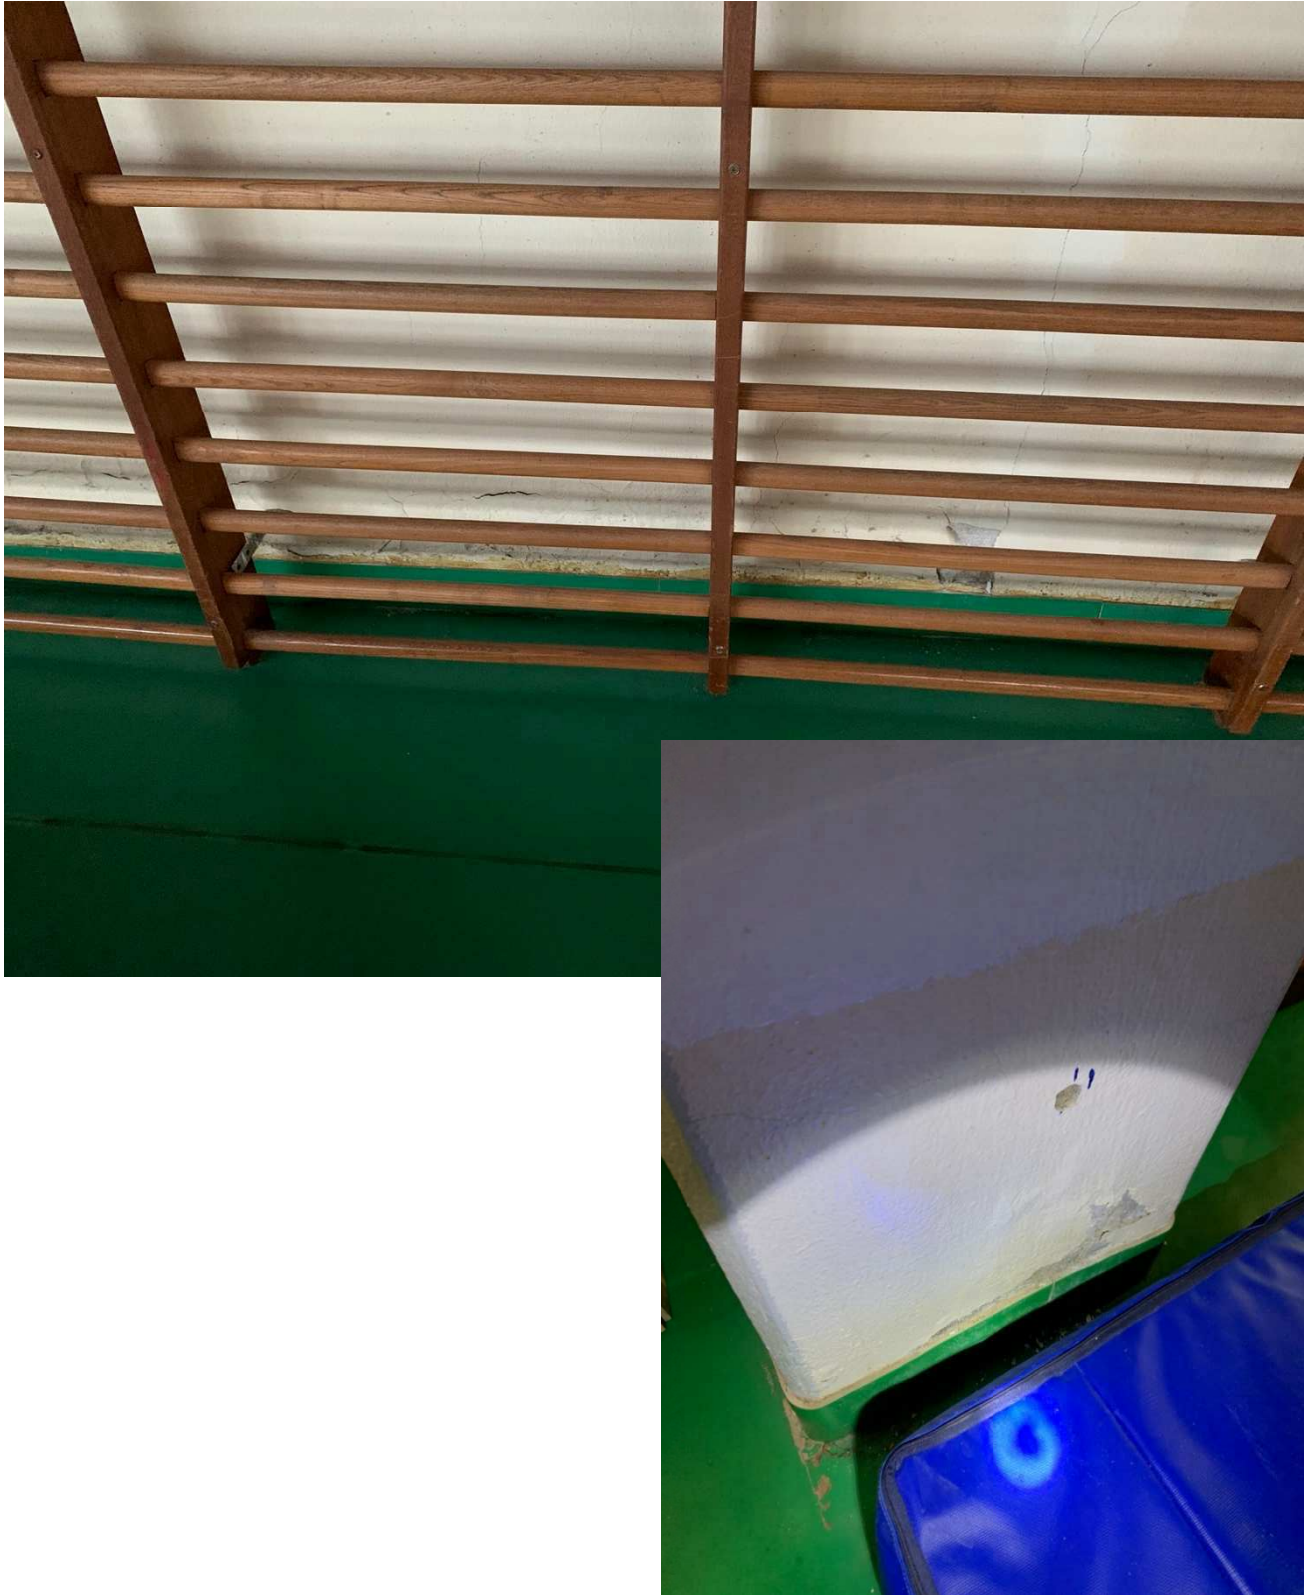
8

10	Gymnasium Building	28.25	-	4.00 mm	-	Refer to obs.no.8 -Number of vertical cracks has been observed on the exterior wall. A gauge meter has been installed in order to determine if those cracks are still developing.
11	Auditorium Building	30.00	-	0.90 mm	-	Refer to obs.no.38 -A diagonal crack on the wall with w=0.9mm. A crack gauge meter has been installed to check further development of the crack

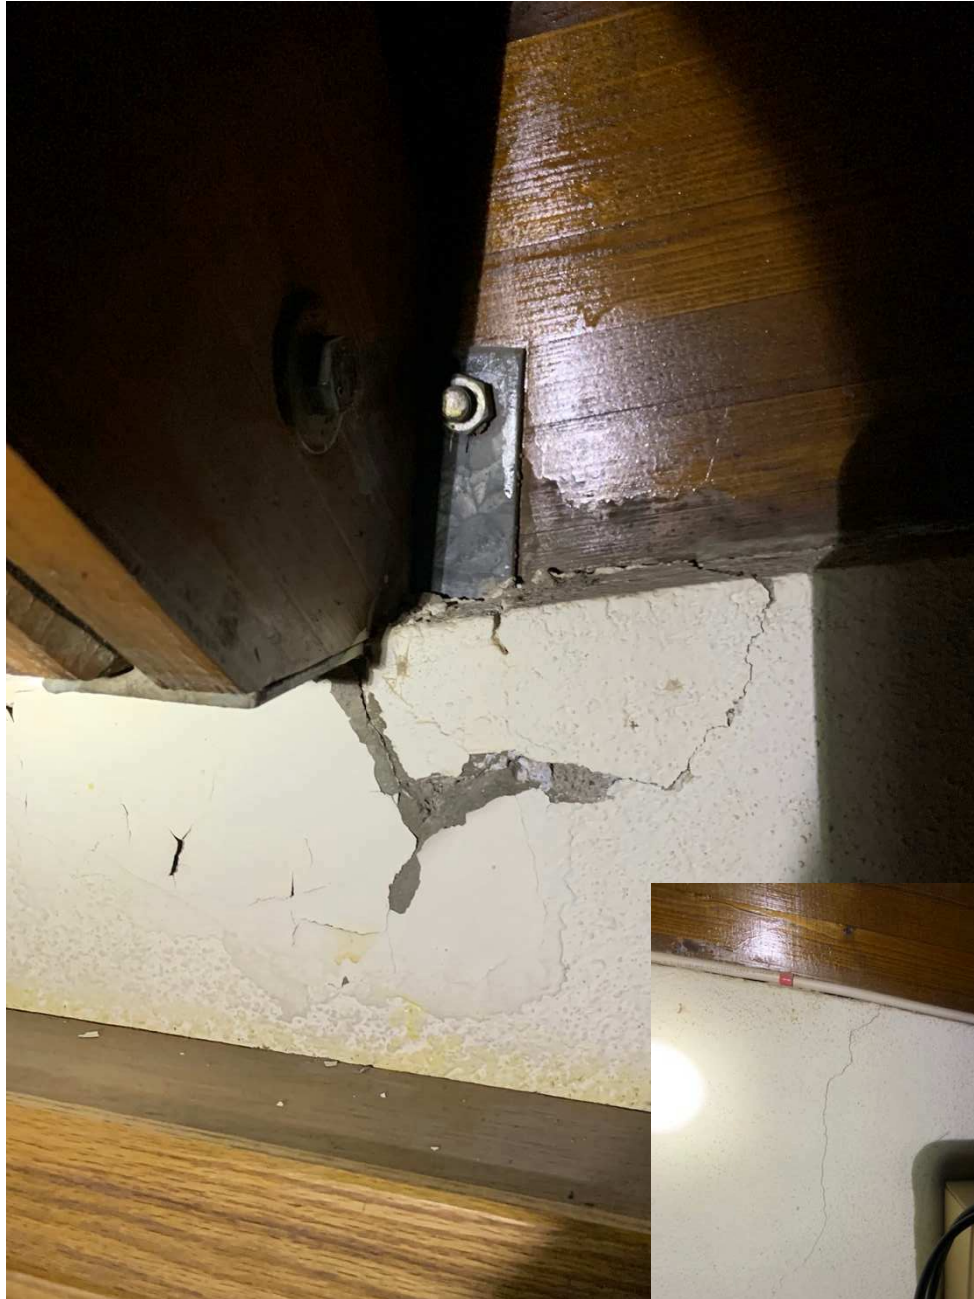
Obs.No.	Location	Defect	Recommendation
		-vertical crack on wall width <0.2mm	
11	Gymnasium Building (roof)	-Cracks on wall and column which is supporting the wooden girder -multiple cracks, w=0.5mm	-to be repaired
12	Gymnasium Building (roof)	-Cracks at junction between wall and column/beam	-to be repaired
13	Gymnasium Building (roof)	-Cracks, Exposed Corroded Rebar and concrete scalling on diagonal beams	-to be repaired
14	Gymnasium Building (roof)	Concrete Spalling and Exposed Corroded Rebars	-to be repaired
15	Gymnasium Building (roof)	Concrete Spalling, cracks in junction between column and wall, poor protective paint condition	-to be repaired
16	Auditorium Building (roof – as shown in defect location)	-Crack in between wall and beam -multiple cracks ranging from >0.2mm to 0.4mm	-to be repaired
17	Auditorium Building (roof – as shown in defect location)	-Vertical Crack on wall w=0.35mm	-to be visually monitored yearly to check any visually observable abnormalities

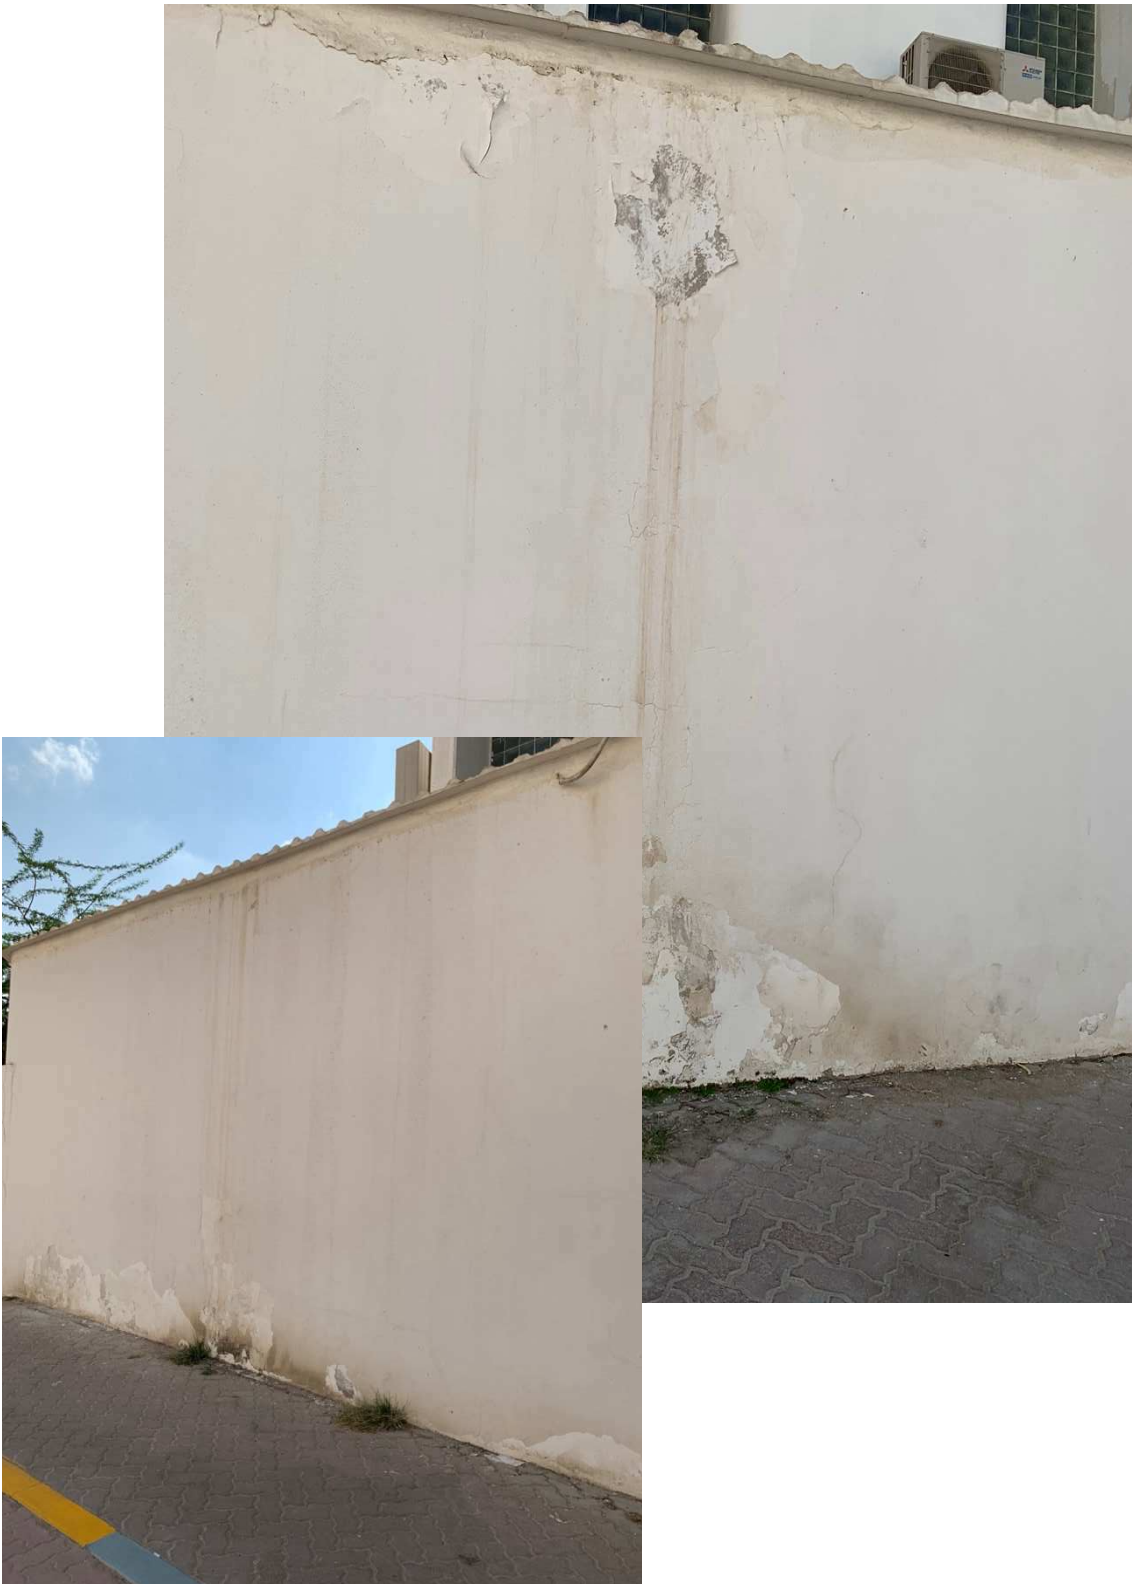
46	Gymnasium Building (corner column at the exit towards the road)	-Concrete spalling / crack, w=0.4mm	-to be repaired
47	Gymnasium Building (corner column at the exit towards the road)	Concrete crack at the junction between column and wall , w=0.3mm	-to be visually monitored yearly to check any visually observable abnormalities
