RENOVATION OF BLOCK B' FOR FRENCH SCHOOL (LYCEE LOUIS MASSIGNON)

CONCRETE REPAIRS AND STRUCTURAL REINFORCEMENT

**VOLUME 5 – Part 5 of 7
M/s eForce Inspection Consultancies
Report eForce/1588/2023 dated October 17th, 2023**

**VISUAL INSPECTION OF THE GYMNASIUM, SWIMMING POOL AND
AUDITORIUM LYCÉE LOUIS MASSIGNON SCHOOL, ABU DHABI, UAE
(Preliminary report)**

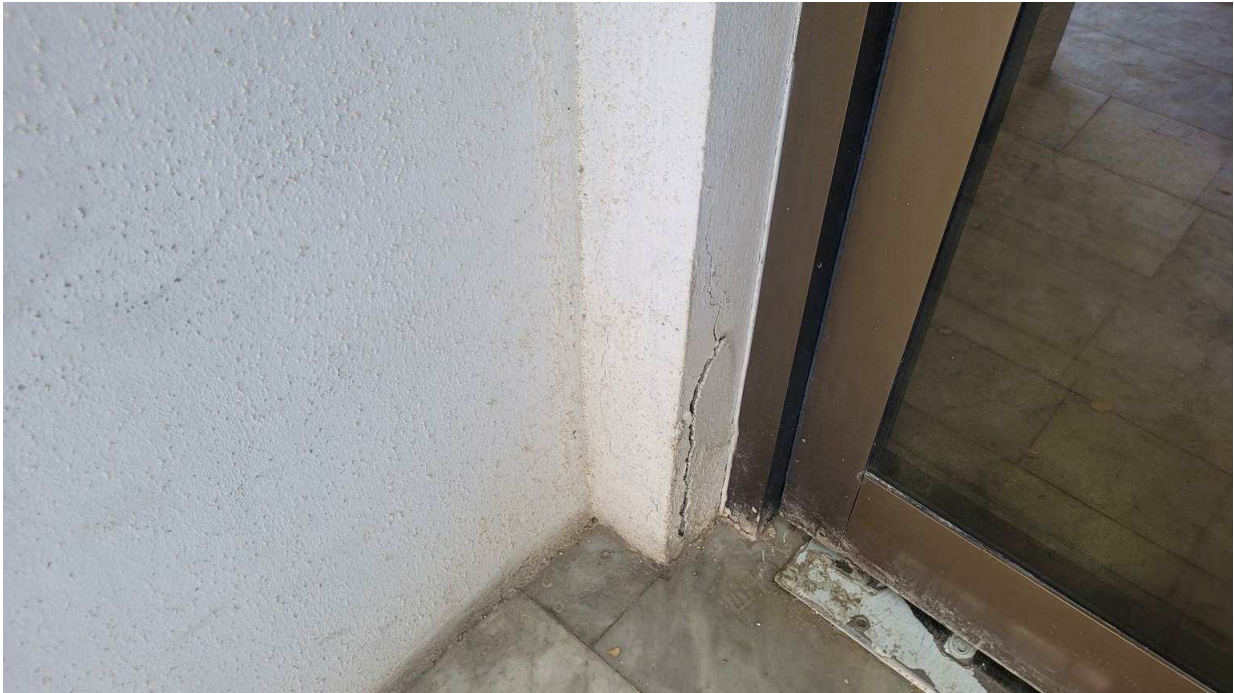
- Figure 4-1 Delamination in column

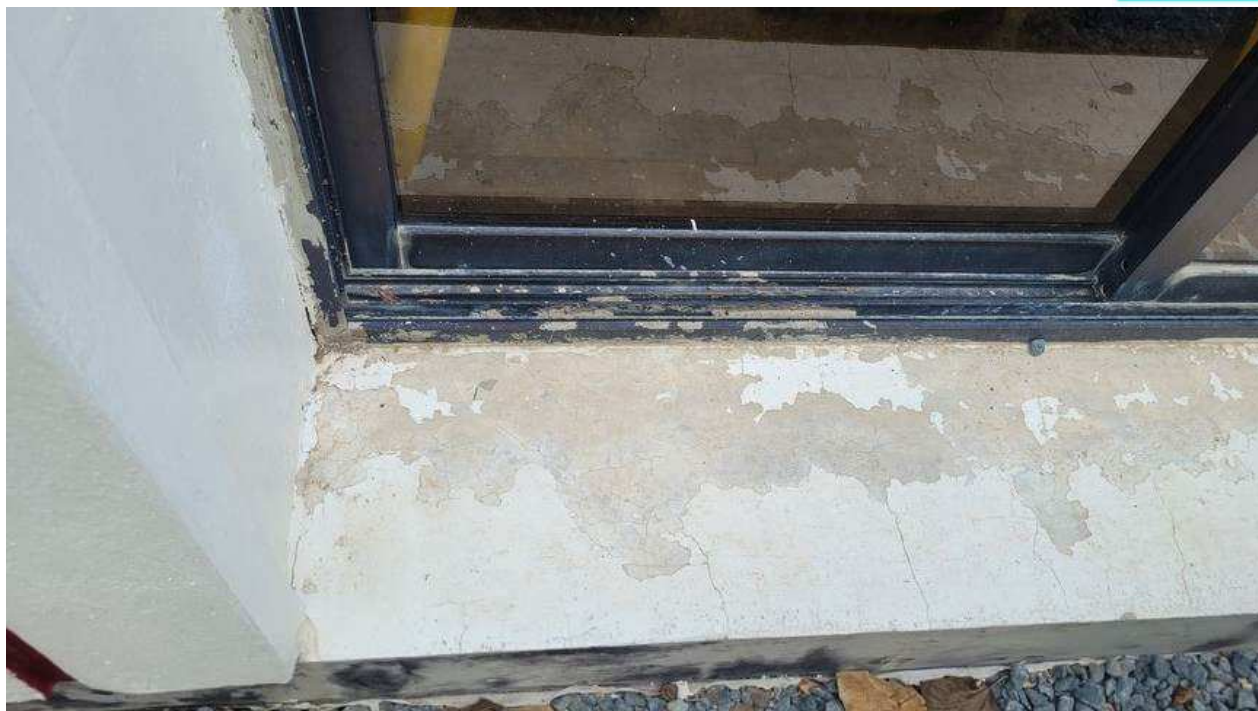
- Figure 4-3 Dampness and cracks in ground beam

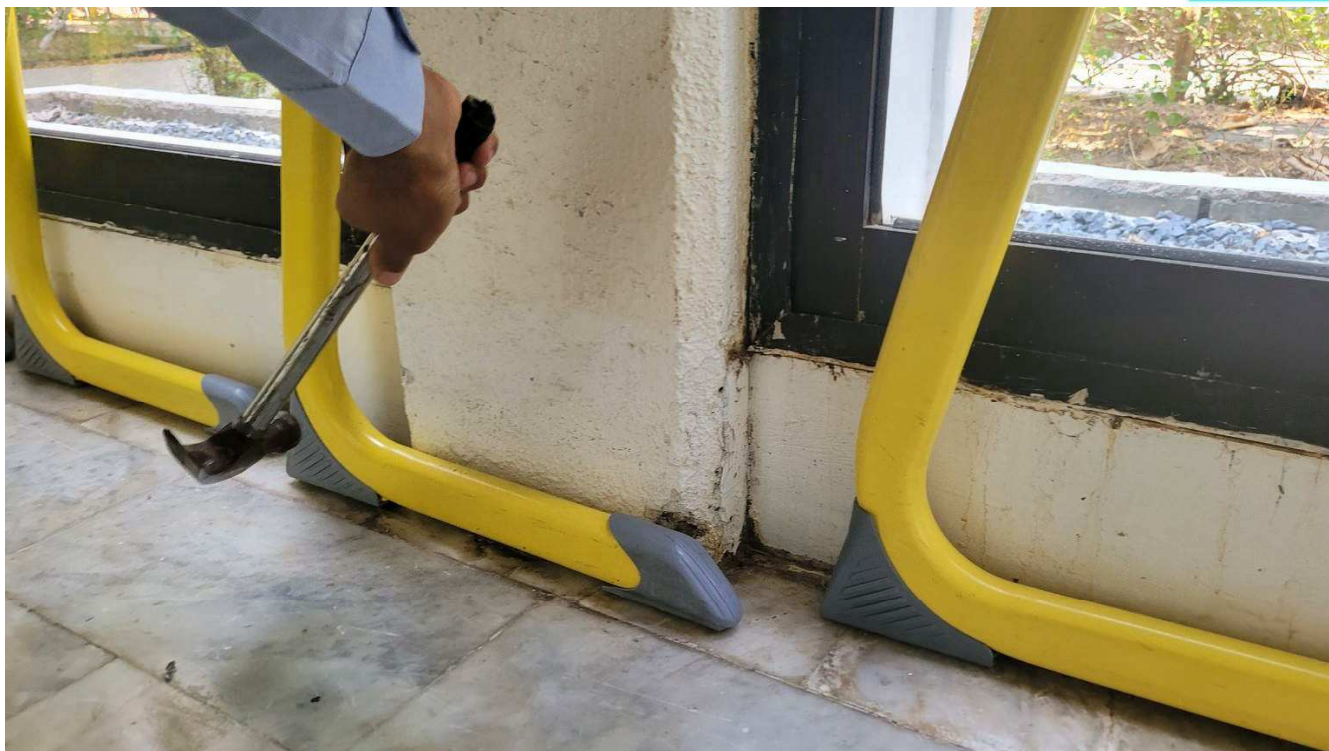
- Figure 4-5 Hollow sound while hammer testing

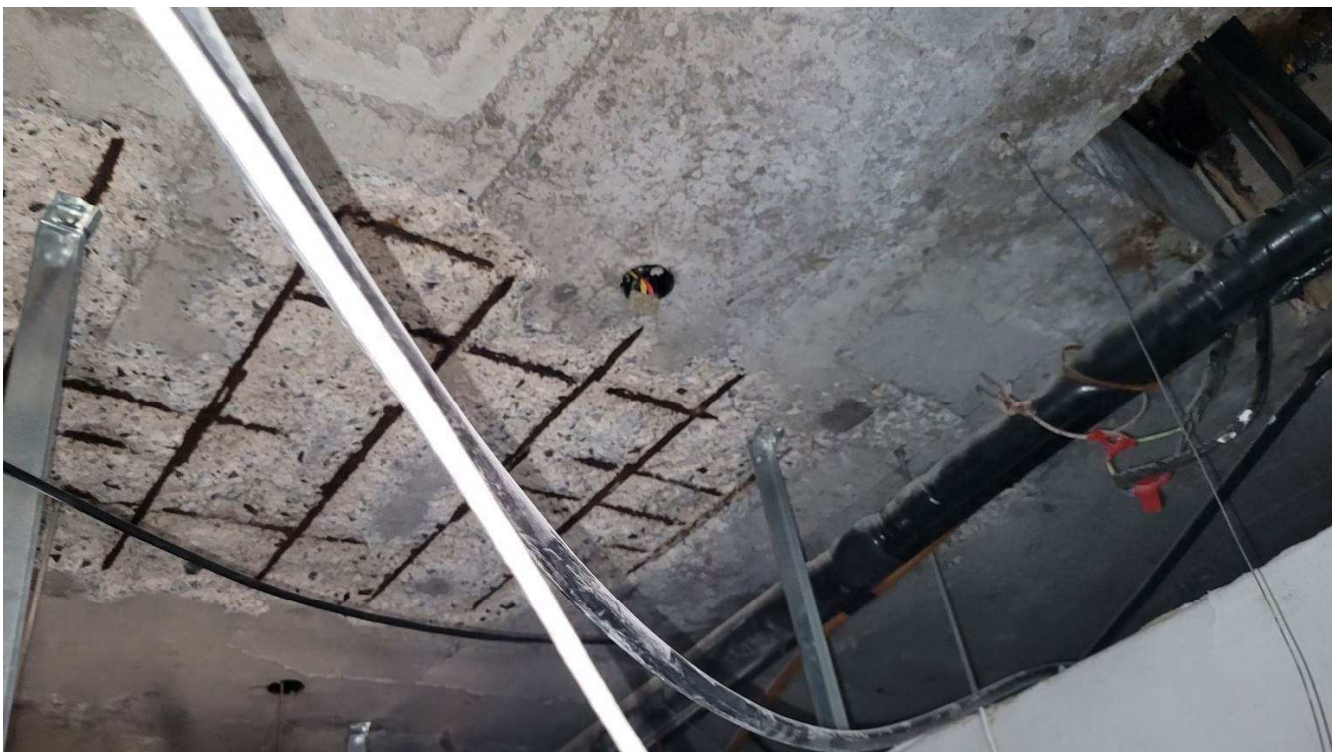
Figure 4-10 Steel exposure with corrosion in slab soffit

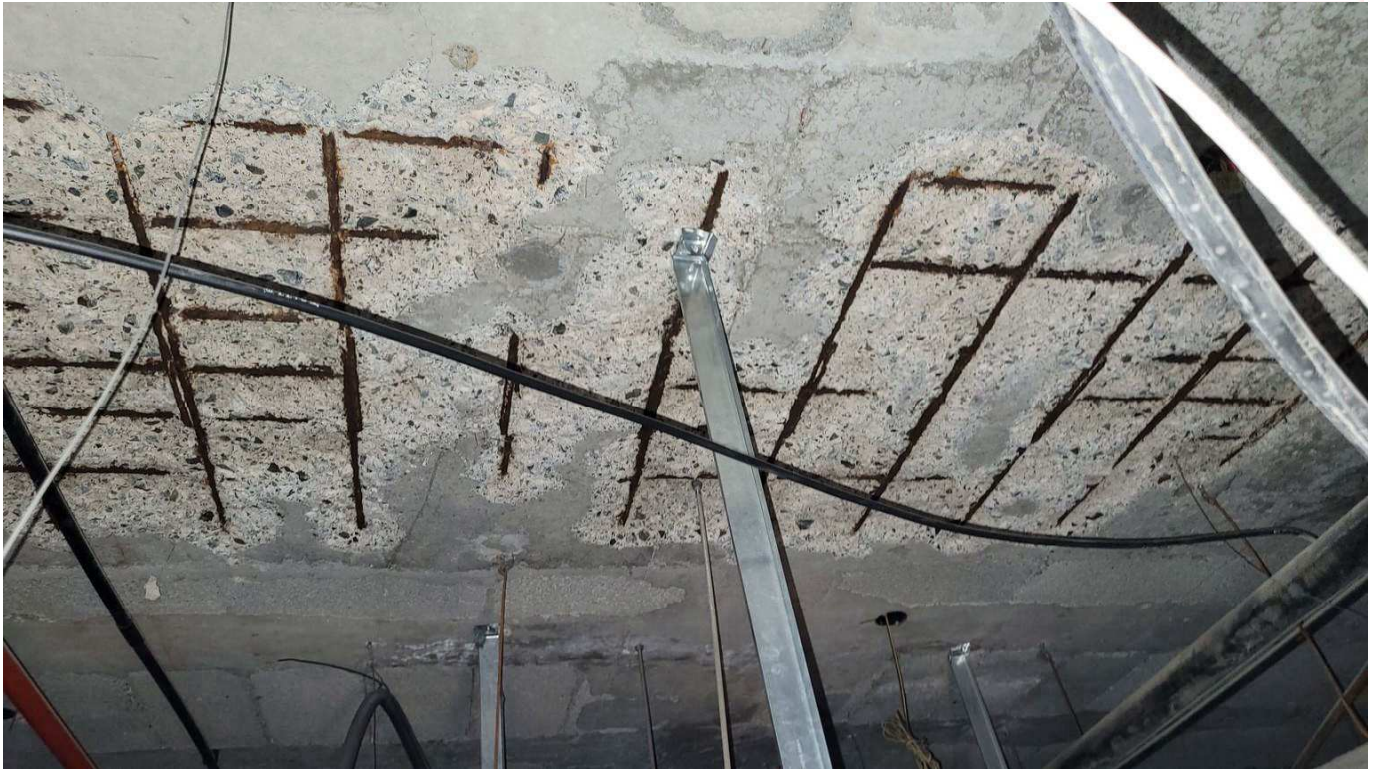
Figure 4-11 Steel exposure with corrosion in slab soffit

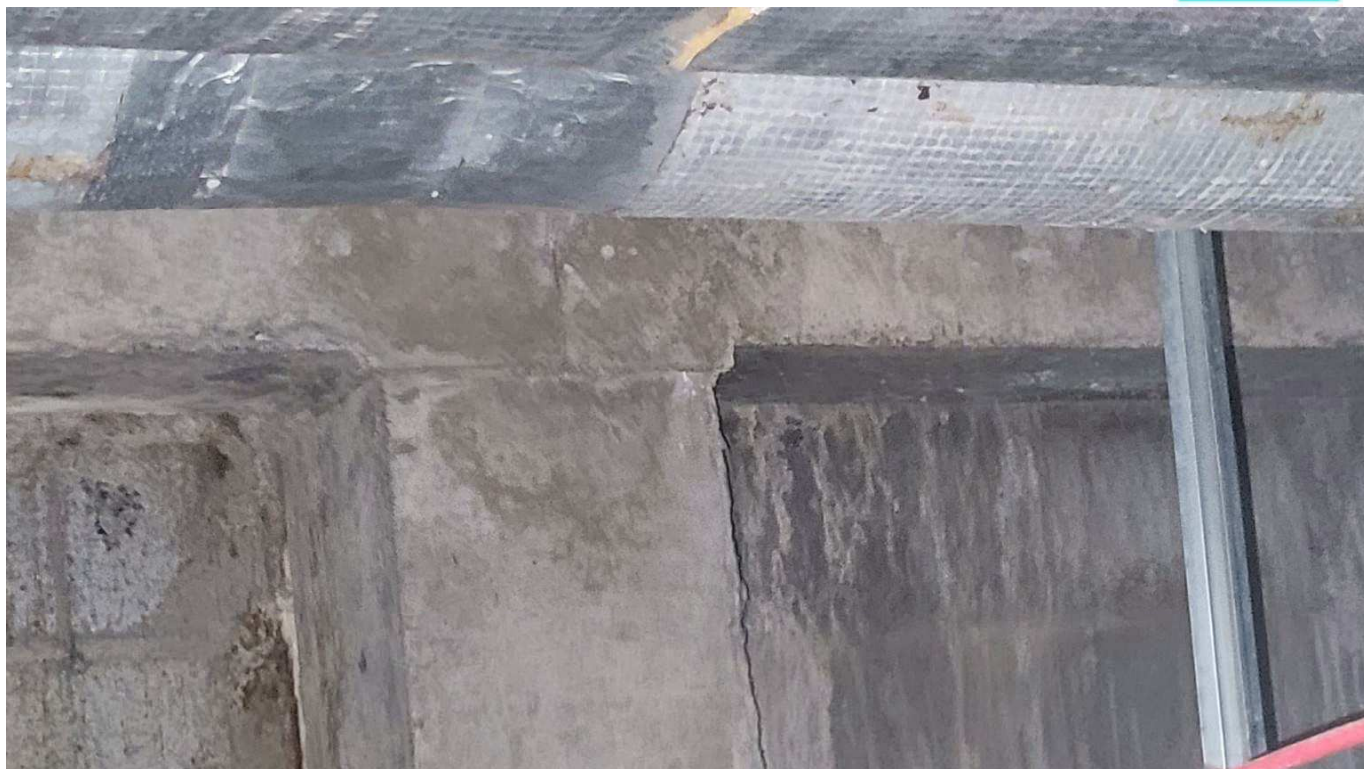
Figure 4-13 Previous leakage in beam and block wall

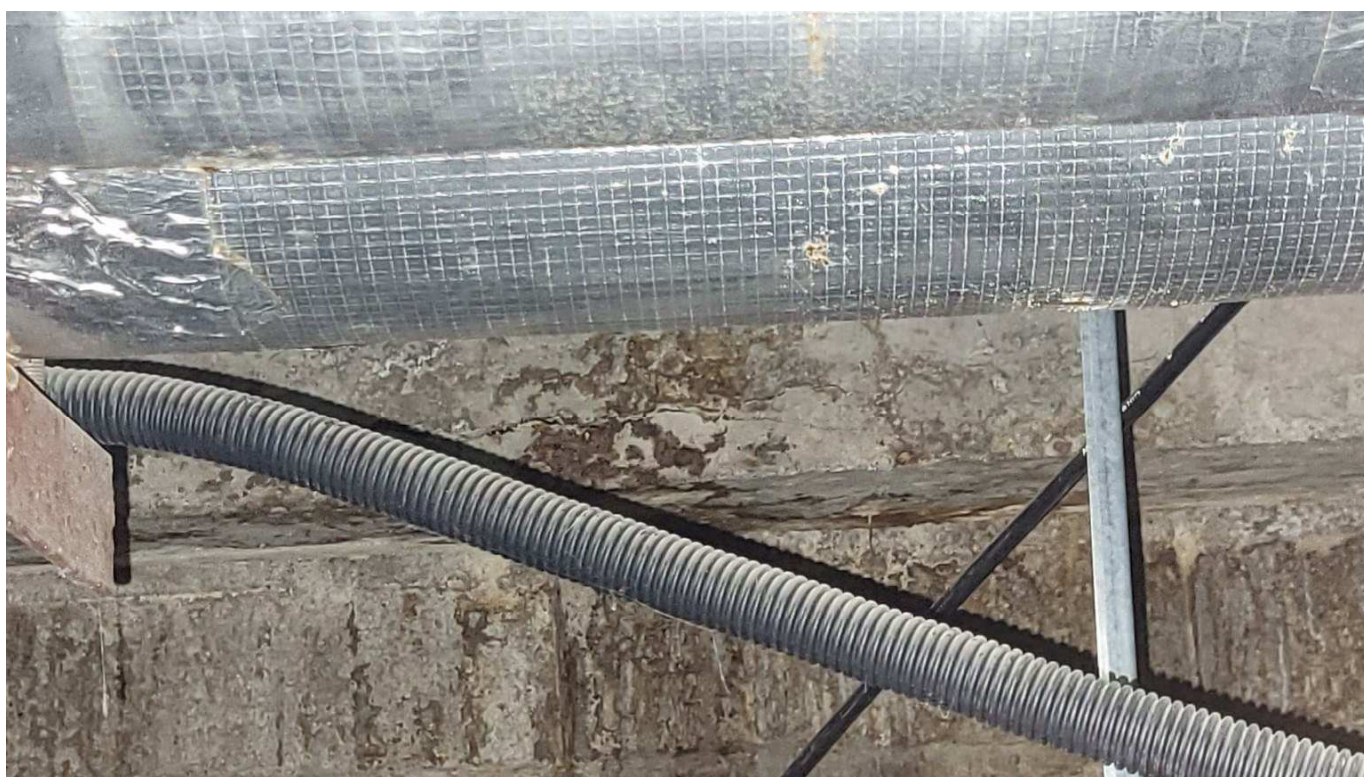
Figure 4-14 Delamination in beam

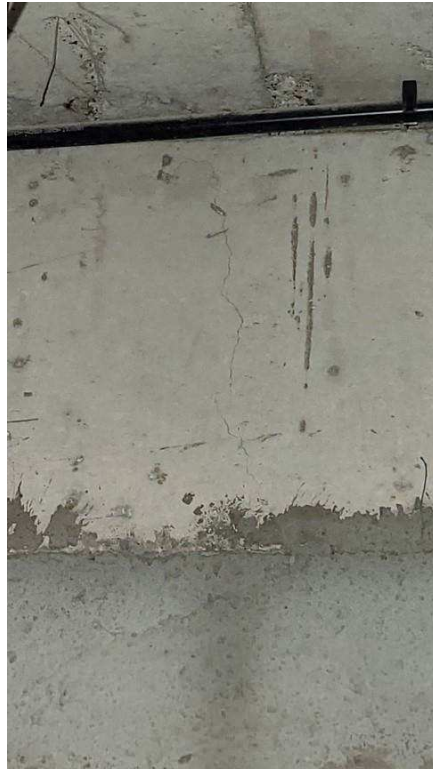
Figure 4-15 Crack in beam

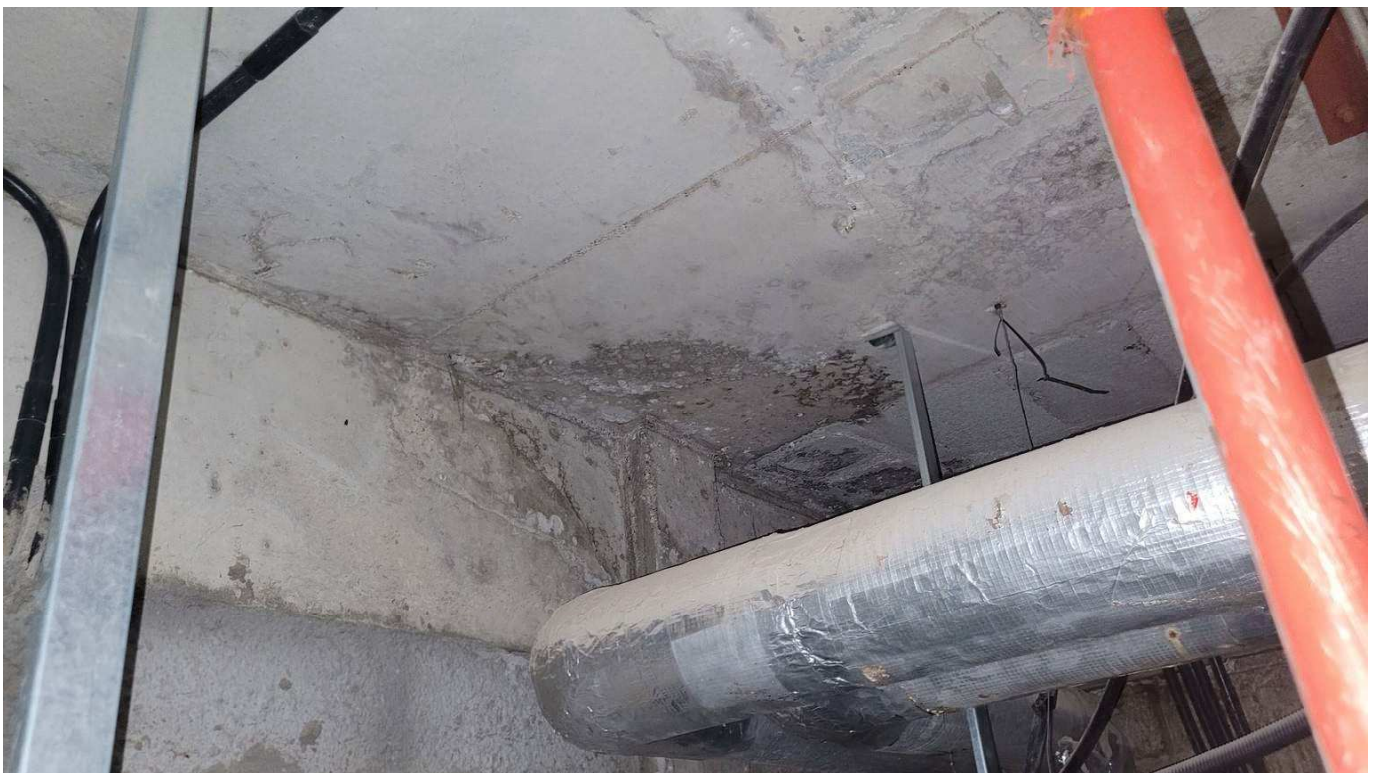
Figure 4-16 Previous leakage in beam and slab

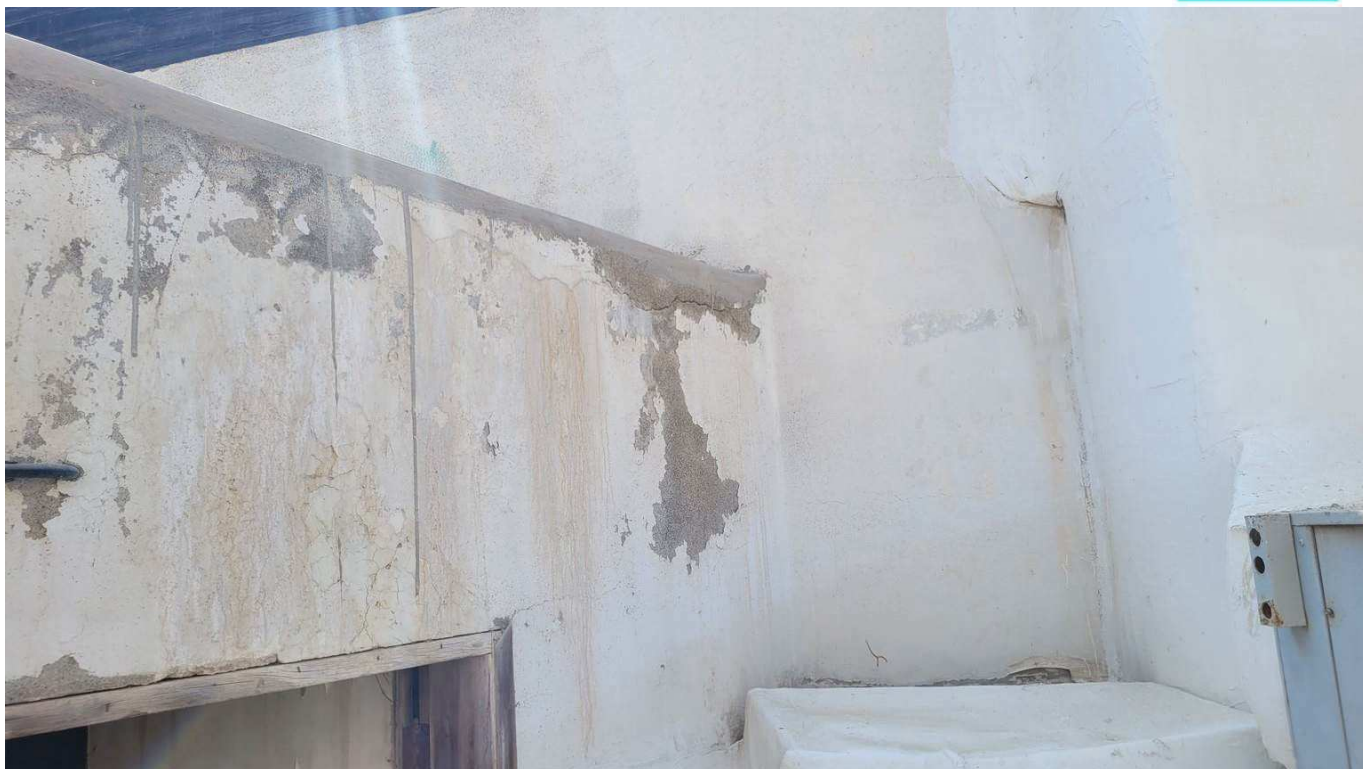
Figure 4-17 Previous leakage and cracks in roof walls and ceiling

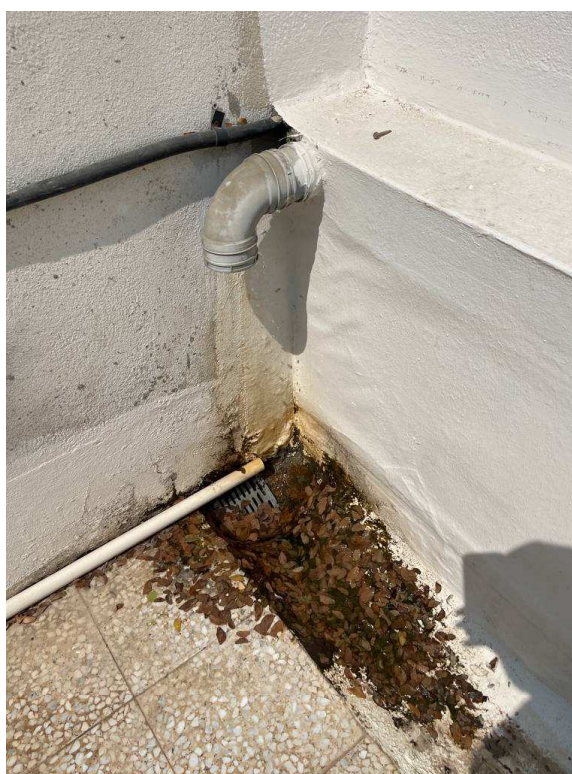
Figure 4-18 Sign of previous leakage in walls

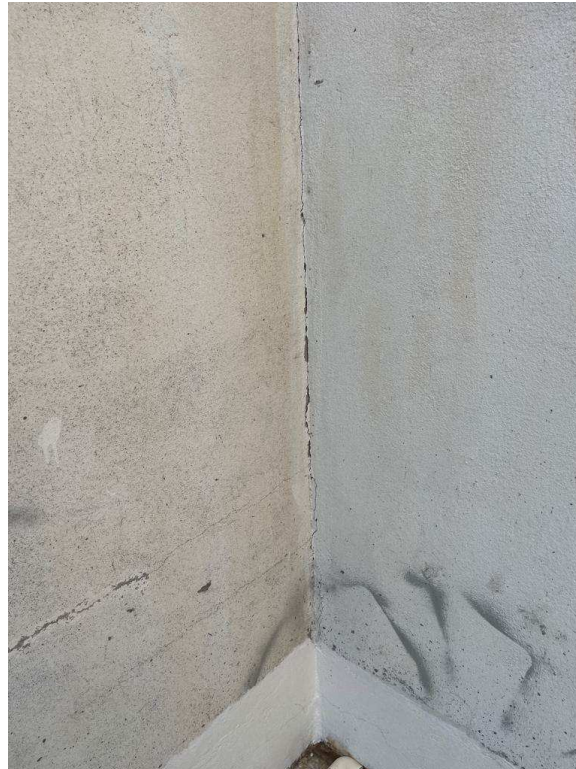
Figure 4-19 Cracks between block walls

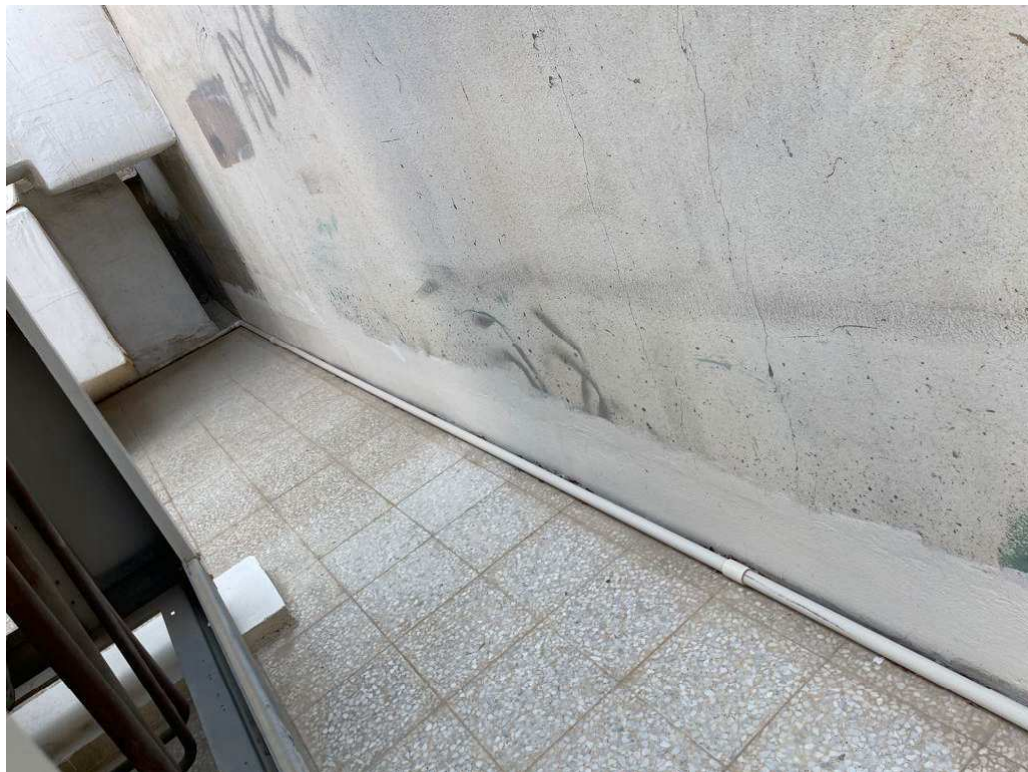
Figure 4-20 Cracks between block walls and concrete elements

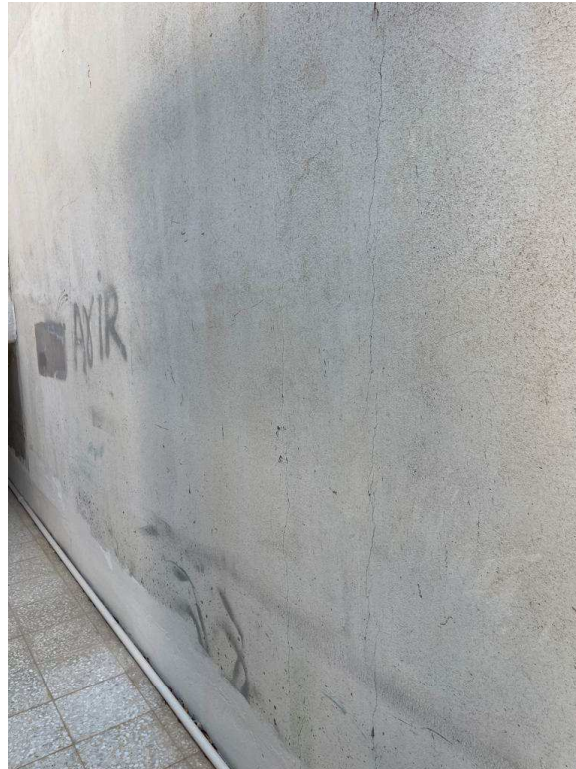
Figure 4-21 Cracks between block wall and concrete elements

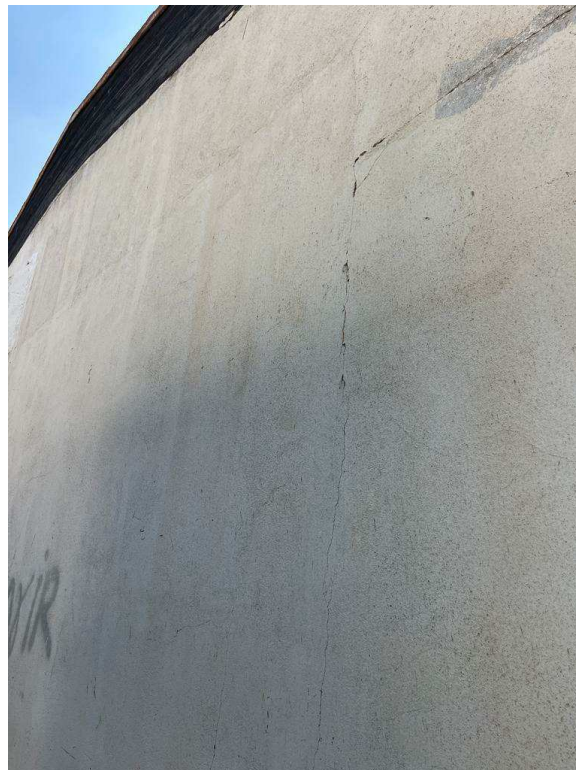
Figure 4-22 Dampness in block wall

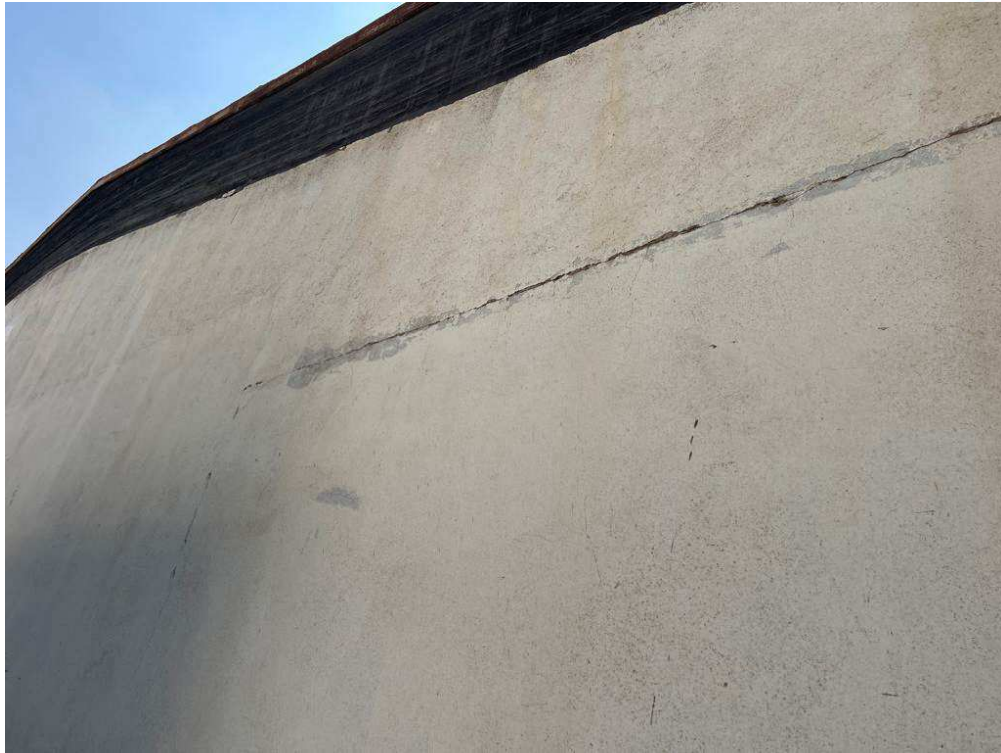
Figure 4-23 Crack between block wall and concrete element

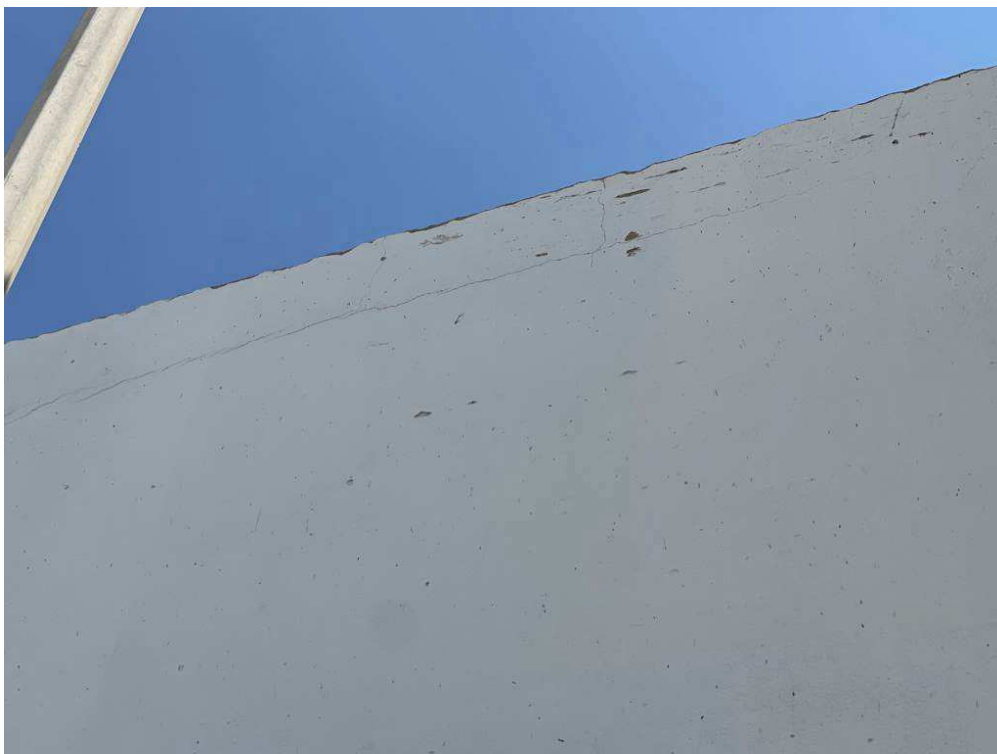
Figure 4-24 Crack between block wall and slab

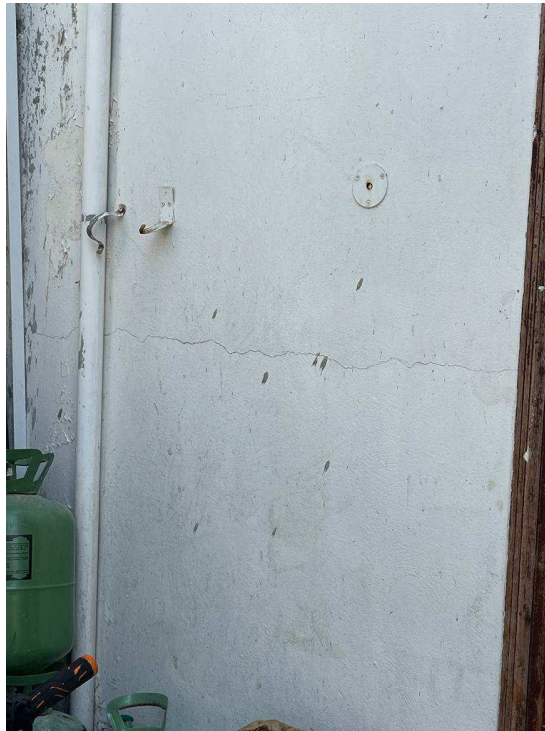
Figure 4-25 Crack between block wall

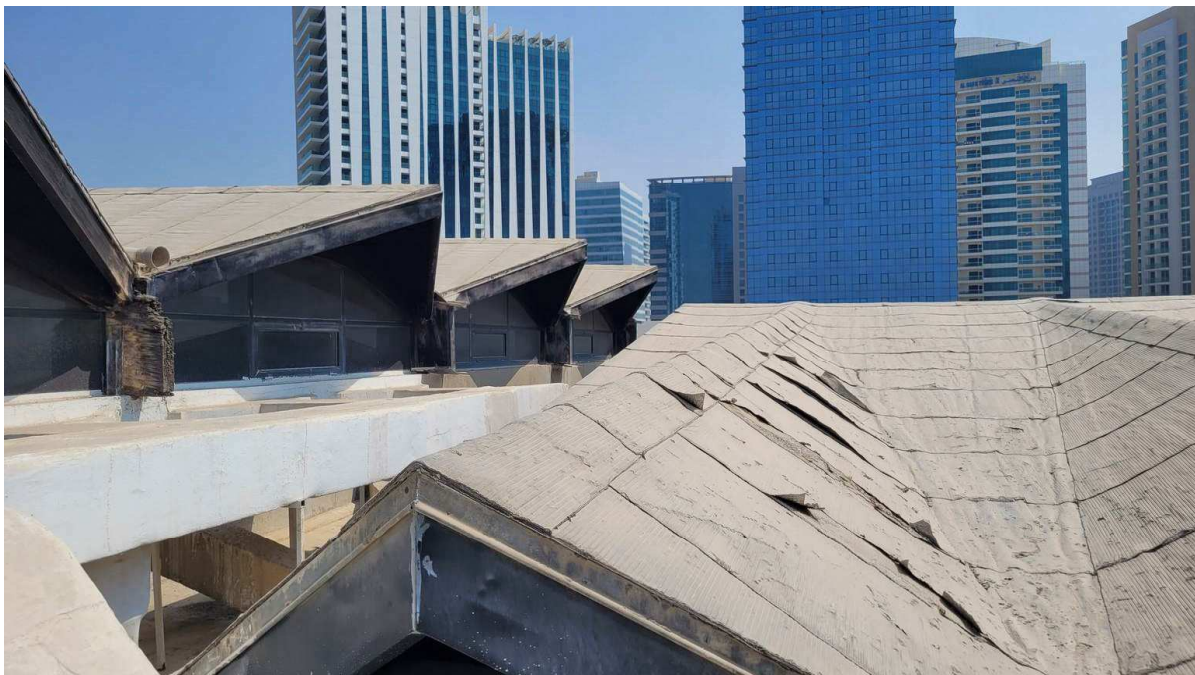
Figure 4-26 Dampness in wooden roof

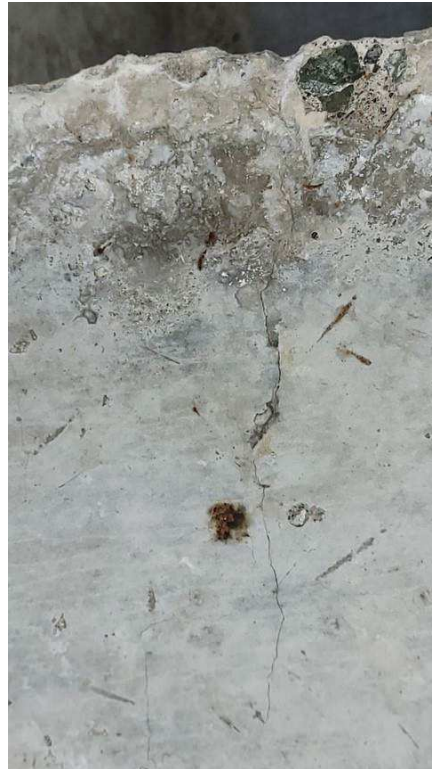
Figure 4-31 Crack in slab soffit

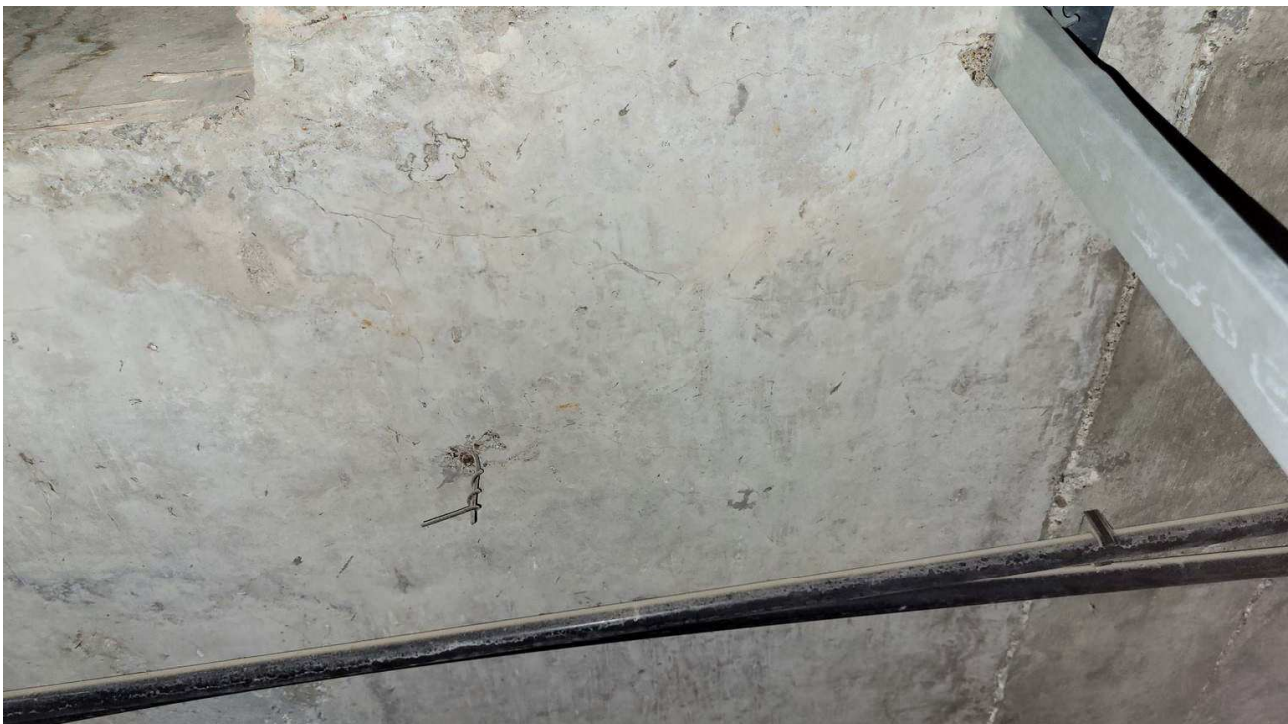
Figure 4-32 cracks in slab soffit

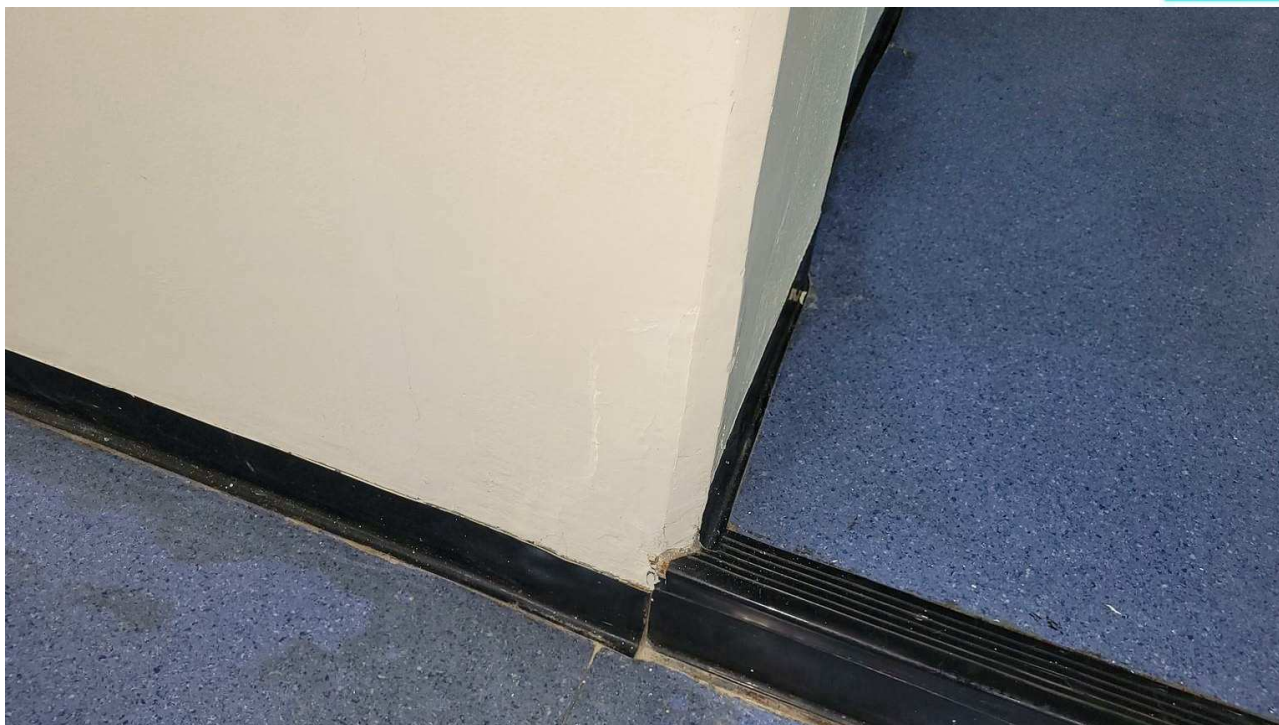
Figure 4-33 Delamination in column

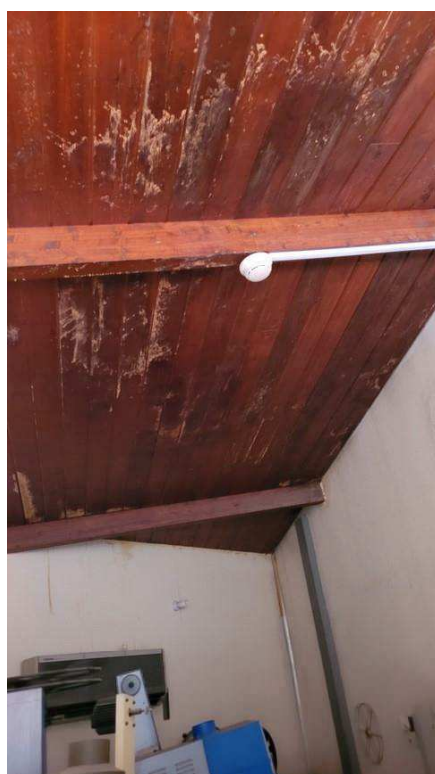
Figure 4-34 previous leakage in wooden roof

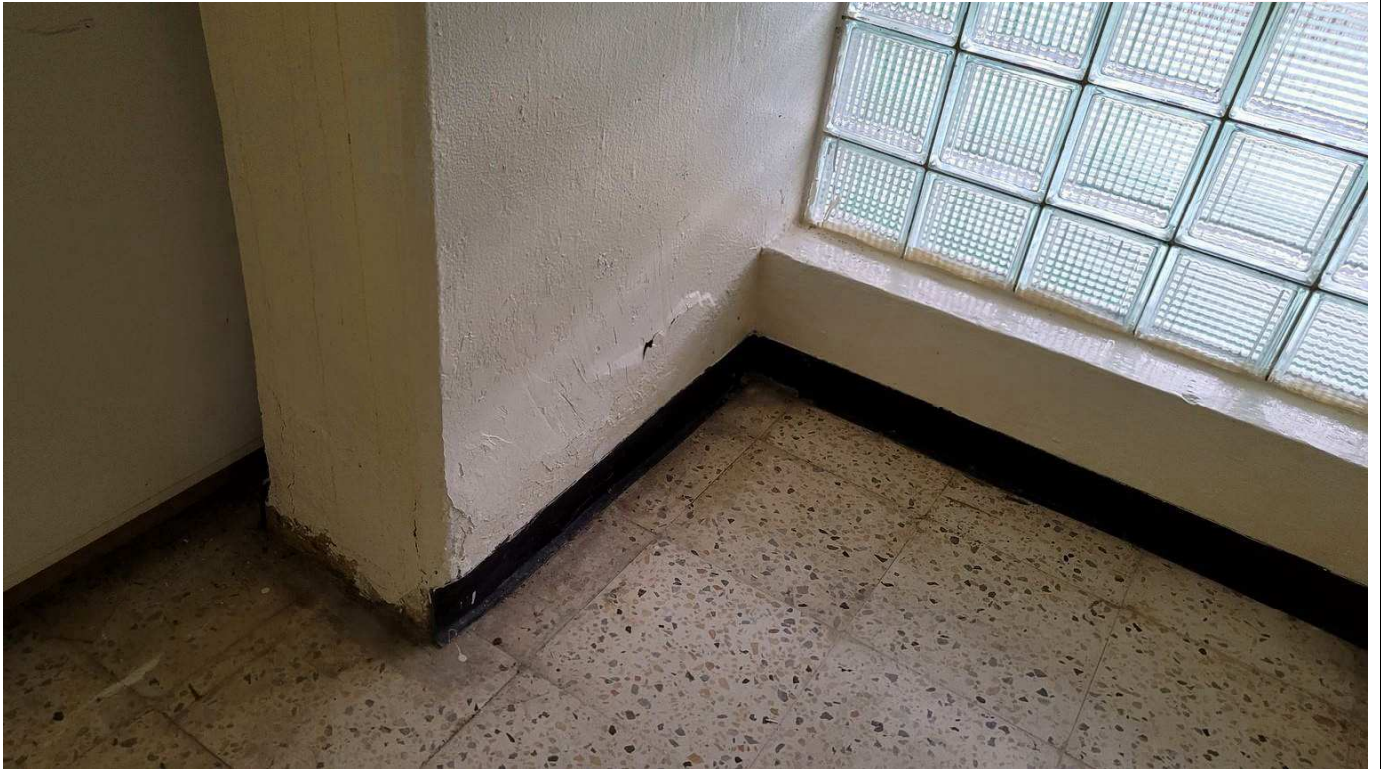
Figure 4-37 delamination in column

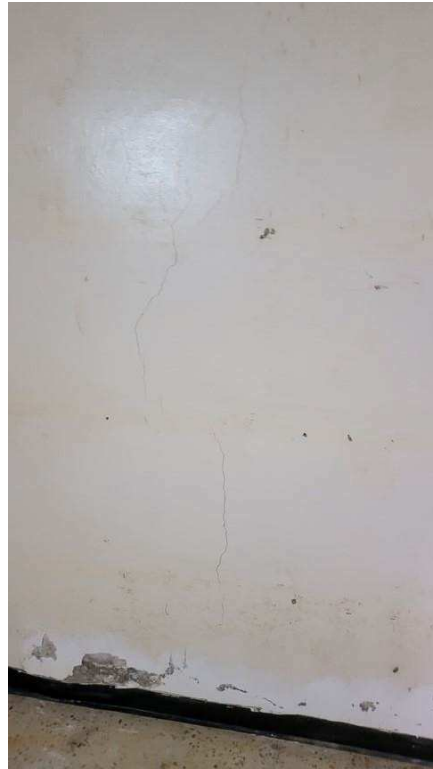
Figure 4-39 Dampness and cracks in block walls

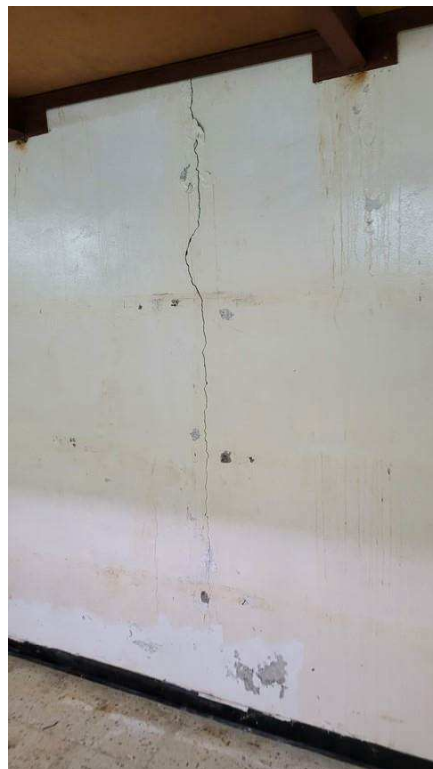
Figure 4-40 Dampness and cracks in block walls

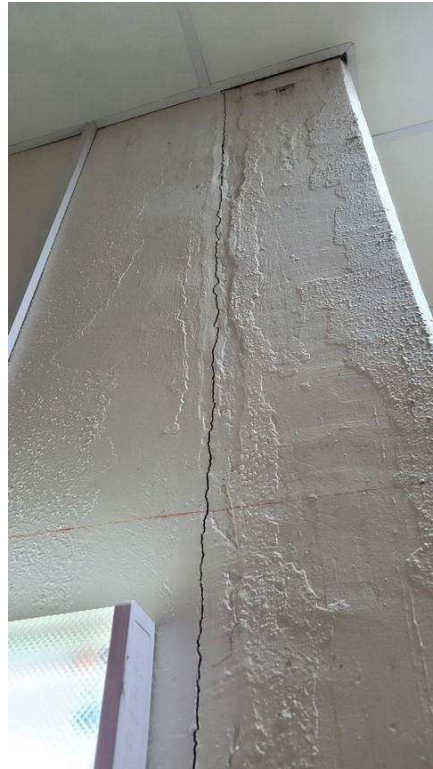
Figure 4-41 crack between block wall and concrete element

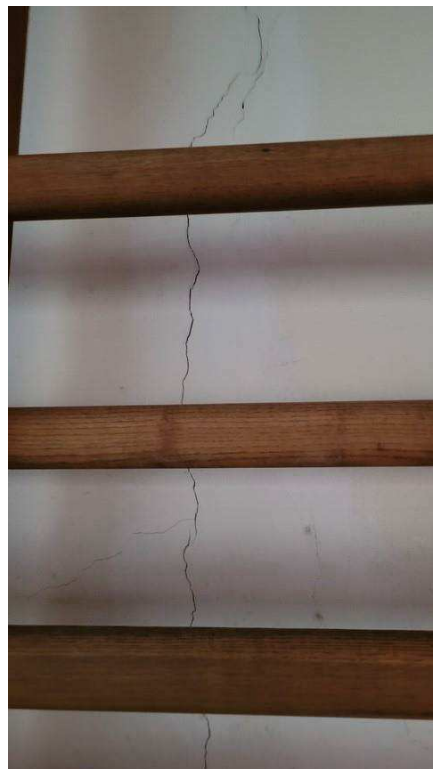
Figure 4-42 cracks in block wall

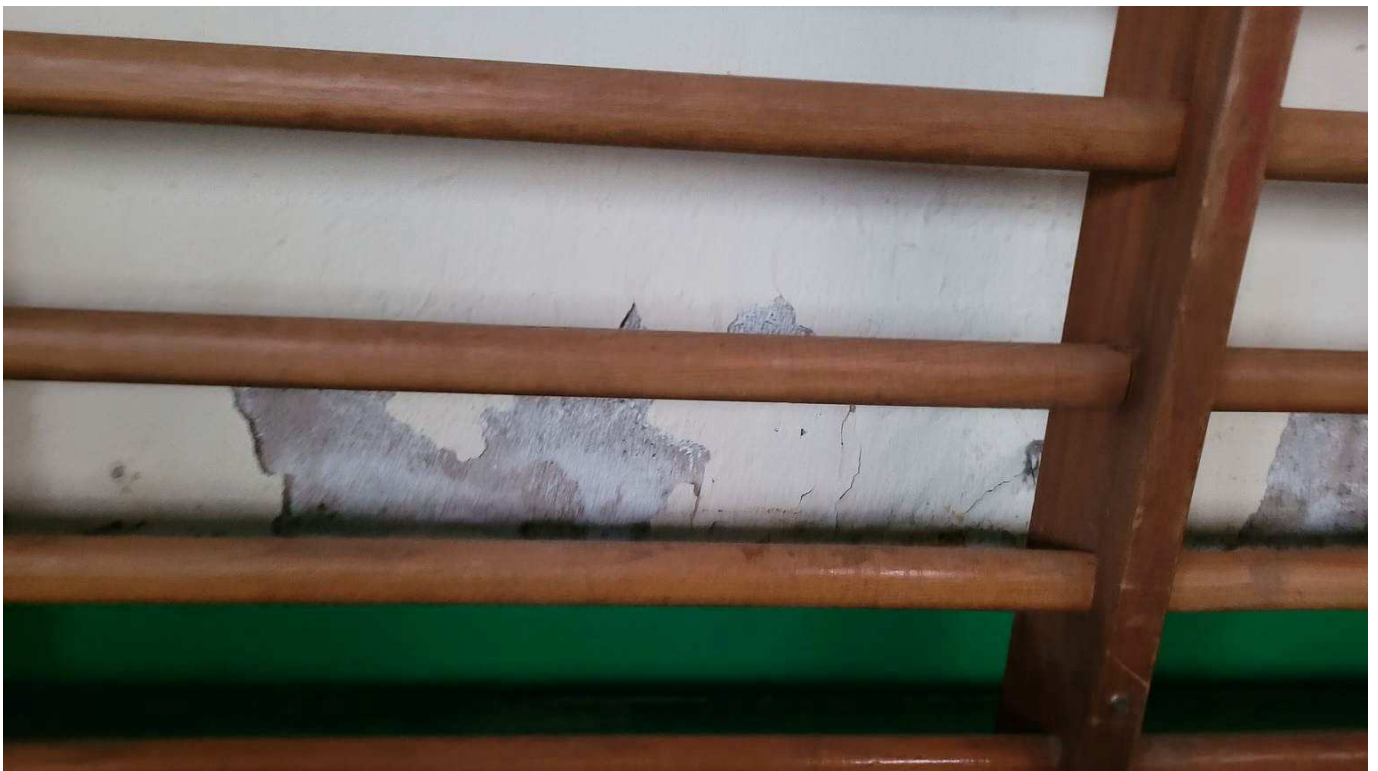
Figure 4-44 Dampness and delamination in ground beam

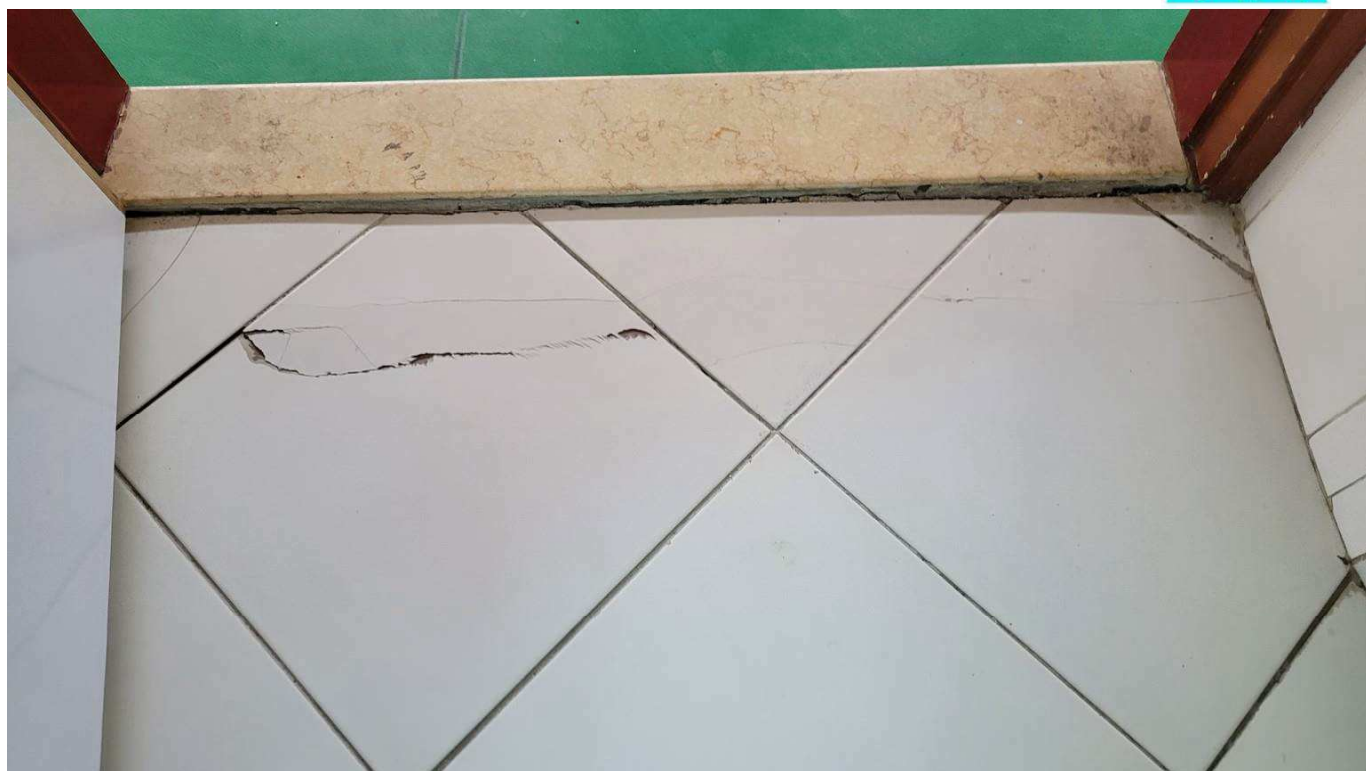
Figure 4-47 cracks in tiles in toilets in gym

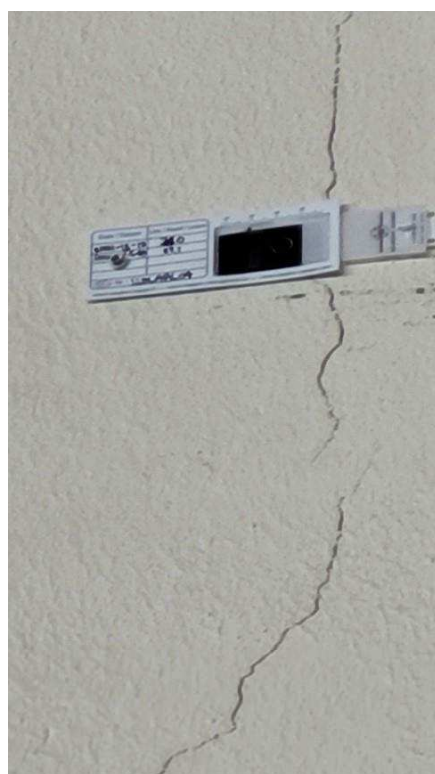
Figure 4-48 Crack in concrete wall
