RENOVATION OF BLOCK B' FOR FRENCH SCHOOL (LYCEE LOUIS MASSIGNON)

CONCRETE REPAIRS AND STRUCTURAL REINFORCEMENT

**VOLUME 5 – Part 5 of 7
M/s eForce Inspection Consultancies
Report eForce/1588/2023 dated October 17th, 2023**

**VISUAL INSPECTION OF THE GYMNASIUM, SWIMMING POOL AND
AUDITORIUM LYCÉE LOUIS MASSIGNON SCHOOL, ABU DHABI, UAE
(Preliminary report)**

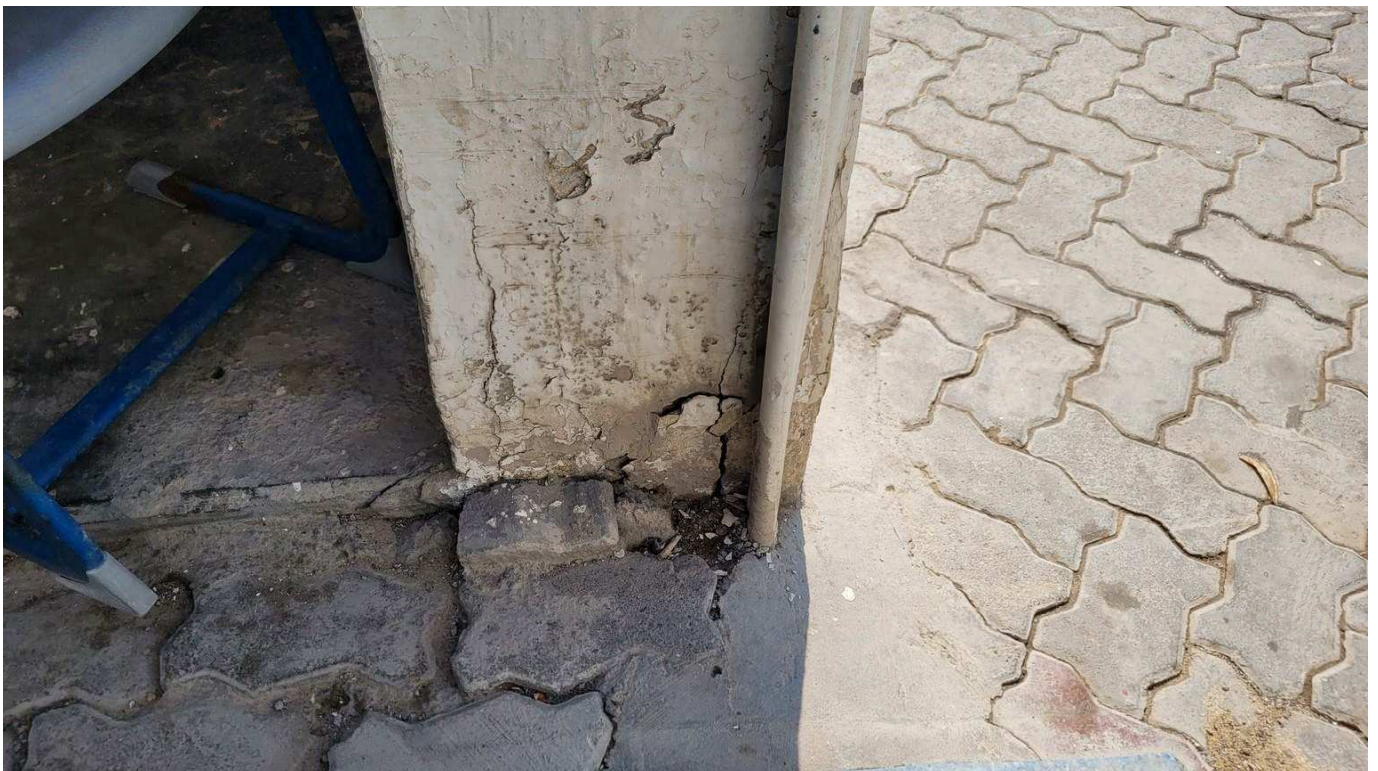
Figure 4-50 delamination and previous leakage in column

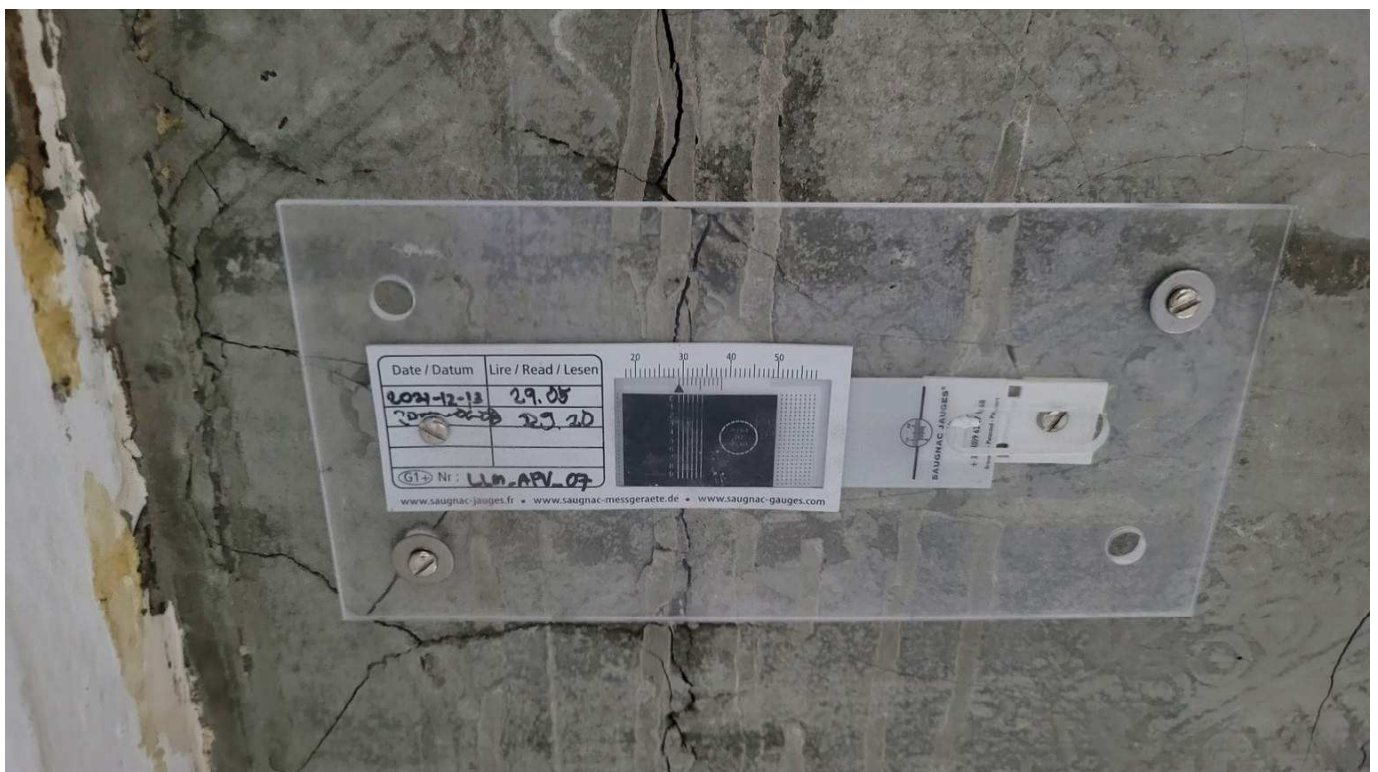
Figure 4-52 cracks and delamination in concrete wall below stands

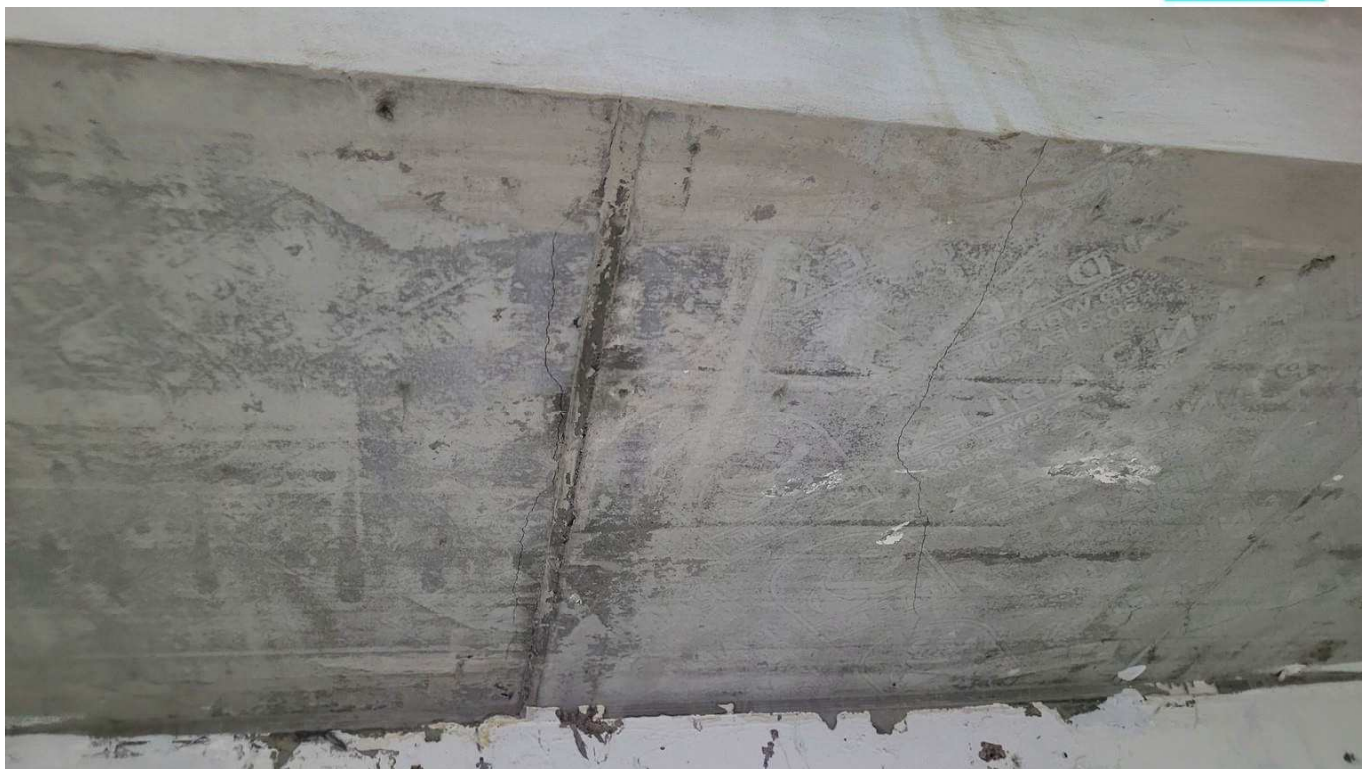
Figure 4-53 cracks in stands soffit

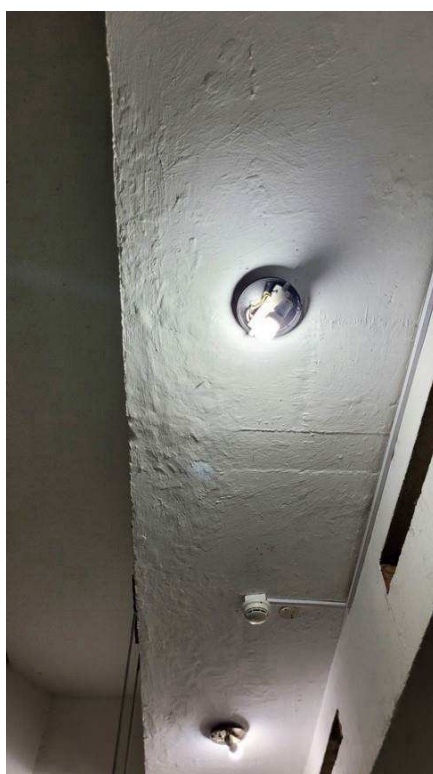
Figure 4-54 previous leakage in stands soffit

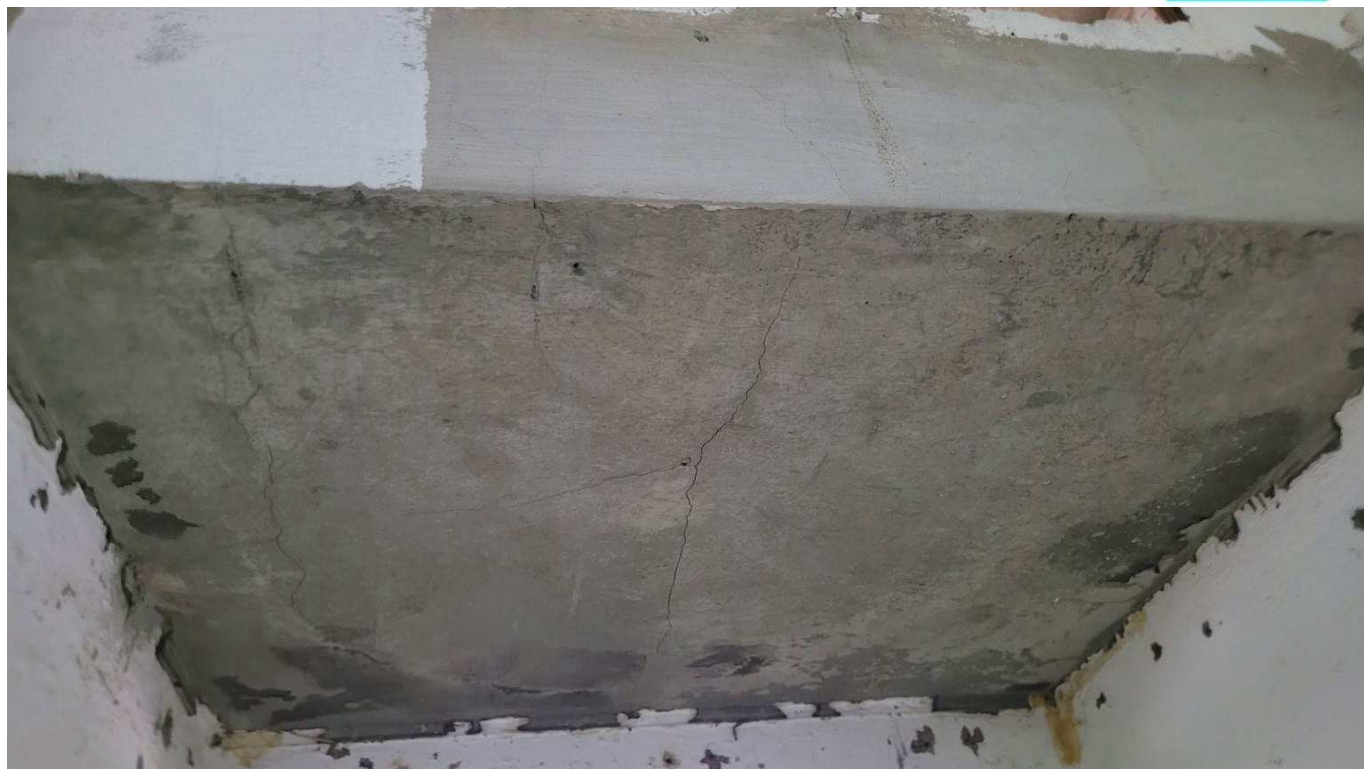
Figure 4-55 Delamination in stands soffit

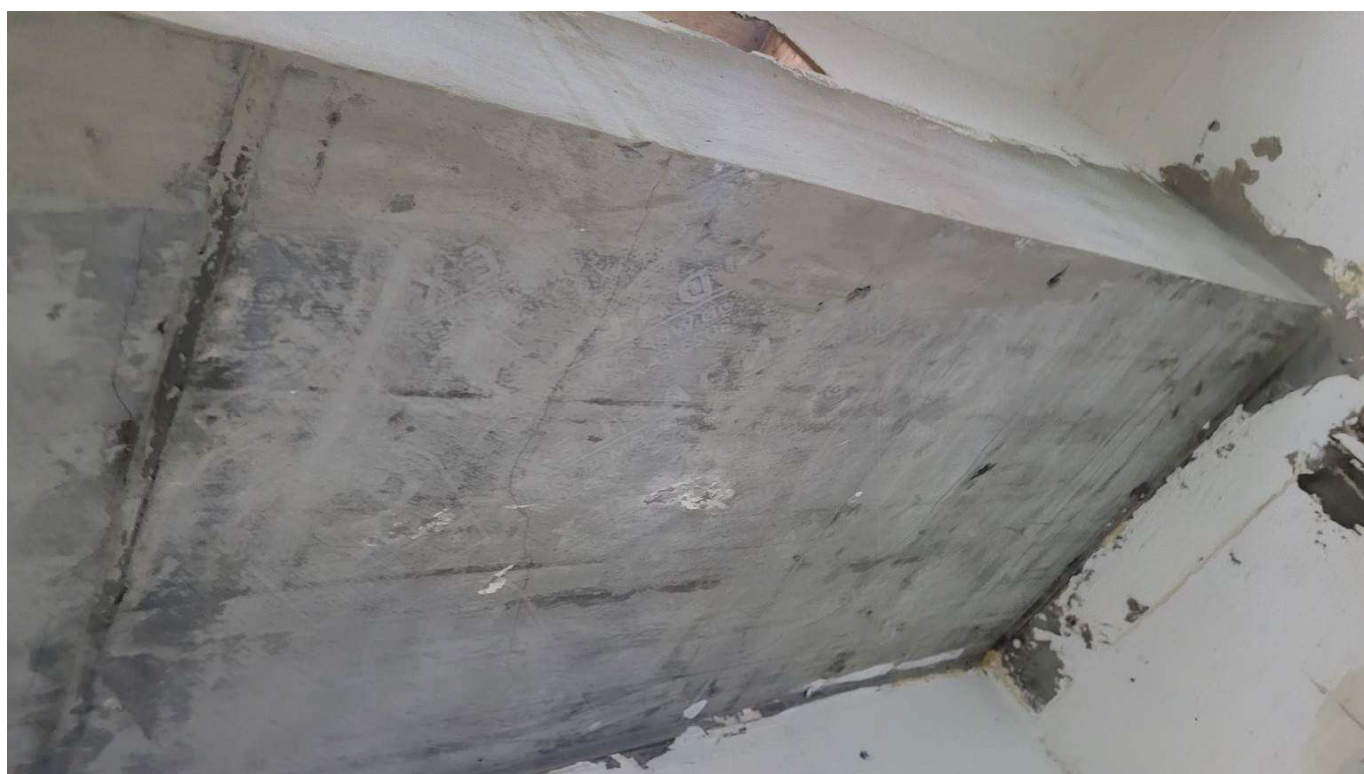
Figure 4-56 Cracks in stands soffit

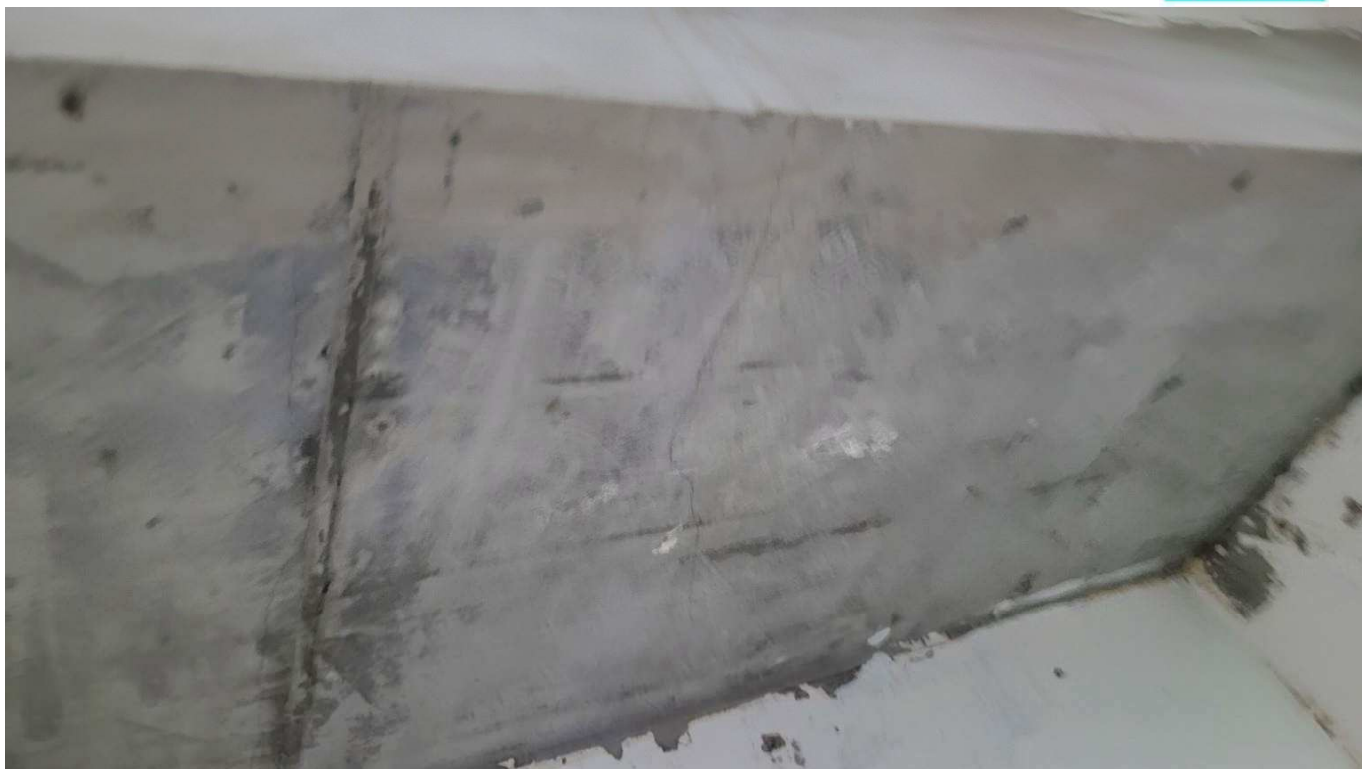
Figure 4-57 Cracks in stands soffit

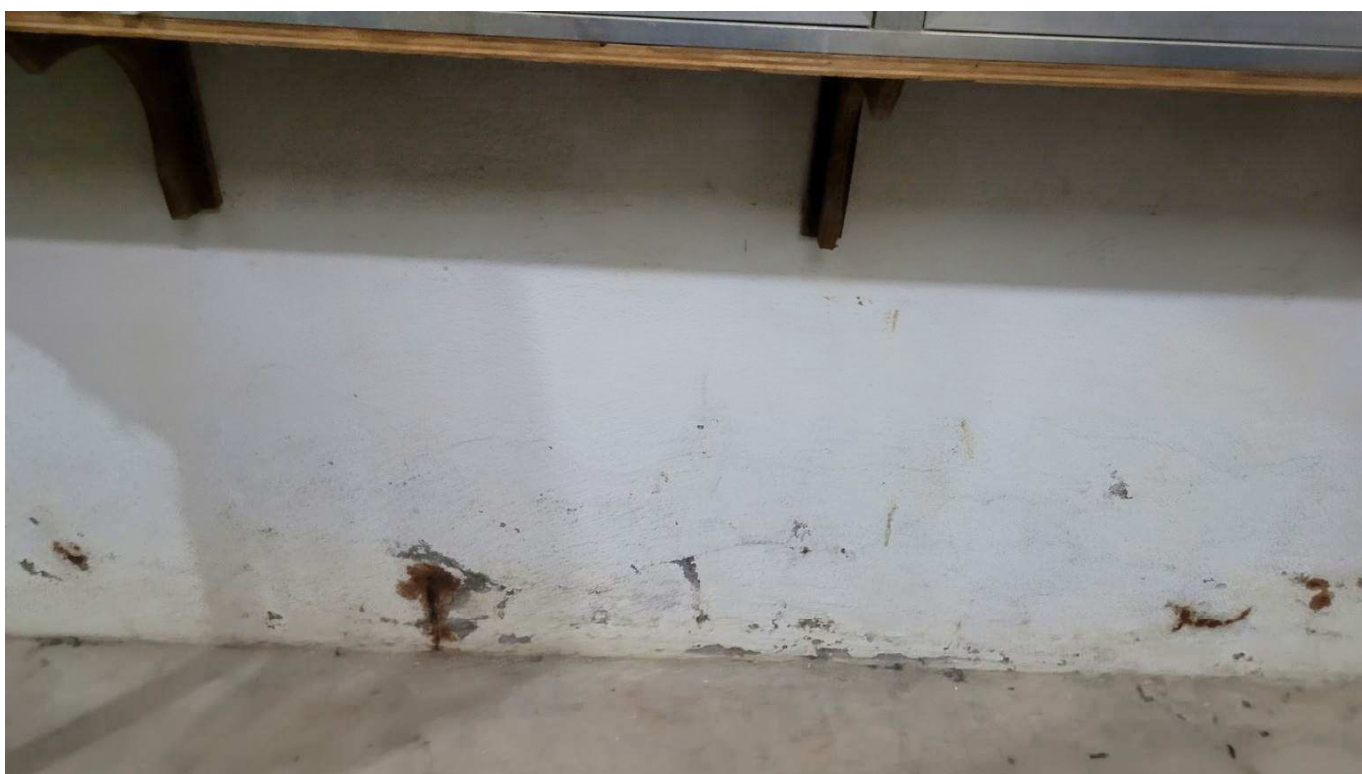
Figure 4-58 Delamination and previous leakage in concrete wall

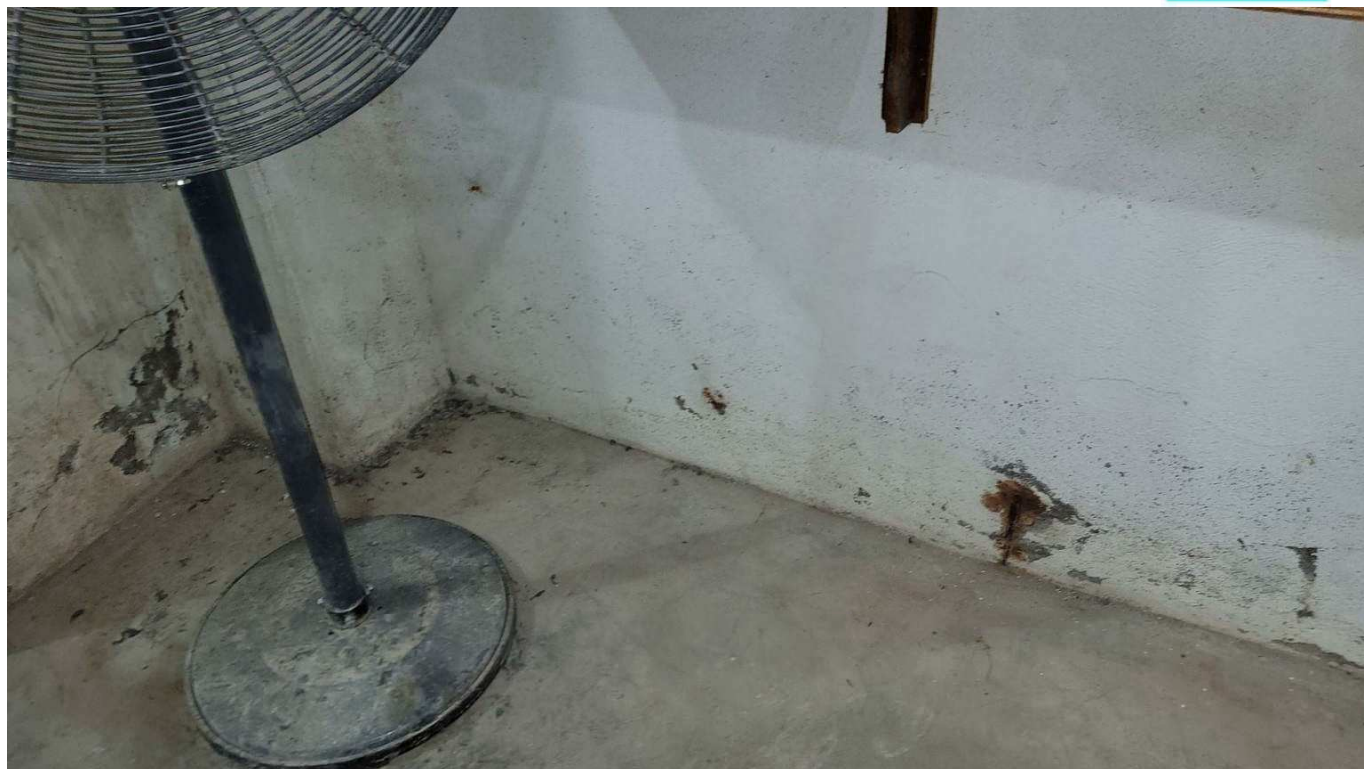
Figure 4-59 Delamination and previous leakage in concrete wall

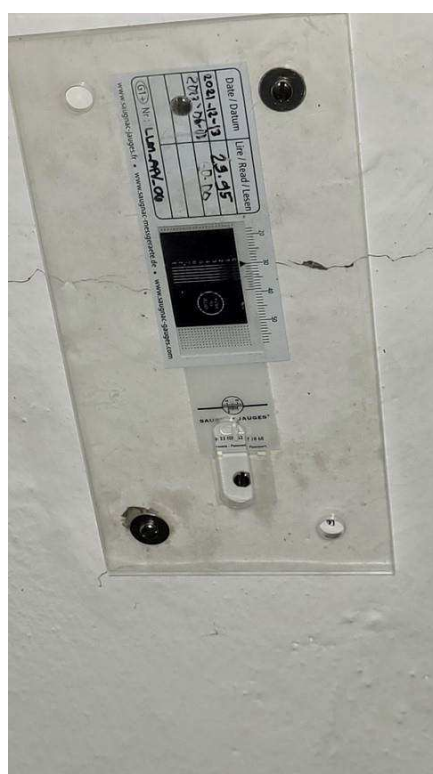
Figure 4-60 Cracks in concrete below stands

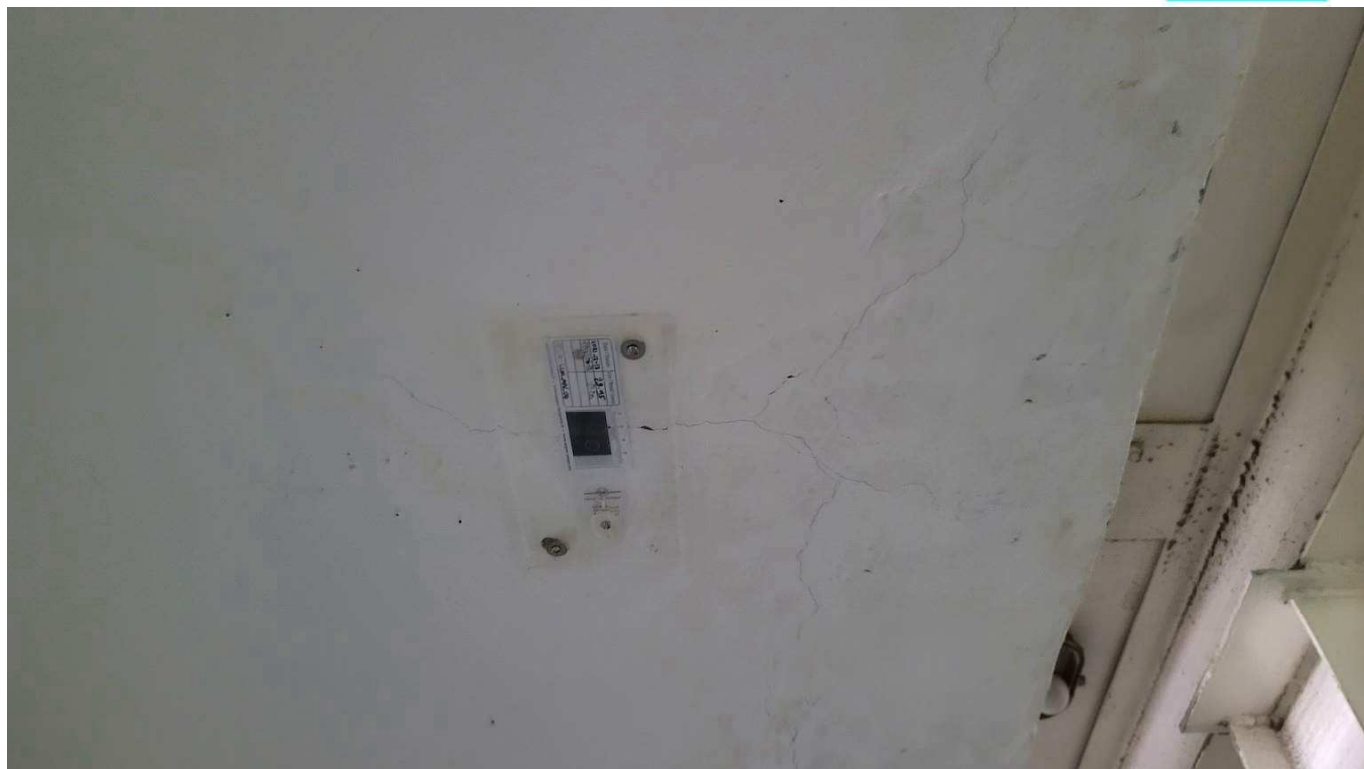
Figure 4-61 cracks in stands soffit

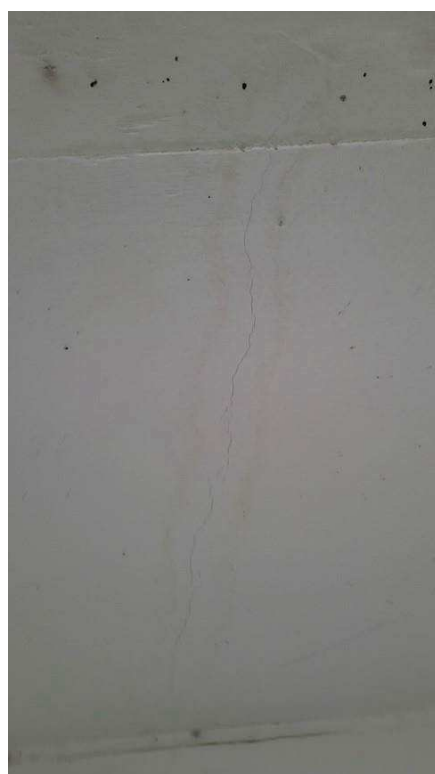
Figure 4-62 crack with previous leakage in stands soffit

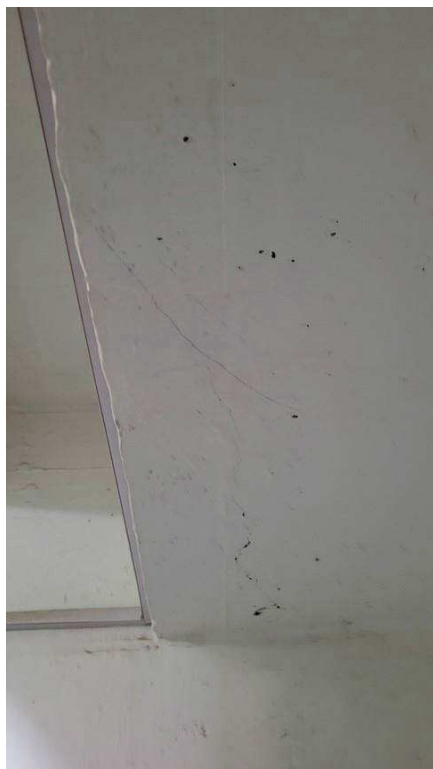
Figure 4-63 Crack in stands soffit

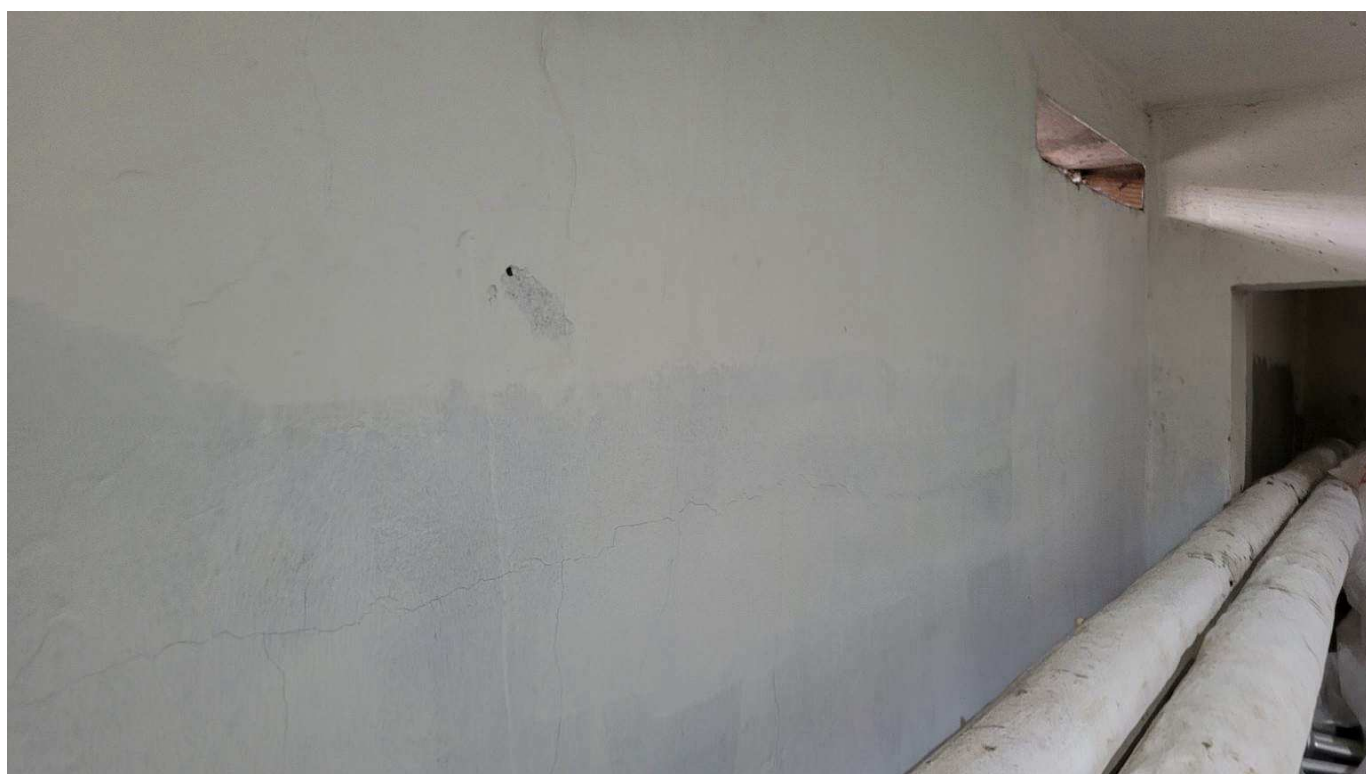
Figure 4-64 Crack in concrete wall

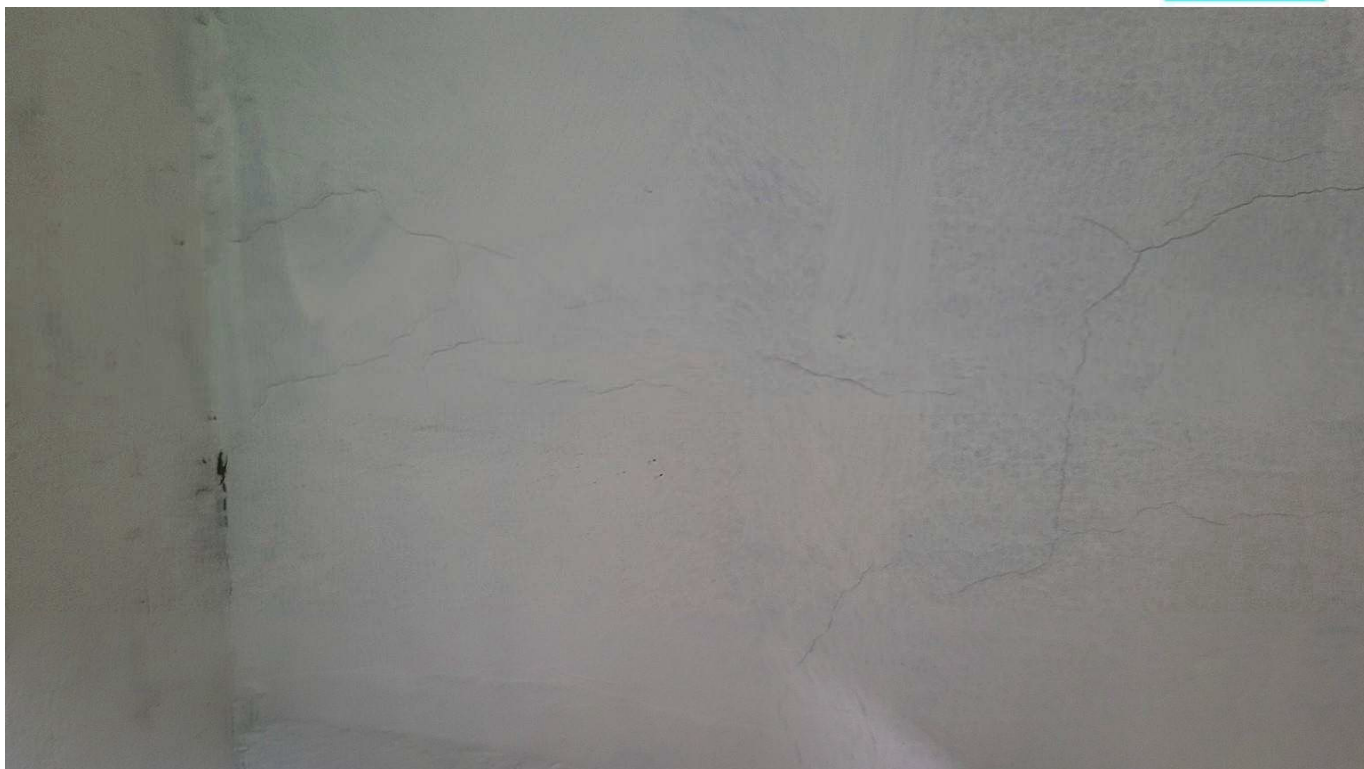
Figure 4-65 Crack in stands soffit

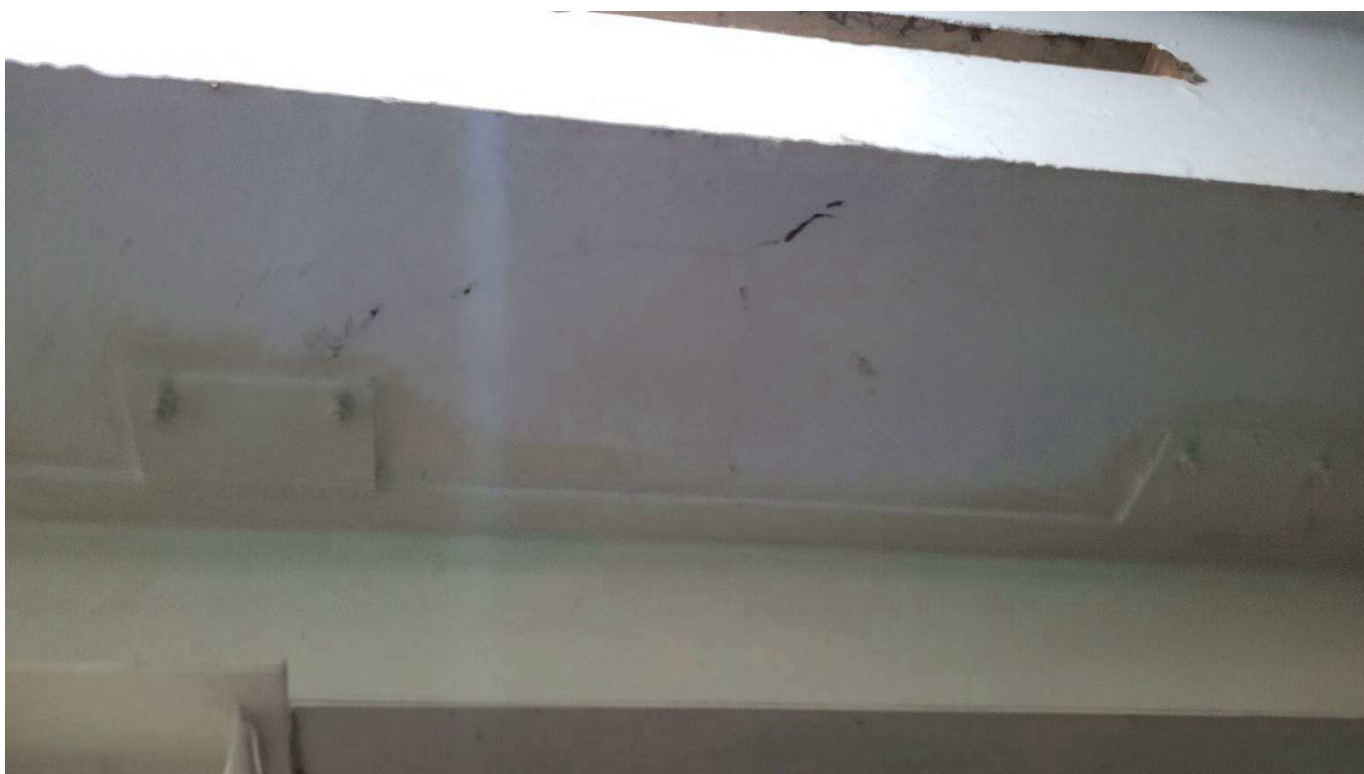
Figure 4-66 Crack in stands soffit

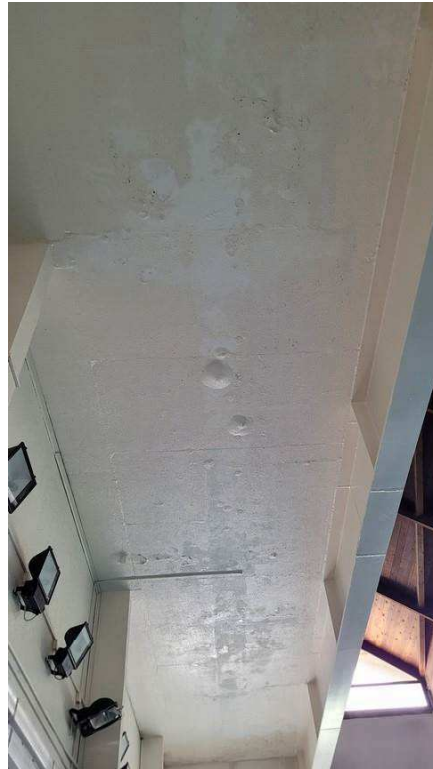
Figure 4-67 sign of previous leakage in slab soffit

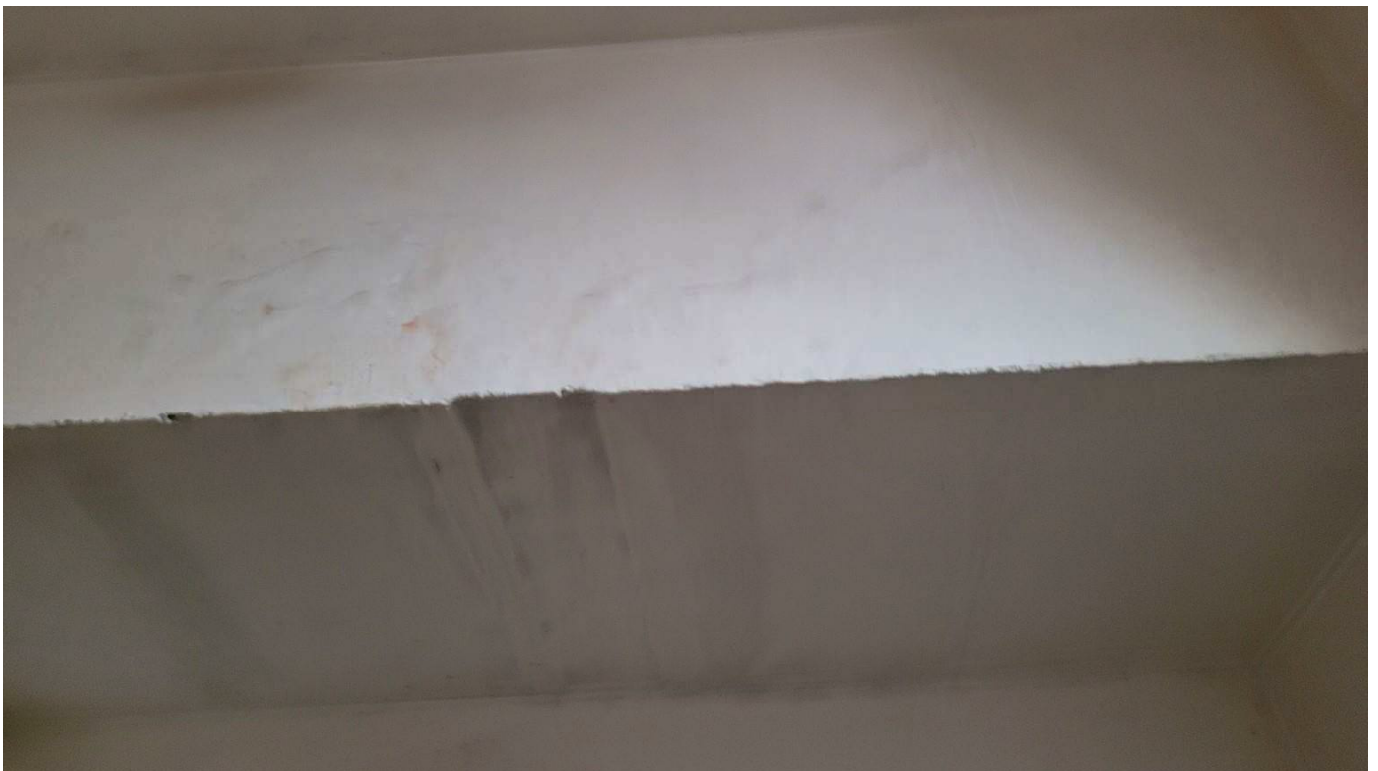
Figure 4-68 previous leakage in stands soffit

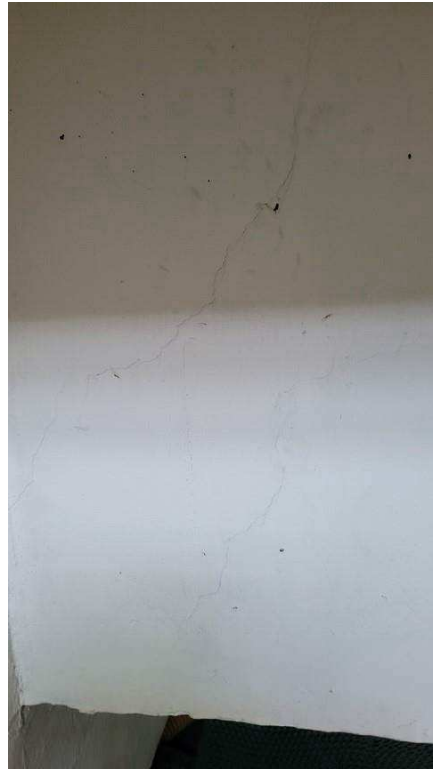
Figure 4-69 cracks in stands soffit

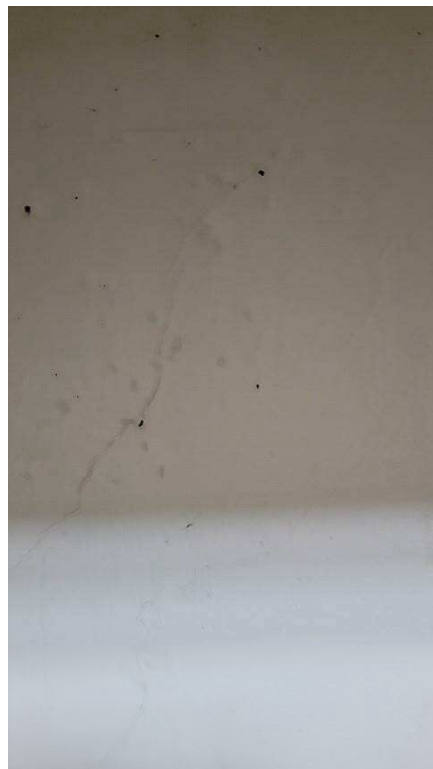
Figure 4-70 cracks in stands soffit

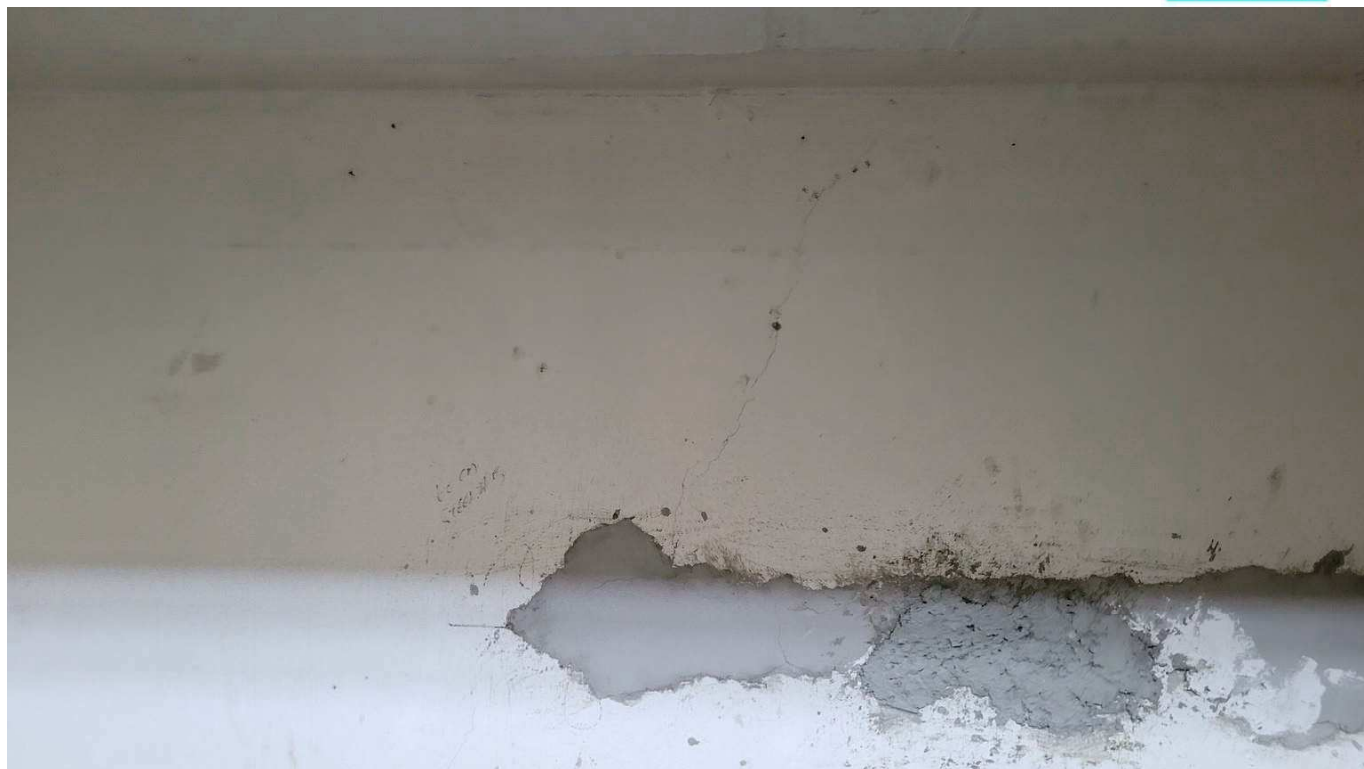
Figure 4-71 Cracks in stands soffit

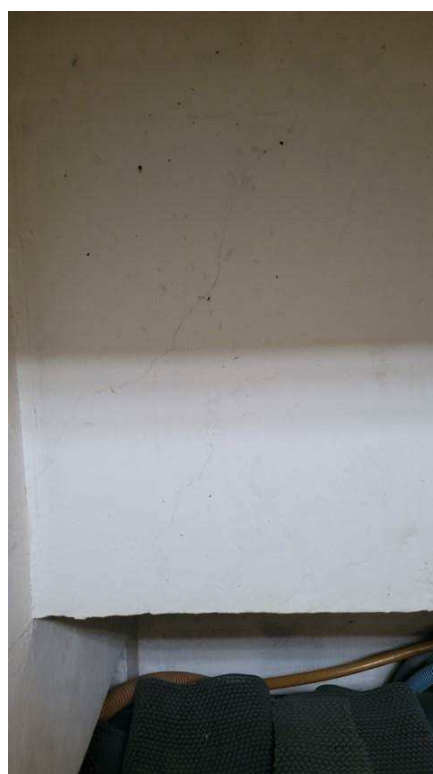
Figure 4-72 Cracks in stands soffit

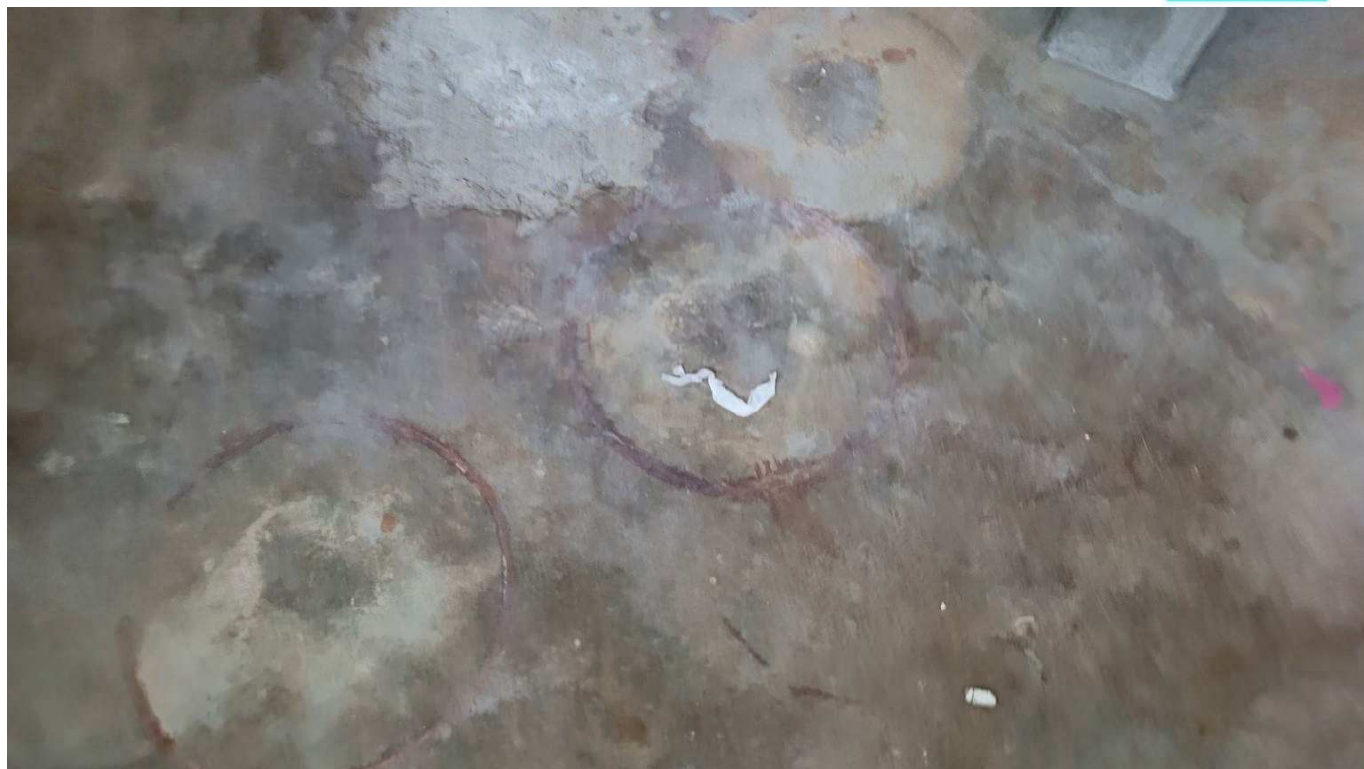
Figure 4-73 sign of previous leakage in flooring

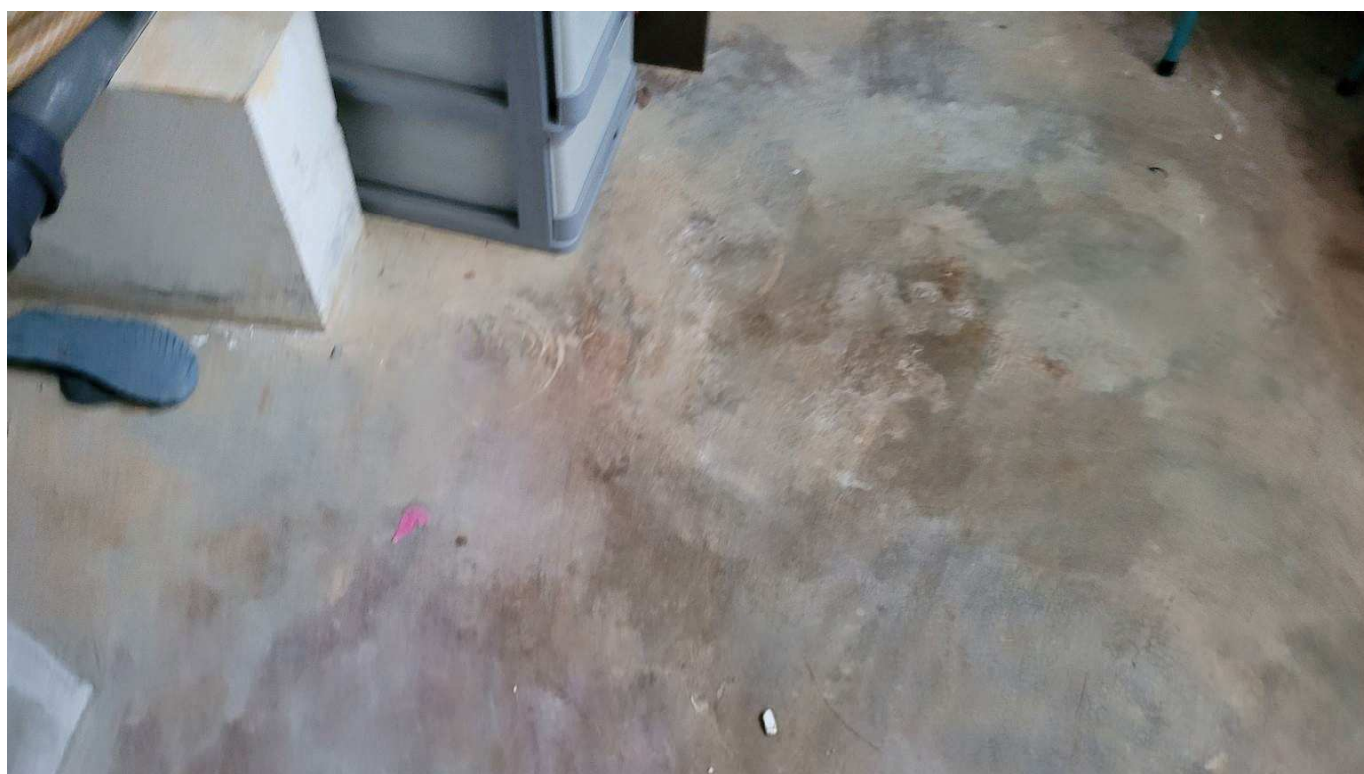
Figure 4-74 sign of previous leakage in flooring

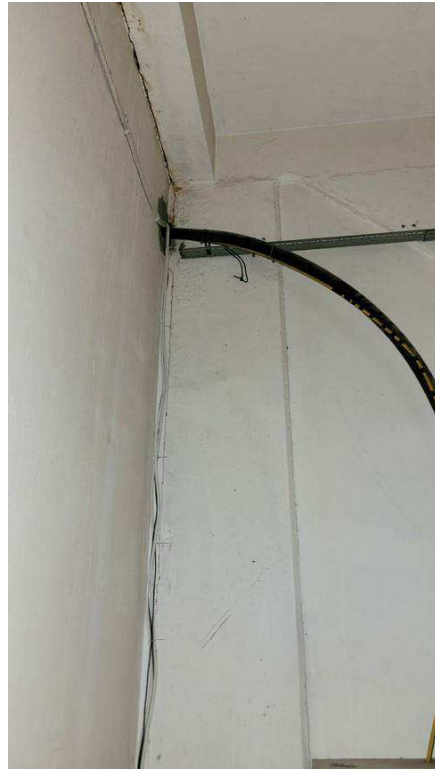
Figure 4-75 previous leakage at expansion joint

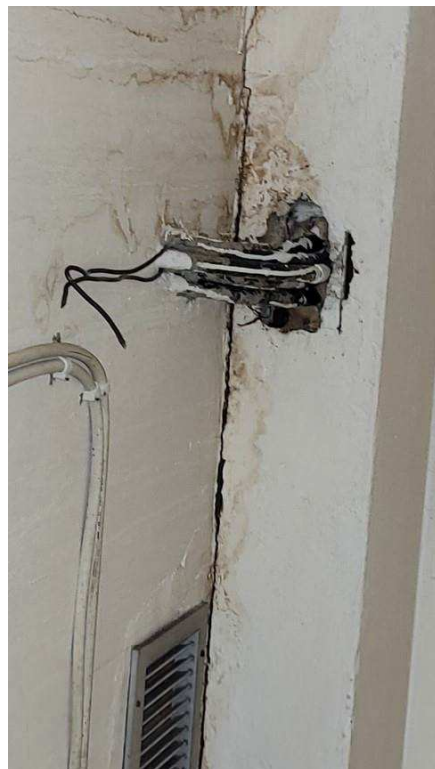
Figure 4-76 previous leakage in expansion joint

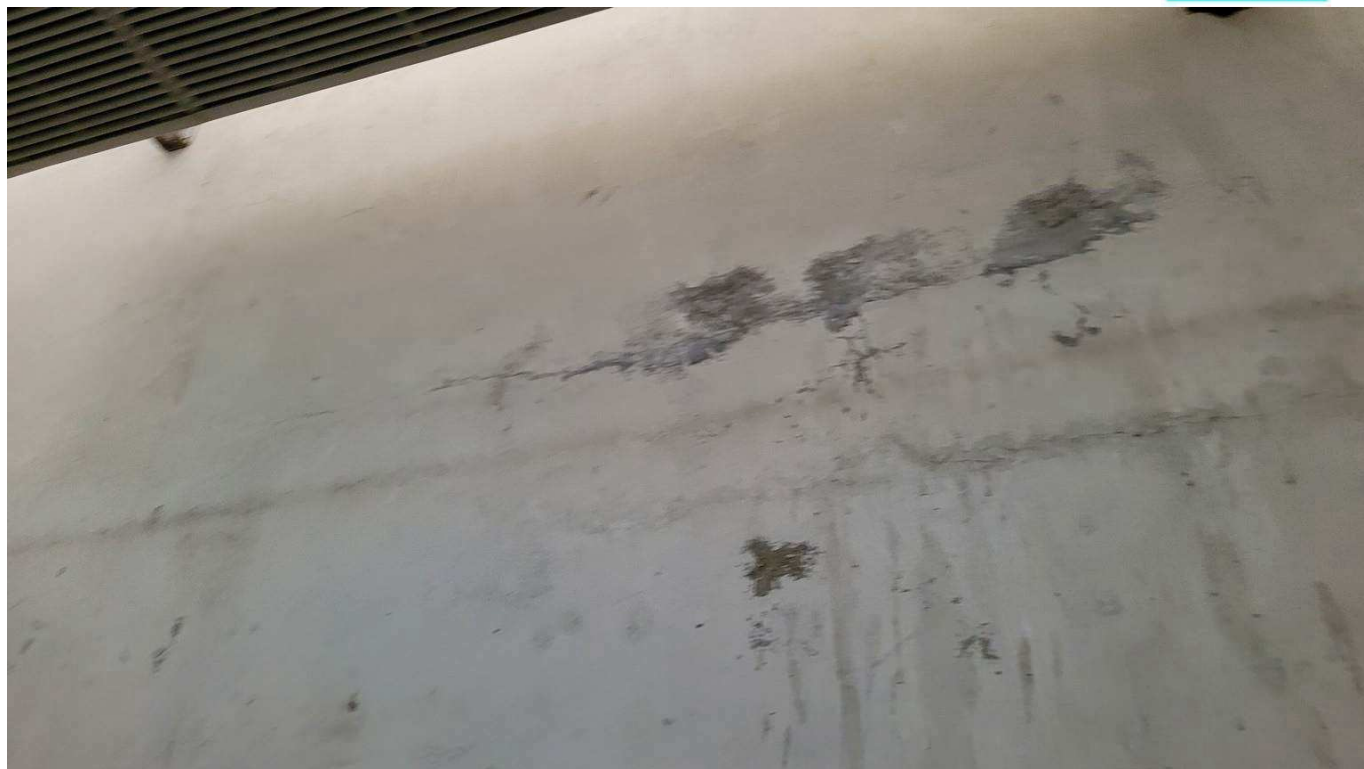
Figure 4-77 Cracks and dampness in wall

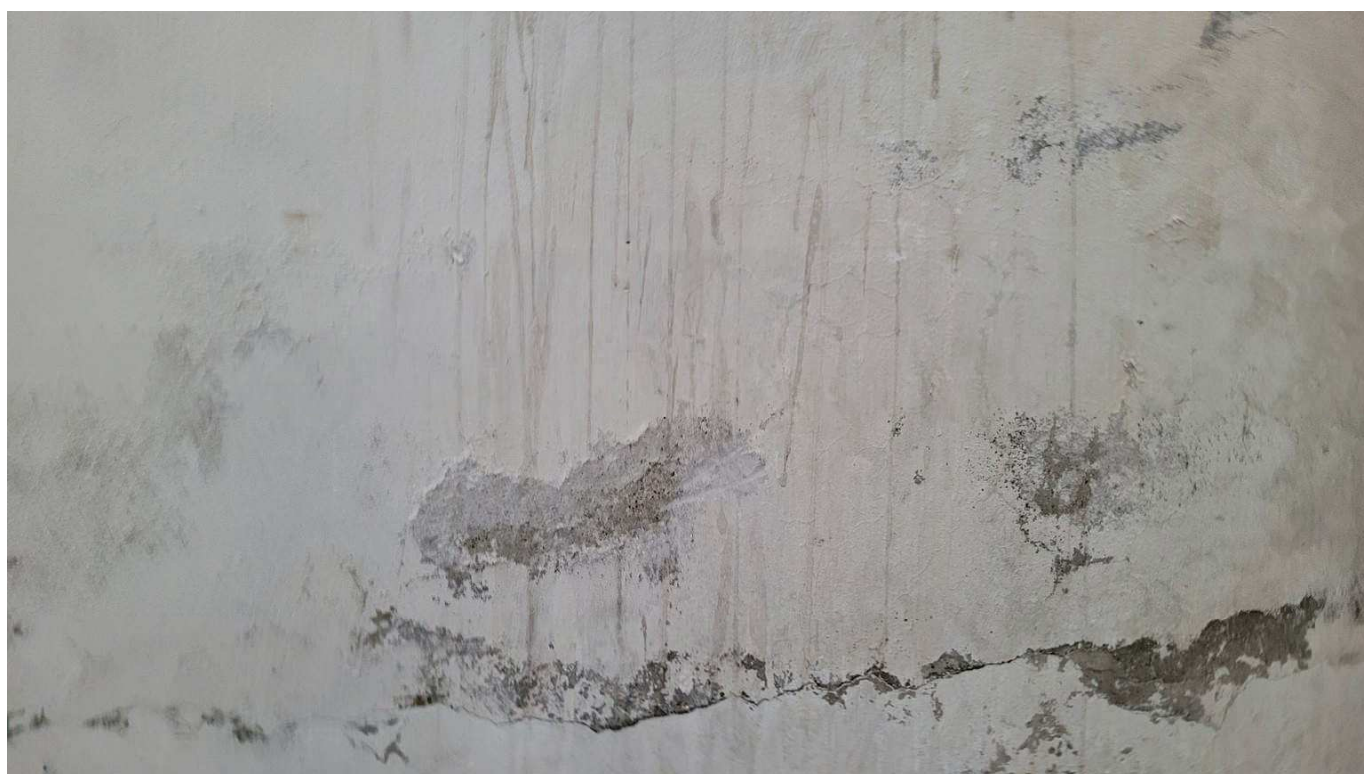
Figure 4-78 Dampness in block wall
