RENOVATION OF BLOCK B' FOR FRENCH SCHOOL (LYCEE LOUIS MASSIGNON)

CONCRETE REPAIRS AND STRUCTURAL REINFORCEMENT

**VOLUME 5 – Part 5 of 7
M/s eForce Inspection Consultancies
Report eForce/1588/2023 dated October 17th, 2023**

**VISUAL INSPECTION OF THE GYMNASIUM, SWIMMING POOL AND
AUDITORIUM LYCÉE LOUIS MASSIGNON SCHOOL, ABU DHABI, UAE
(Preliminary report)**

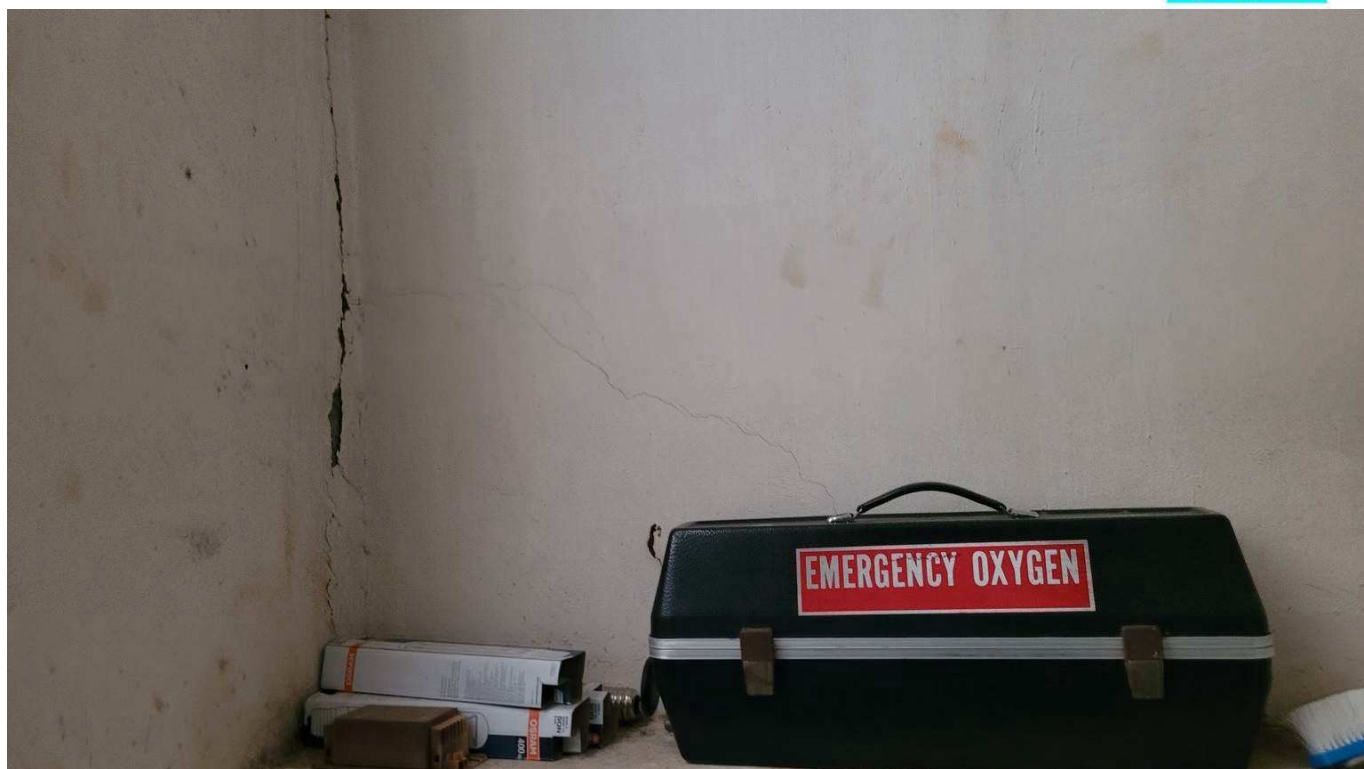
Figure 4-79 Crack in block wall

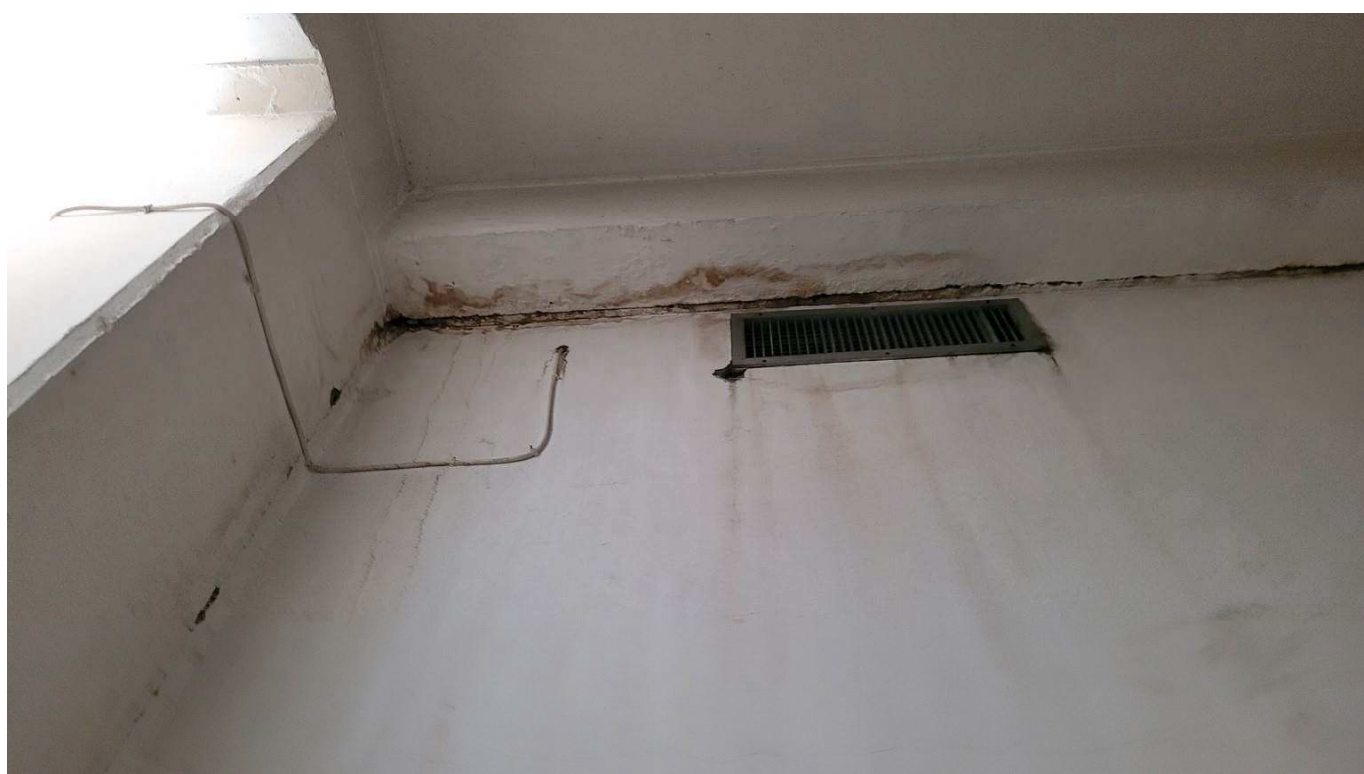
Figure 4-80 previous leakage at expansion joint

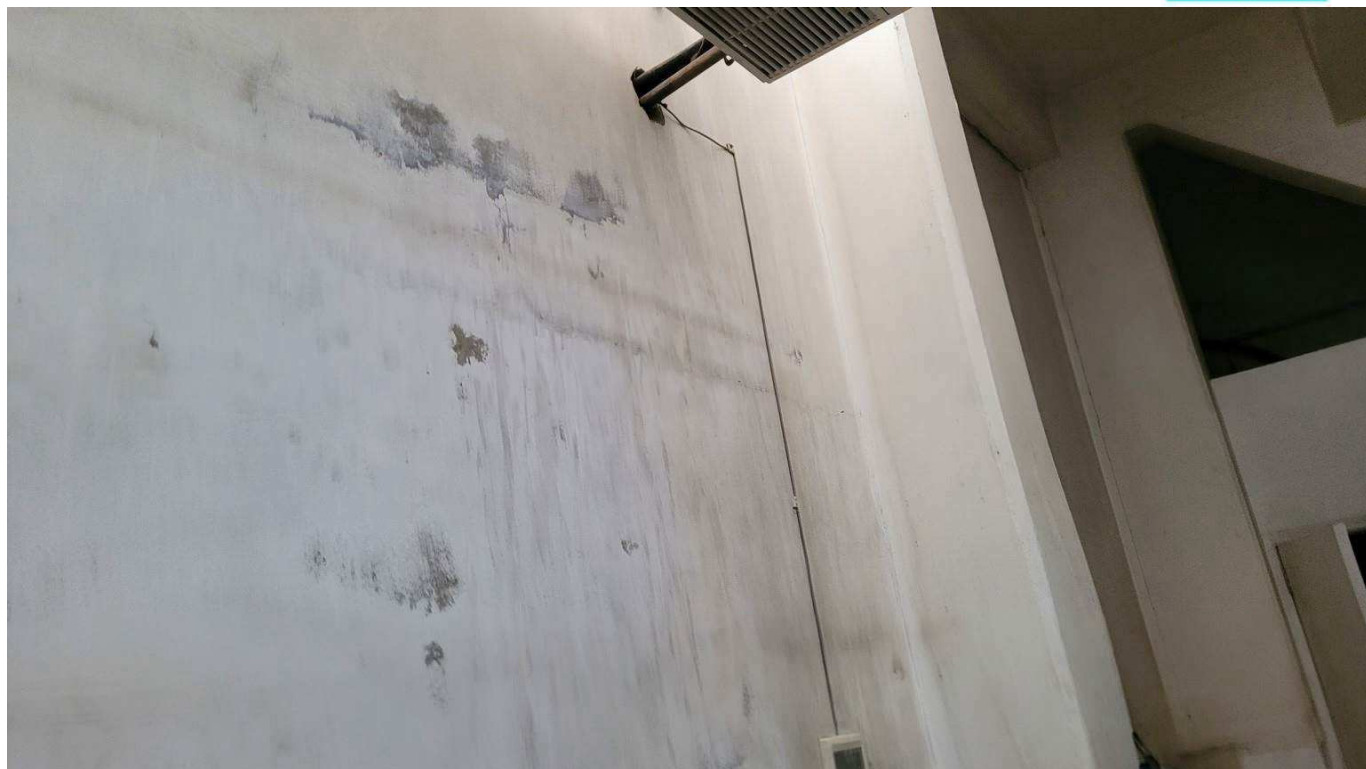
Figure 4-81 dampness and cracks in block wall

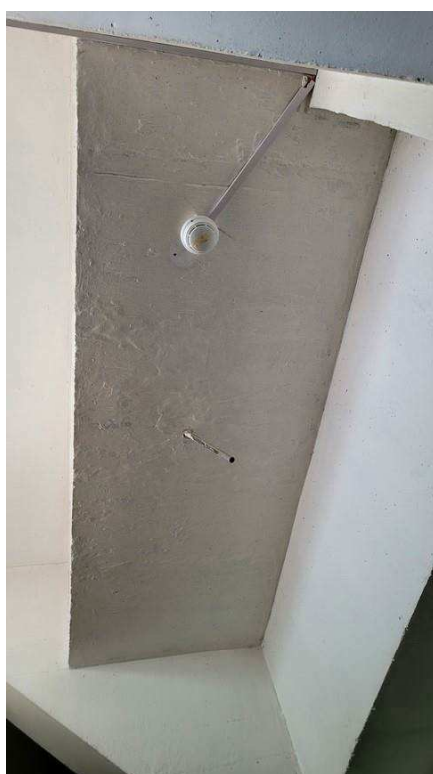
Figure 4-82 previous leakage in stands soffit

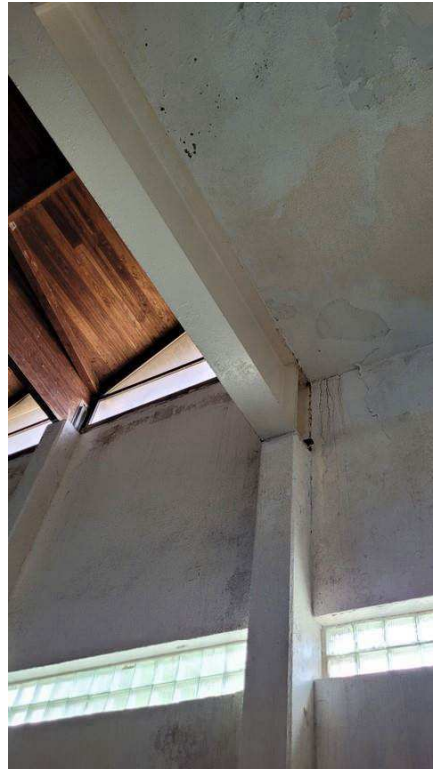
Figure 4-83 dampness in block walls and concrete elements

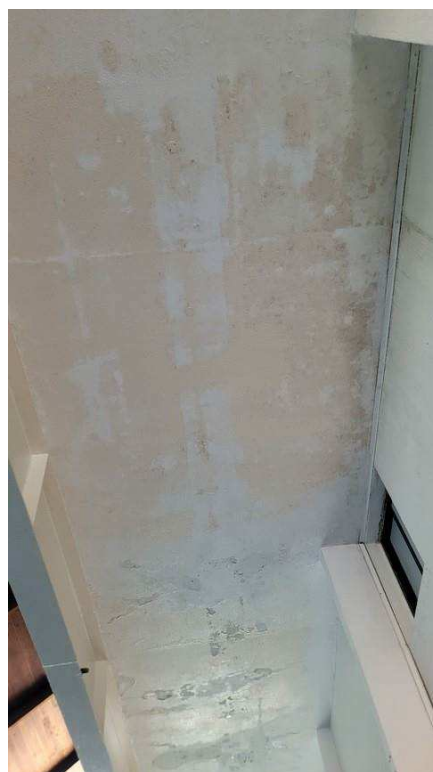
Figure 4-86 Previous leakage in slab soffit

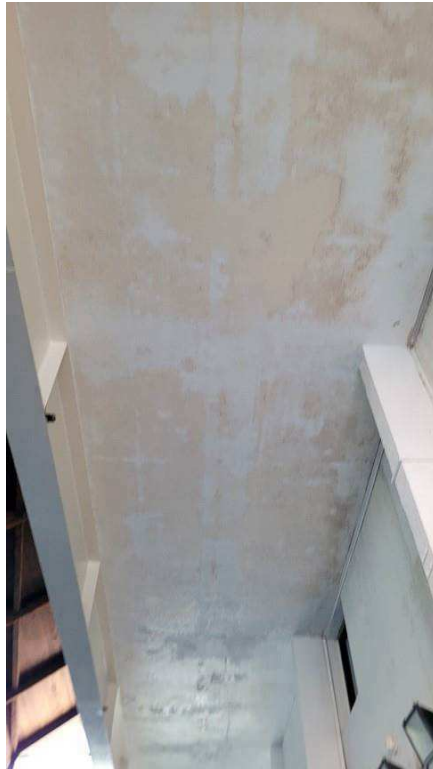
Figure 4-87 Previous leakage in slab soffit

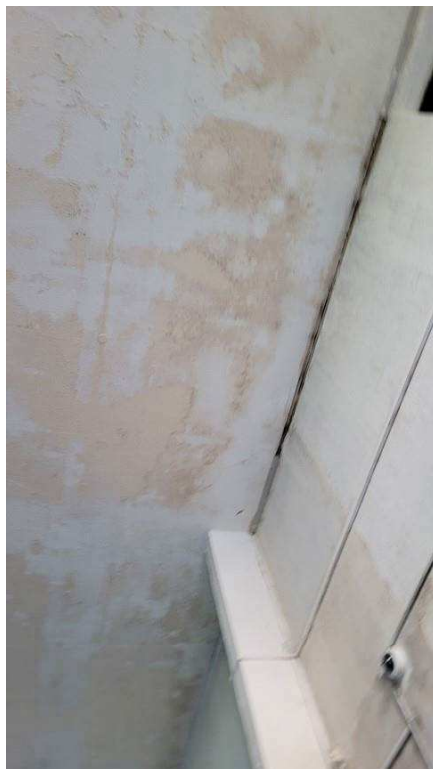
Figure 4-88 previous leakage in slab soffit

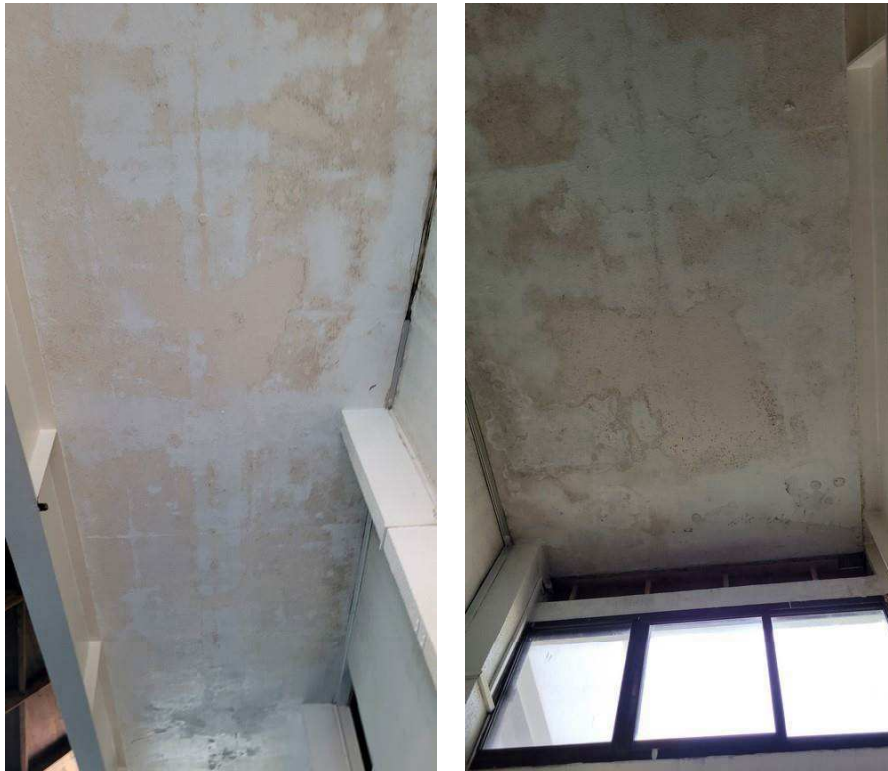
Figure 4-89 previous leakage in slab soffit

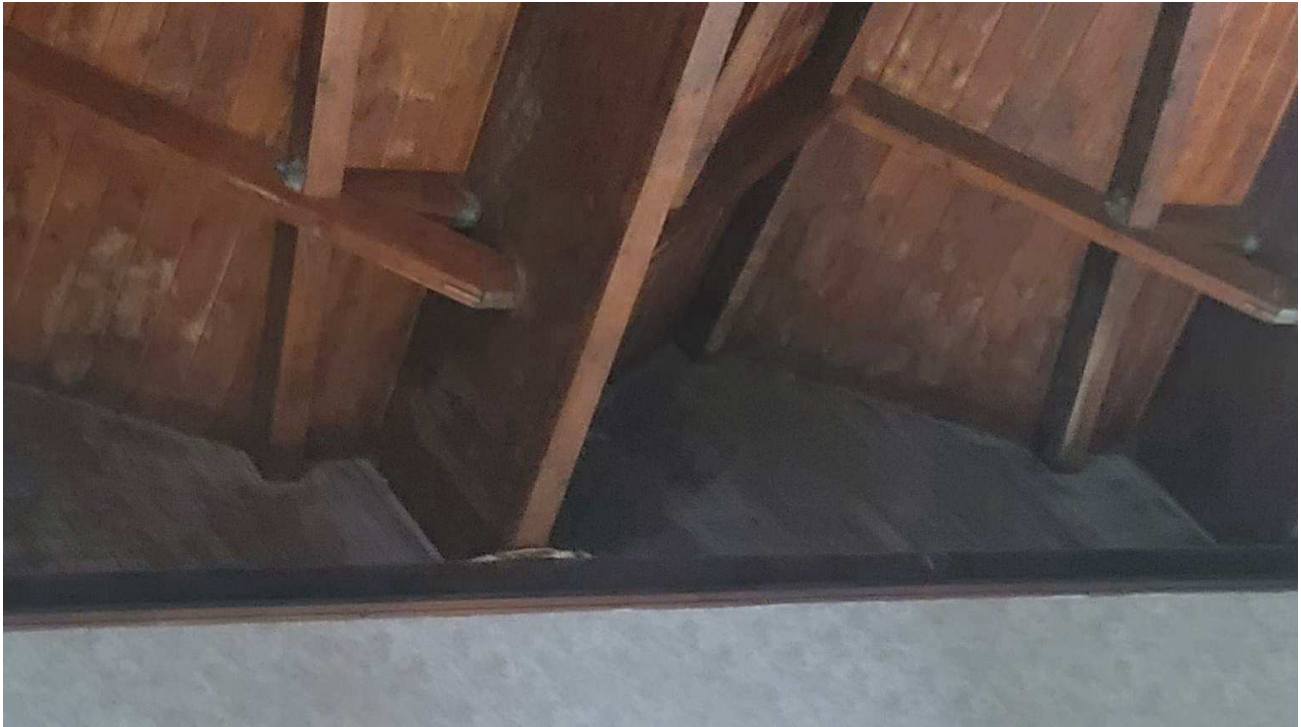
Figure 4-90 previous leakage in slab soffit

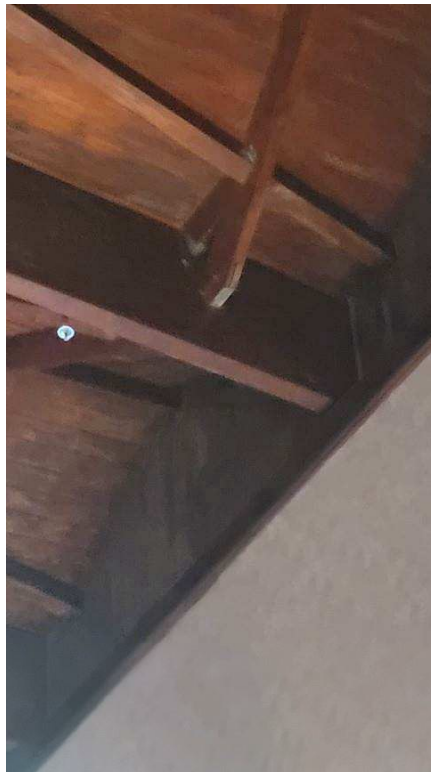
Figure 4-91 previous leakage in wooden slab soffit
