RENOVATION OF BLOCK B' FOR FRENCH SCHOOL (LYCEE LOUIS MASSIGNON)

CONCRETE REPAIRS AND STRUCTURAL REINFORCEMENT

**VOLUME 5 – Part 4 of 7
M/s eForce Inspection Consultancies
Report eForce/195/2019 dated January 28th, 2020**

**STRUCTURAL STUDY OF EXISTING STRUCTURE OF
THE GYMNASIUM, SWIMMING POOL AND AUDITORIUM
LYCÉE LOUIS MASSIGNON SCHOOL, ABU DHABI, UAE
(Phase 1: Assessment, Pre design and Scenarios)**

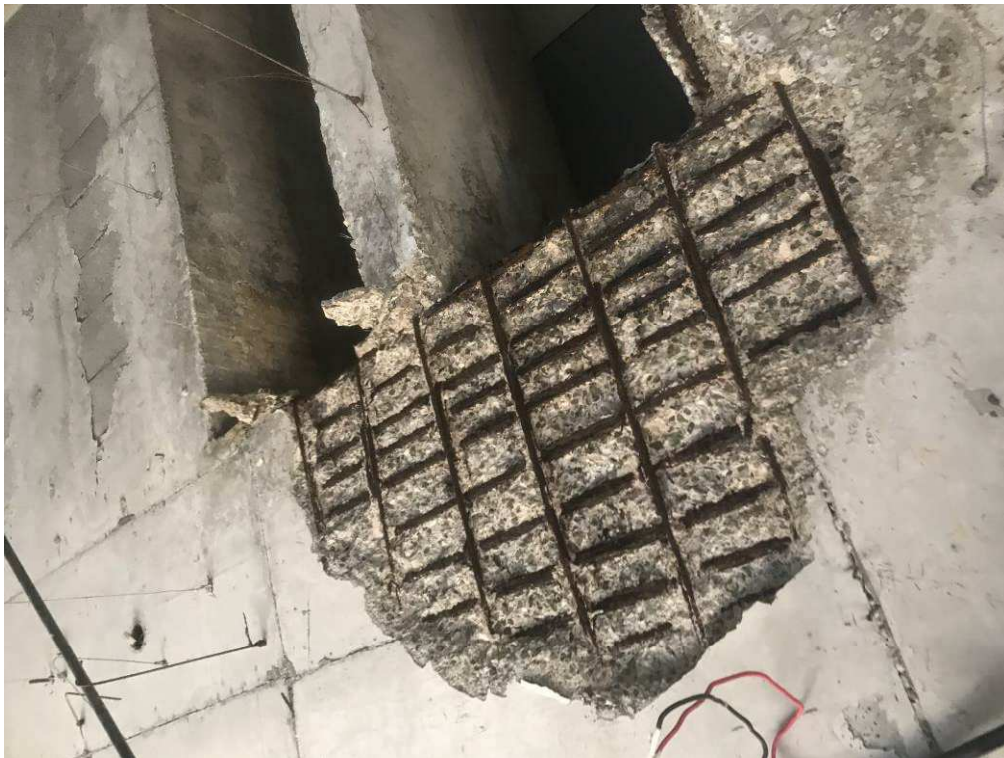
Figure 4-1 spalled cover and corroded steel at the playing area slab soffit

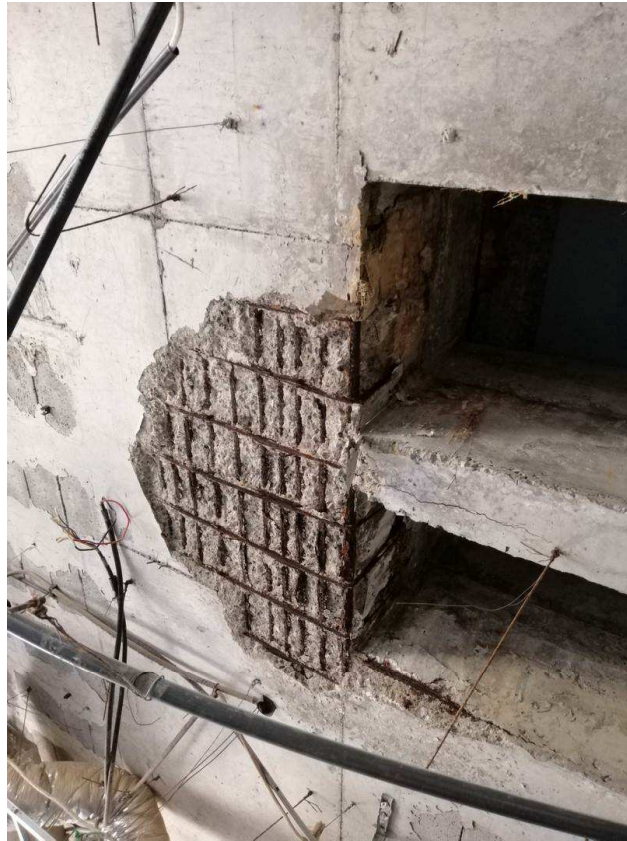
Figure 4-2 spalled cover and corroded steel at the playing area slab soffit

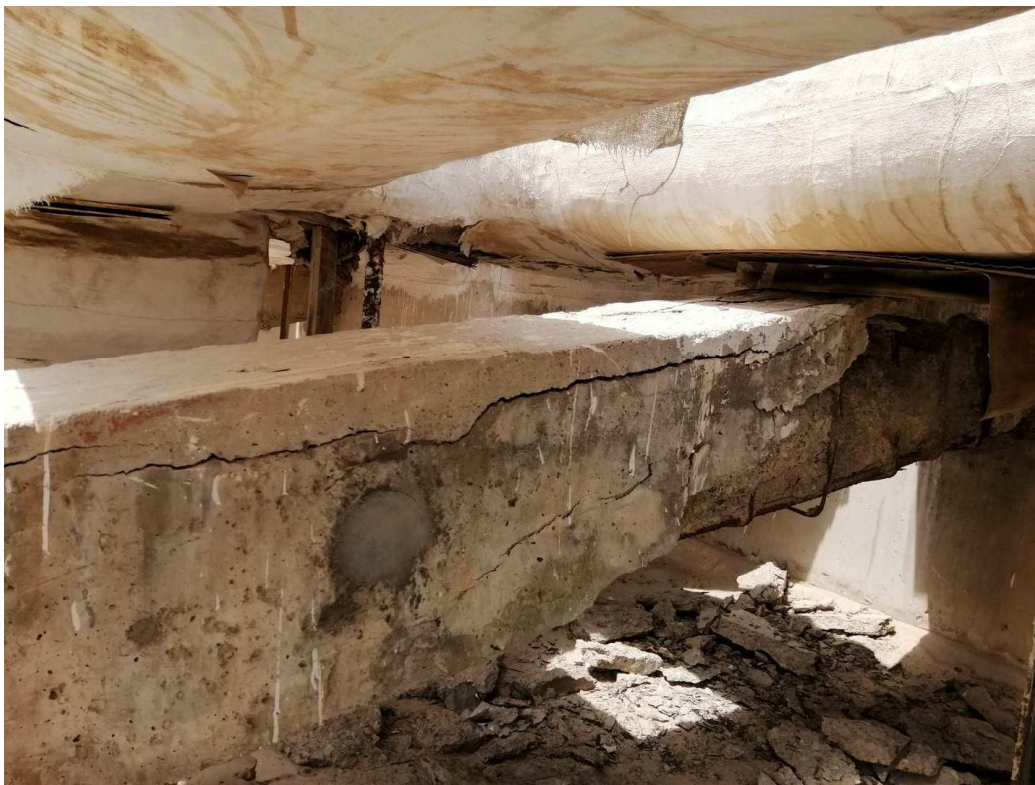
Figure 4-3 spalled cover and corroded steel at the playing area roof

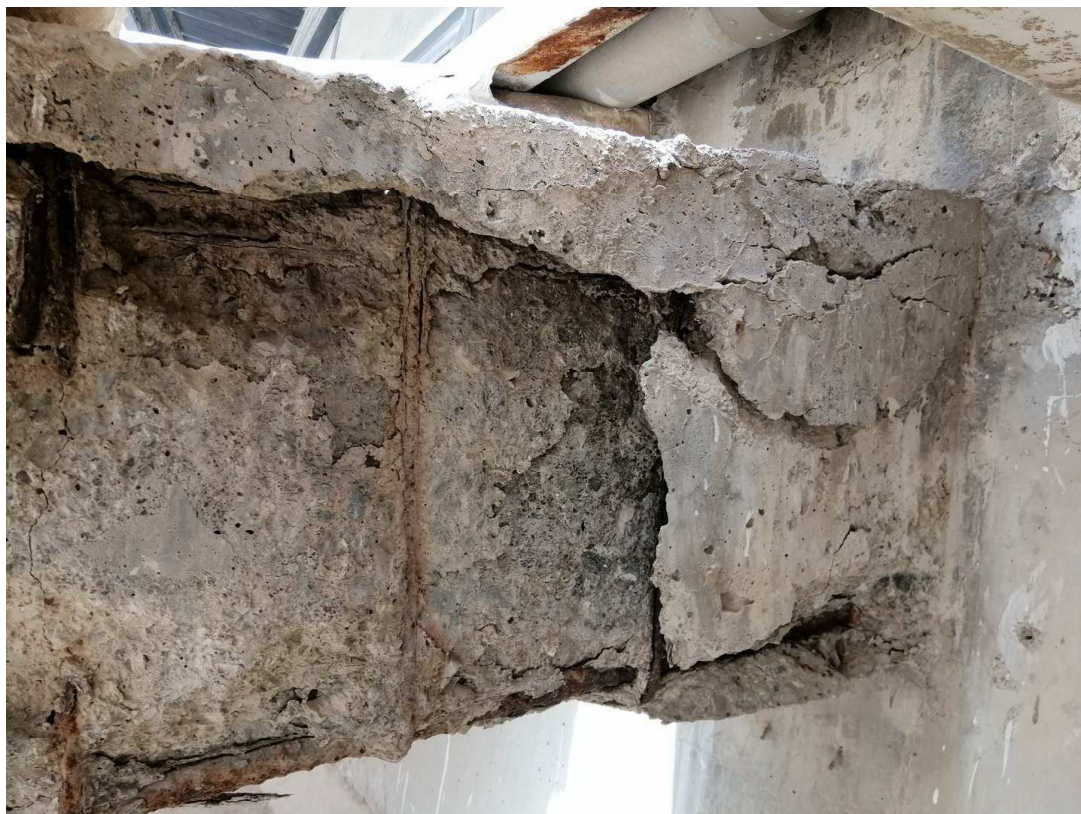
Figure 4-4 spalled cover and corroded steel at the playing area roof

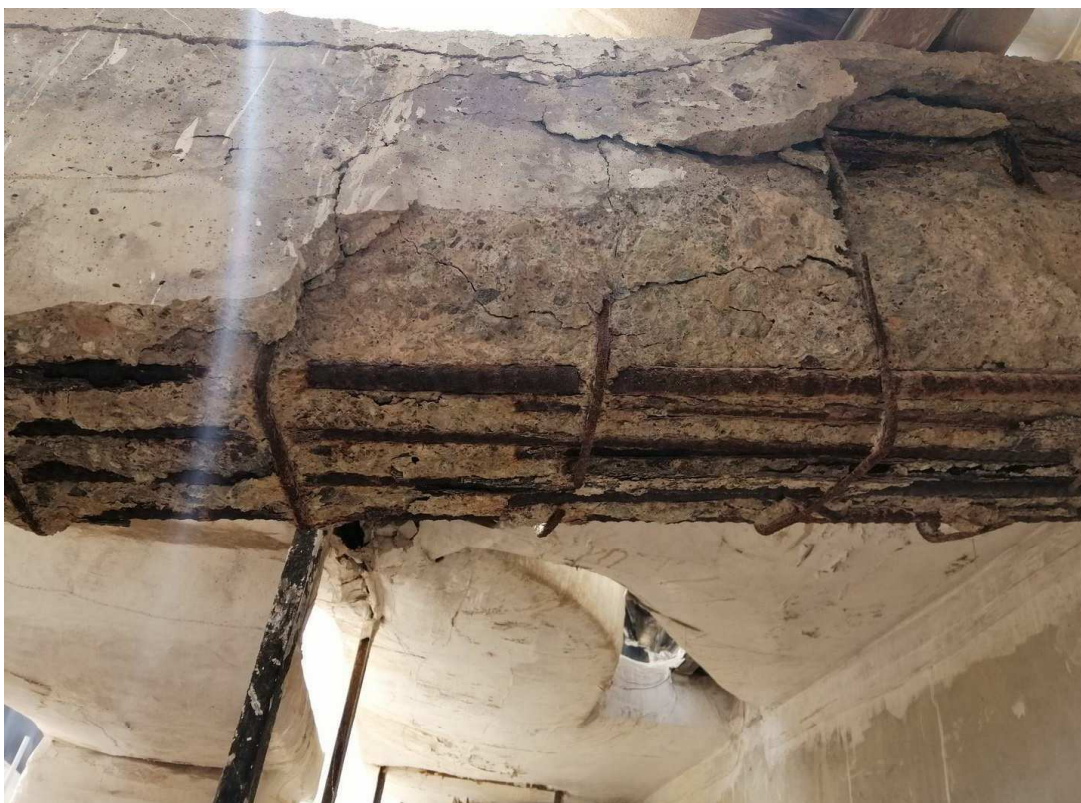
Figure 4-5 spalled cover and corroded steel at the playing area roof

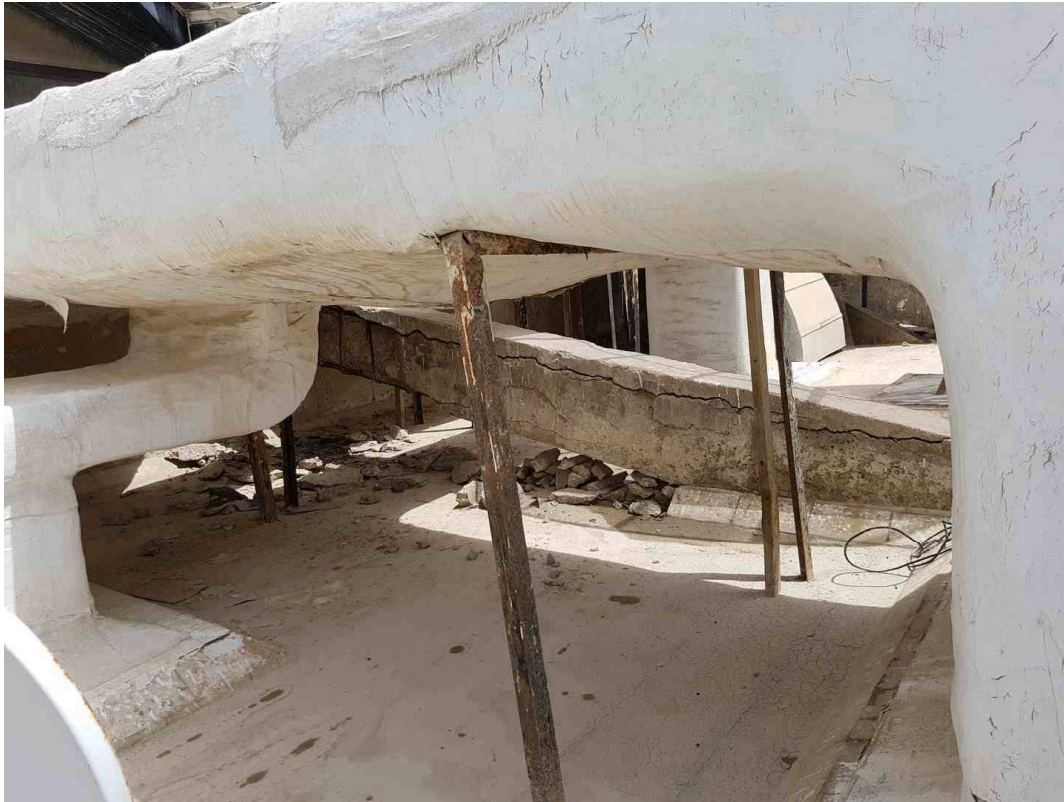
Figure 4-6 Cracks in beam due to steel reinforcement corrosion

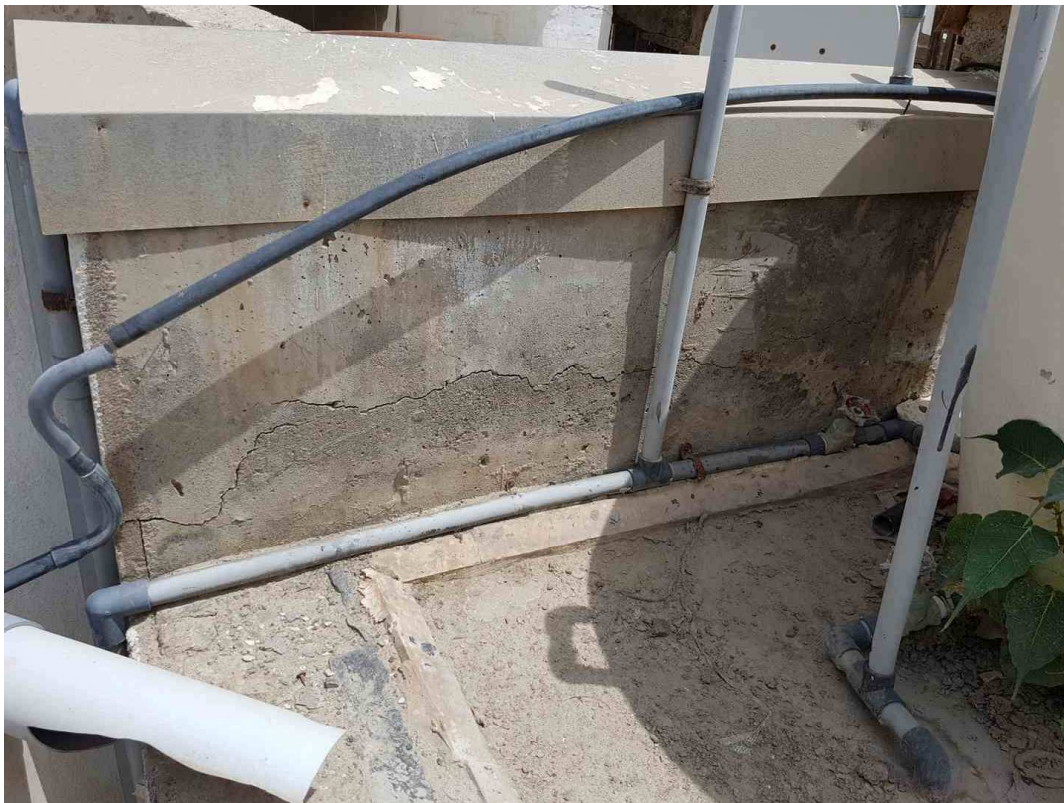
Figure 4-7 Cracks in beam due to steel reinforcement corrosion

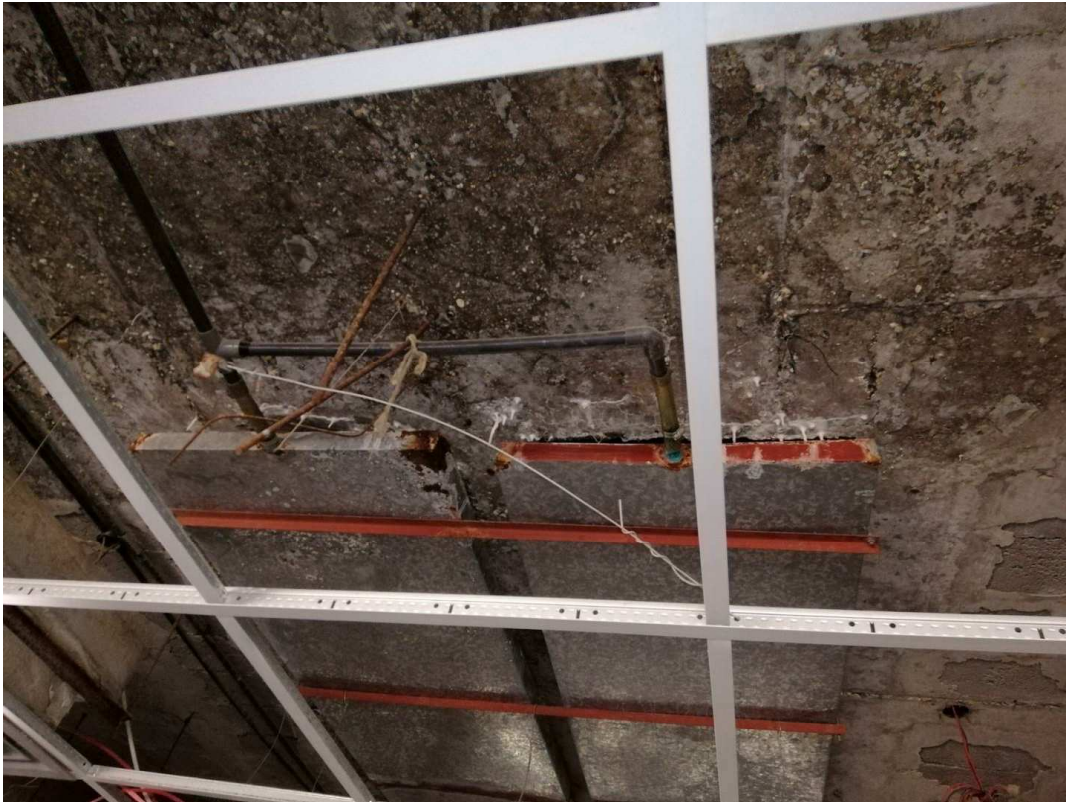
Figure 4-8 Delamination and sign of previous leakage

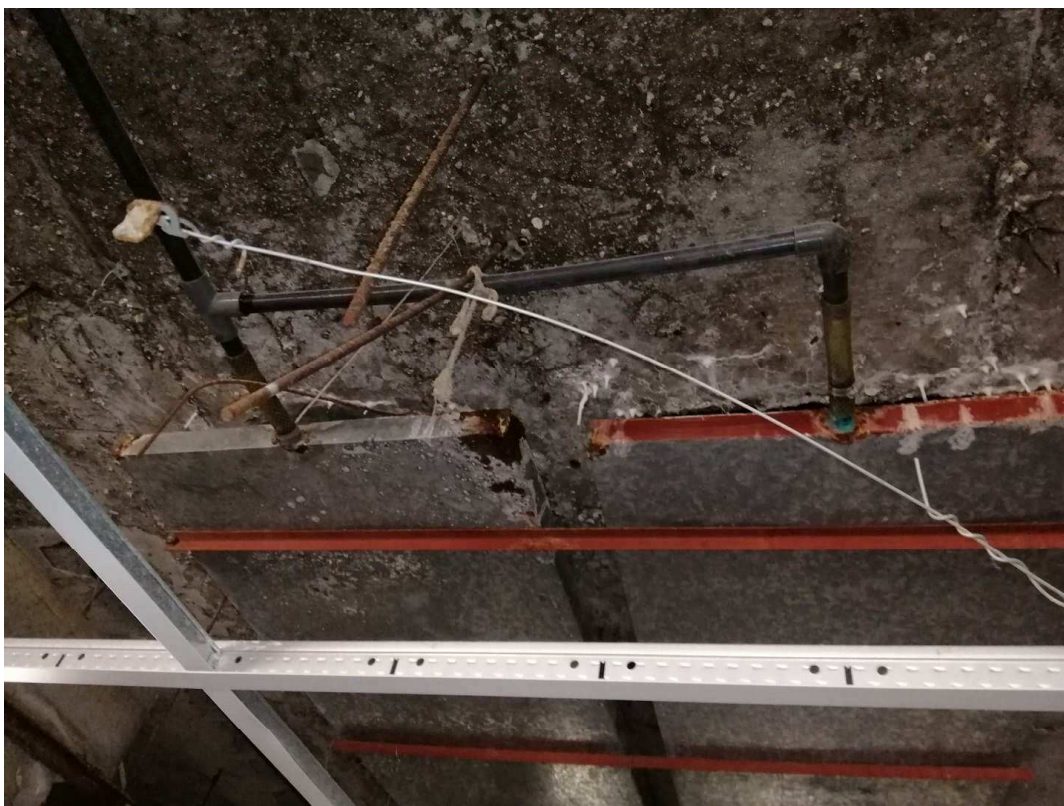
Figure 4-9 Delamination and sign of previous leakage

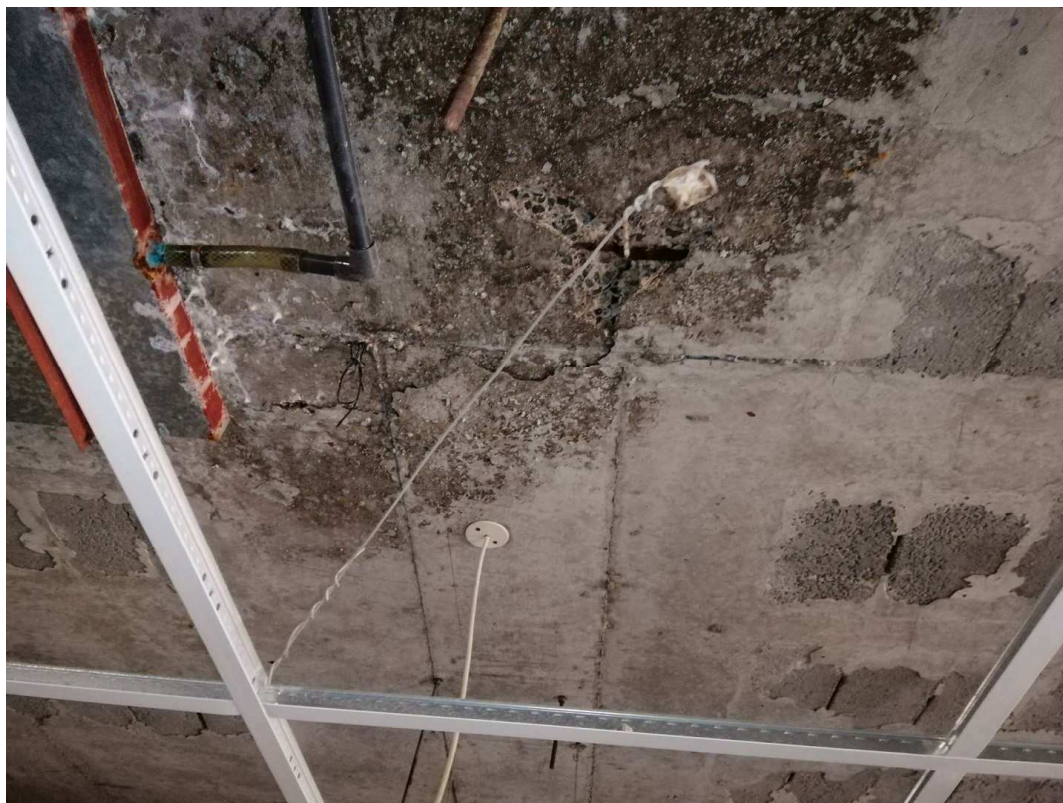
Figure 4-10 Delamination and sign of previous leakage

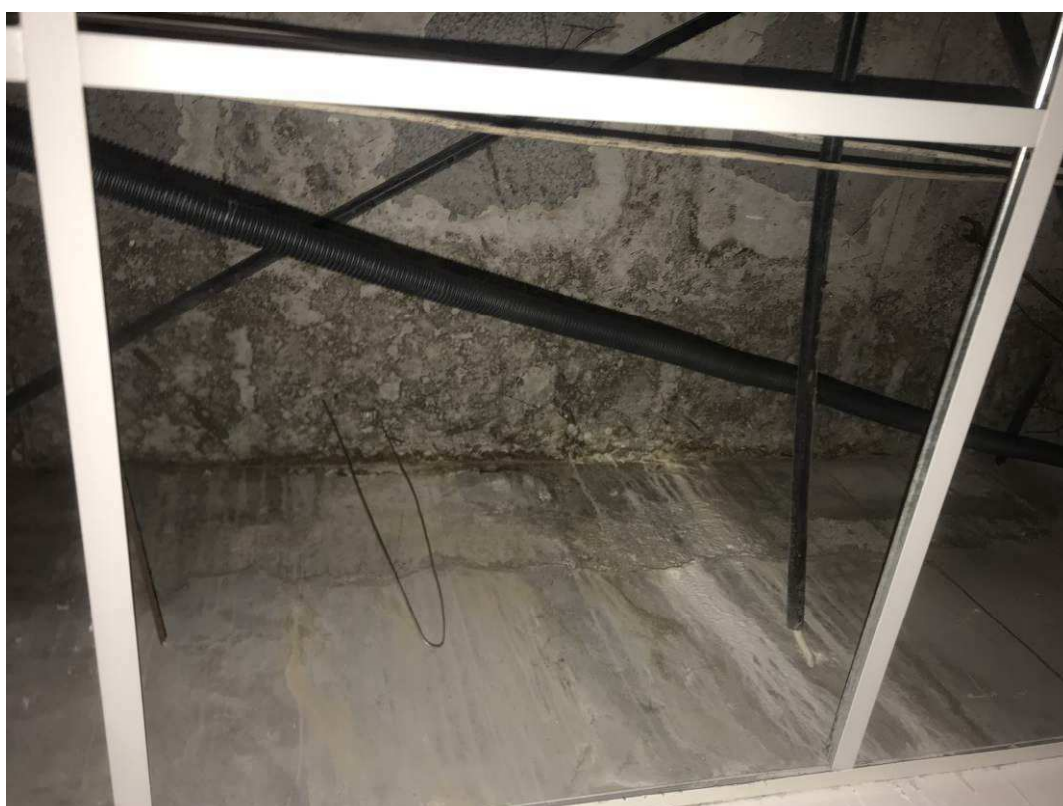
Figure 4-11 sign of previous leakage

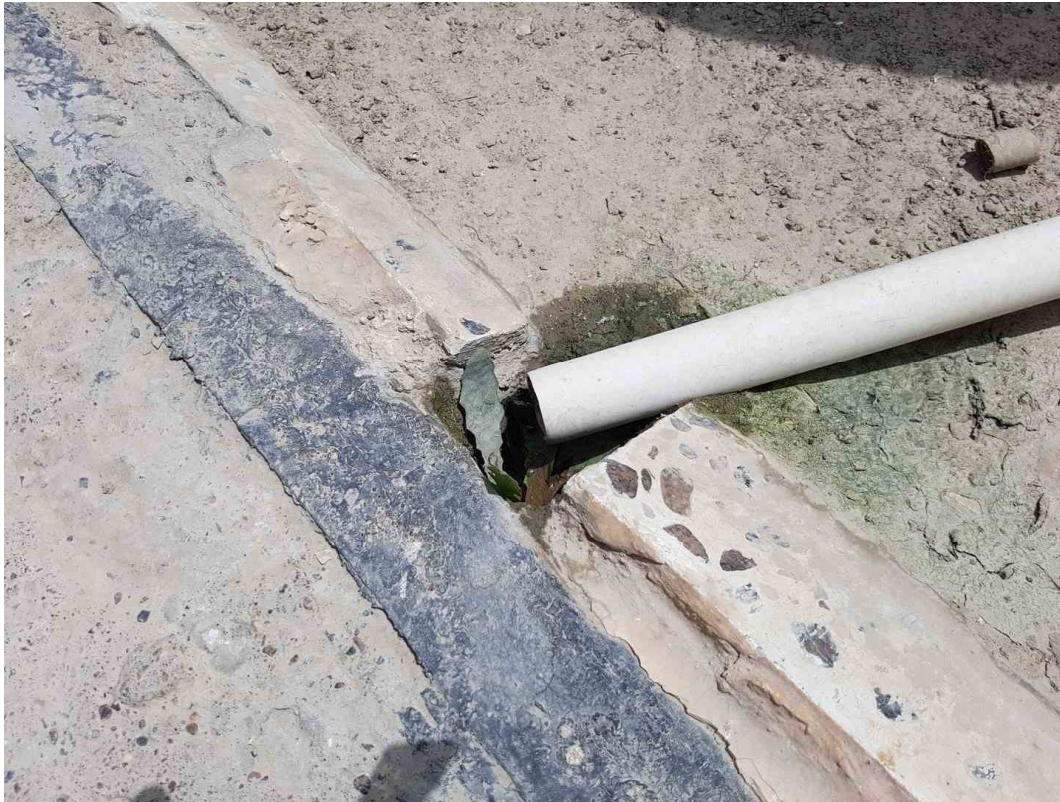
Figure 4-12 sign of previous flooding of water on top of the roof

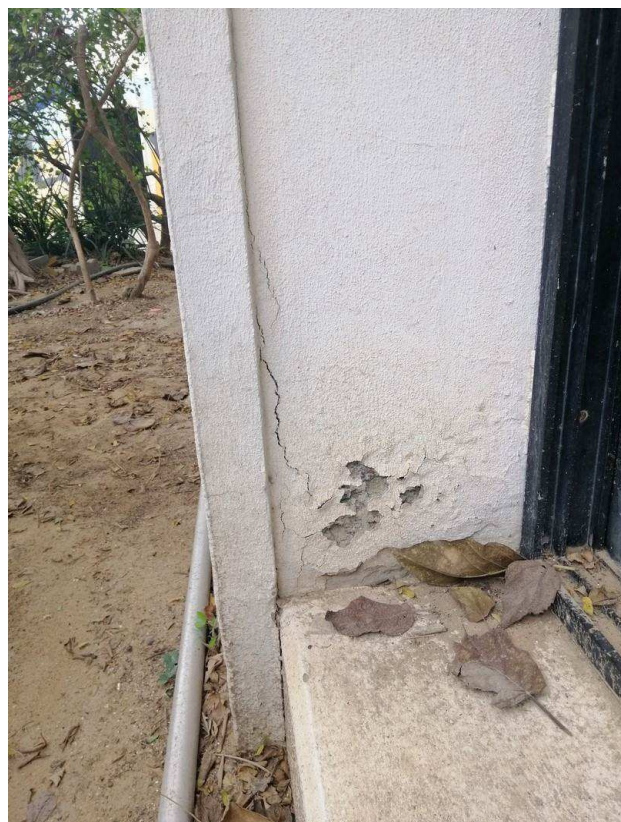
Figure 4-13 Cracks in column due to steel corrosion

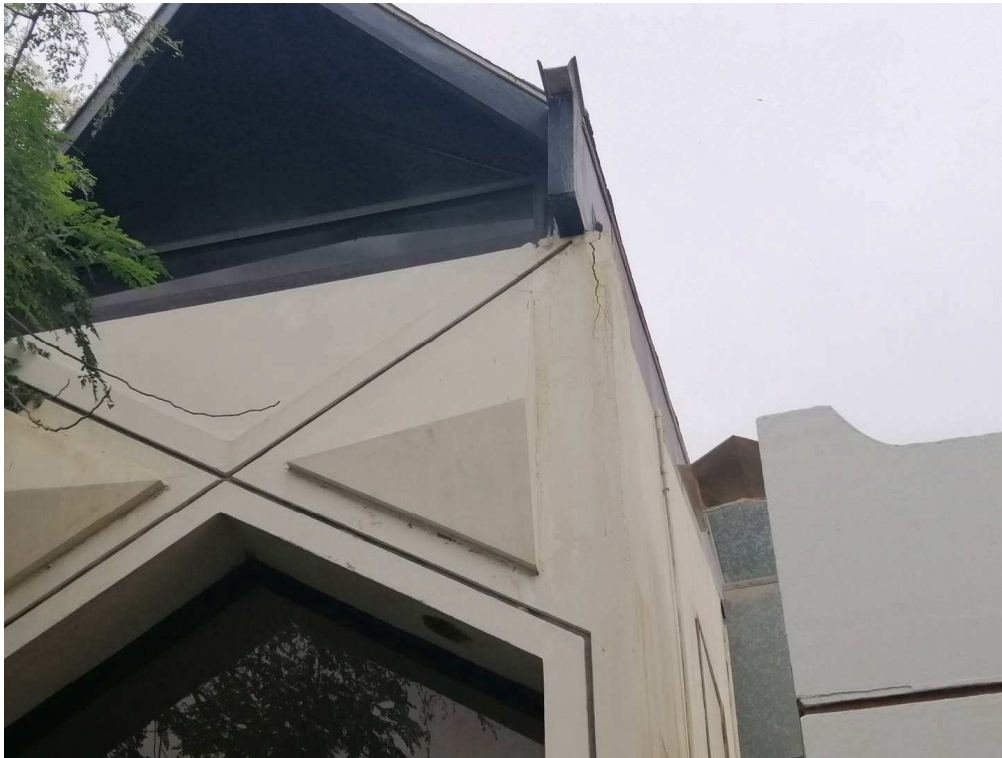
Figure 4-14 Cracks in column due to steel corrosion

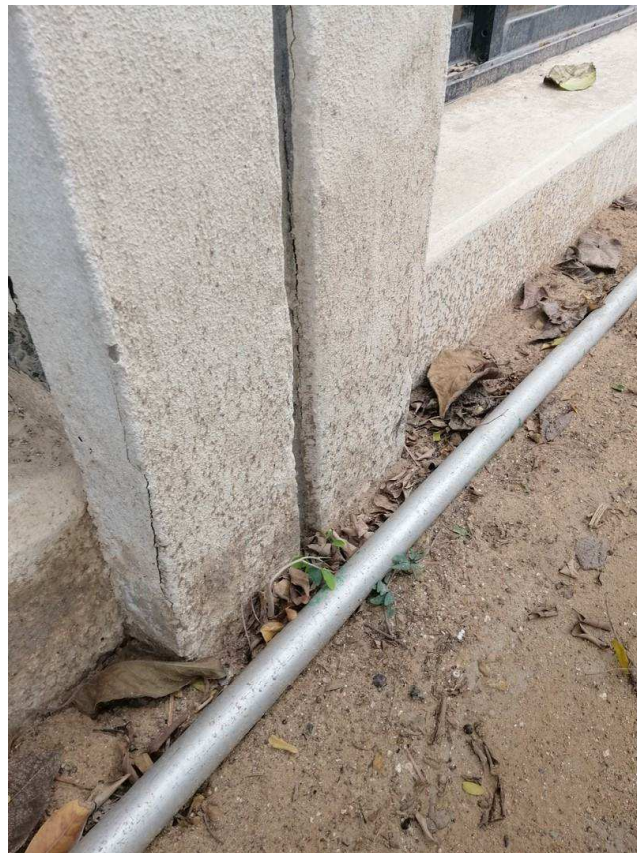
Figure 4-15 Cracks in column due to steel corrosion

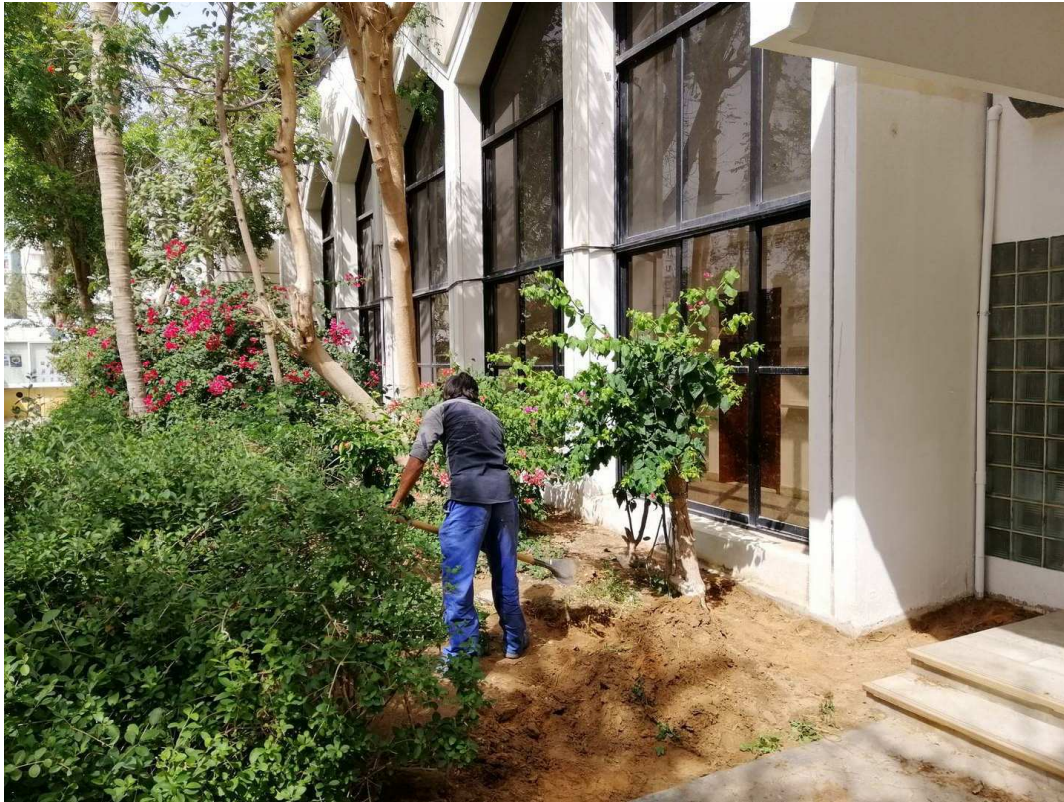
Figure 4-16 landscape work surrounding the building causing steel corrosion

- Replace all waterproofing of the auditorium, swimming pool, gymnasium and the playing area (Dojo).
- Isolate the landscape around the buildings to avoid damage in the adjacent concrete elements.

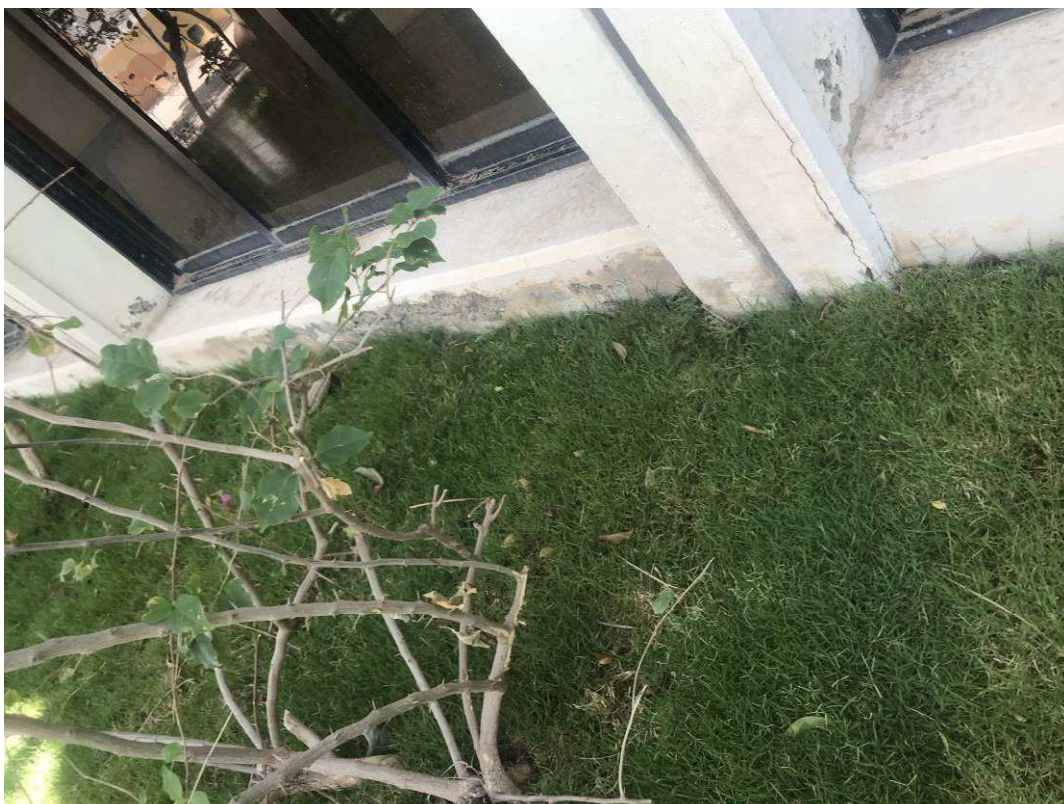
Figure 4-17 landscape work surrounding the building causing steel corrosion

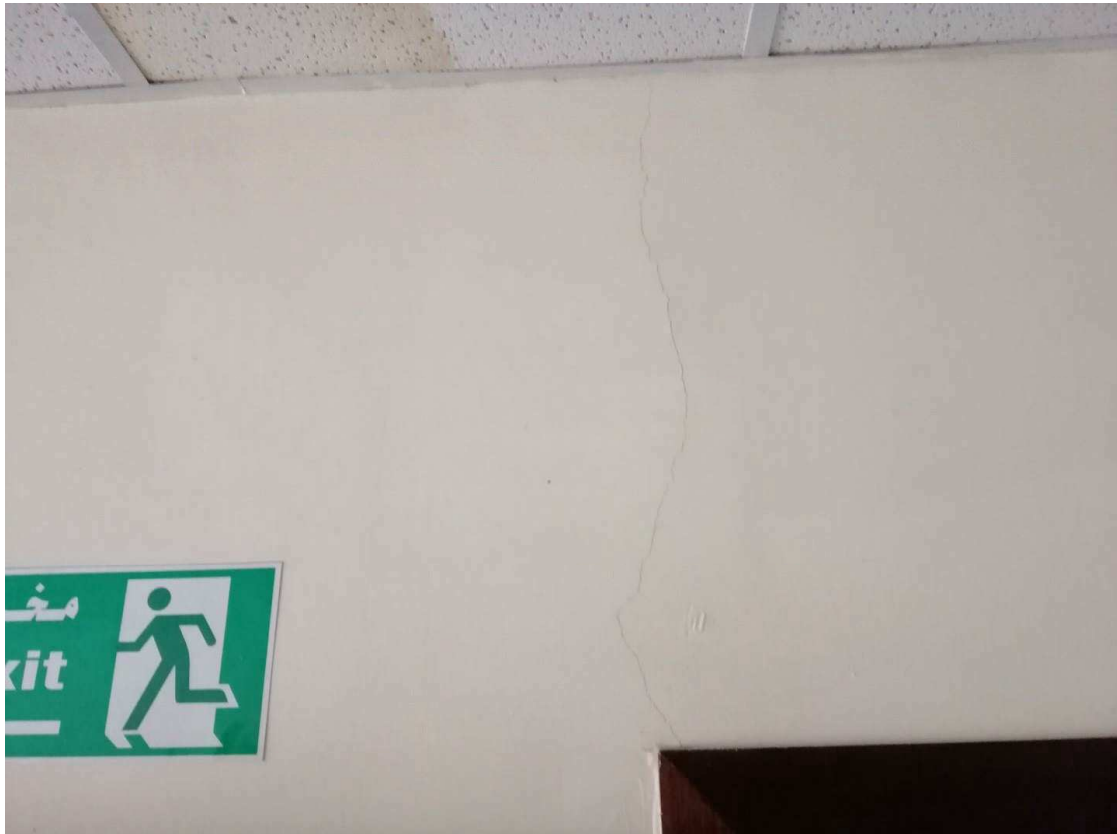
Figure 4-18 crack in block wall

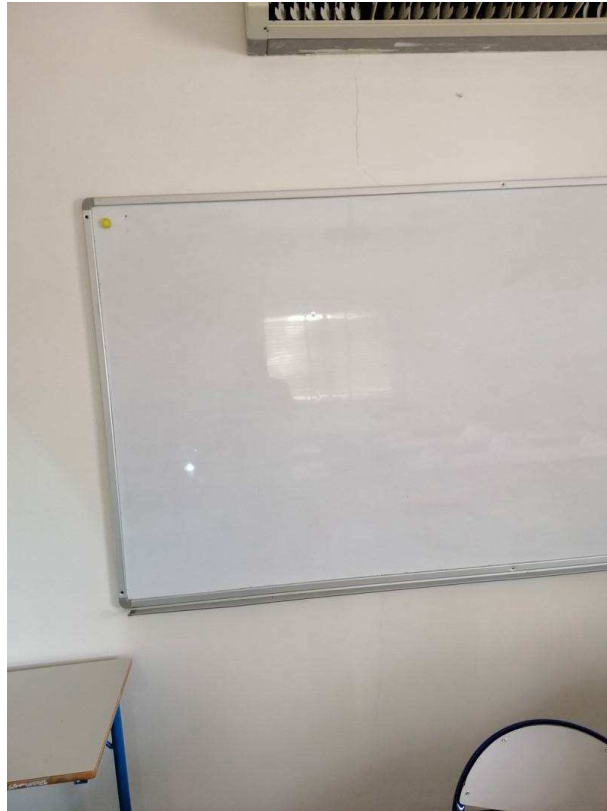
Figure 4-19 crack in block wall

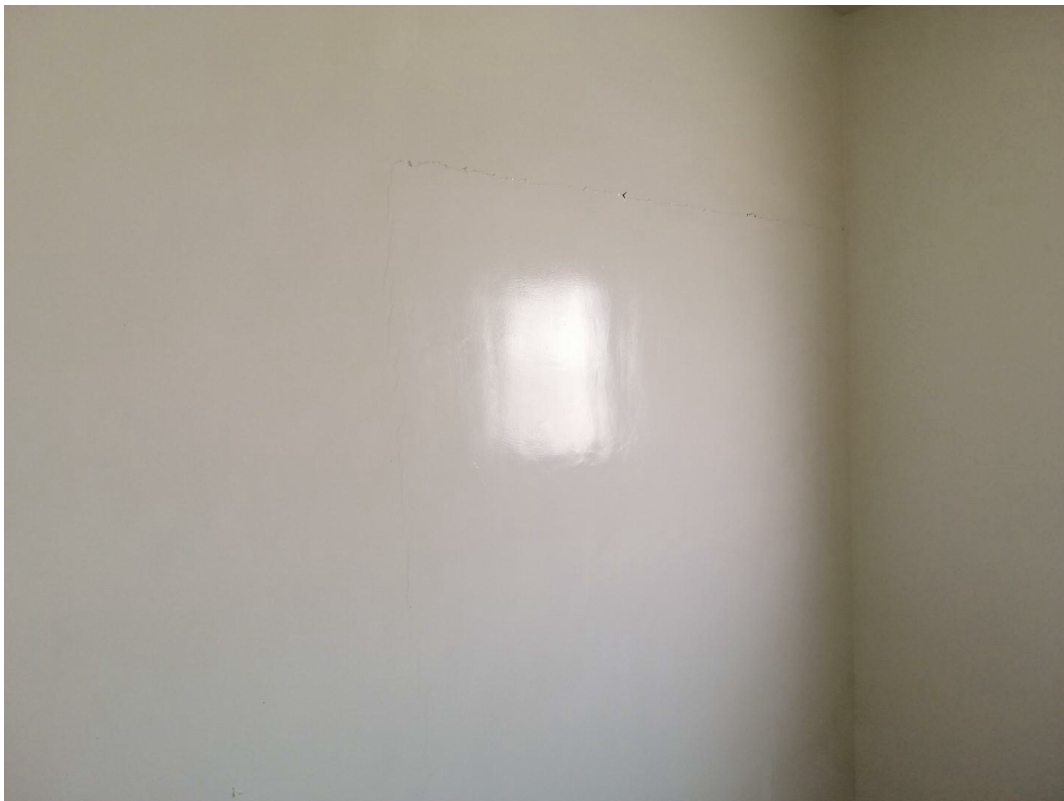
Figure 4-20 crack in block wall

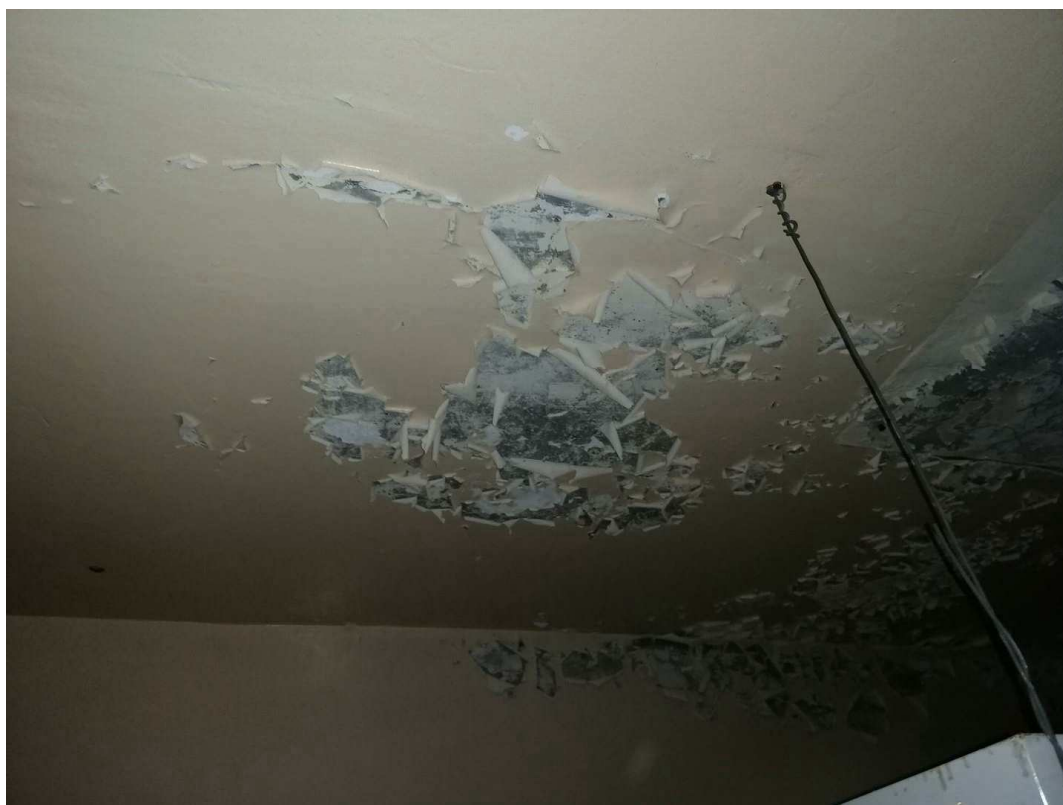
Figure 4-21 Previous dampness in slab

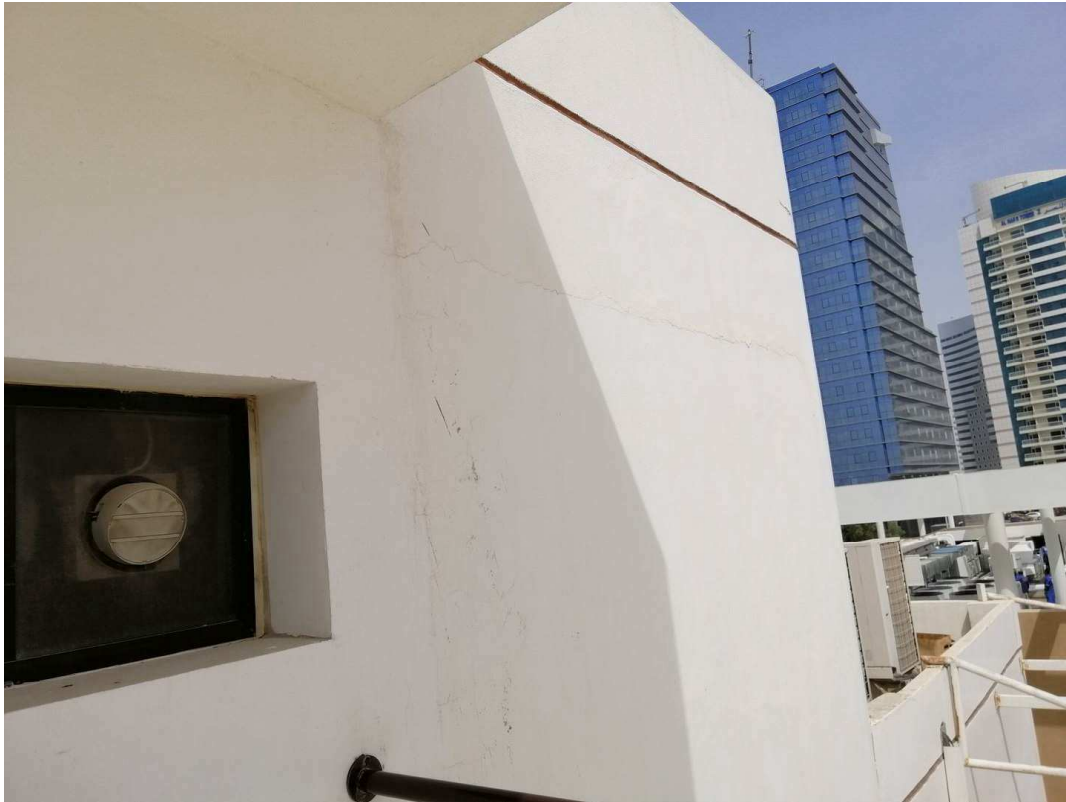
Figure 4-25 crack between block wall and concrete element

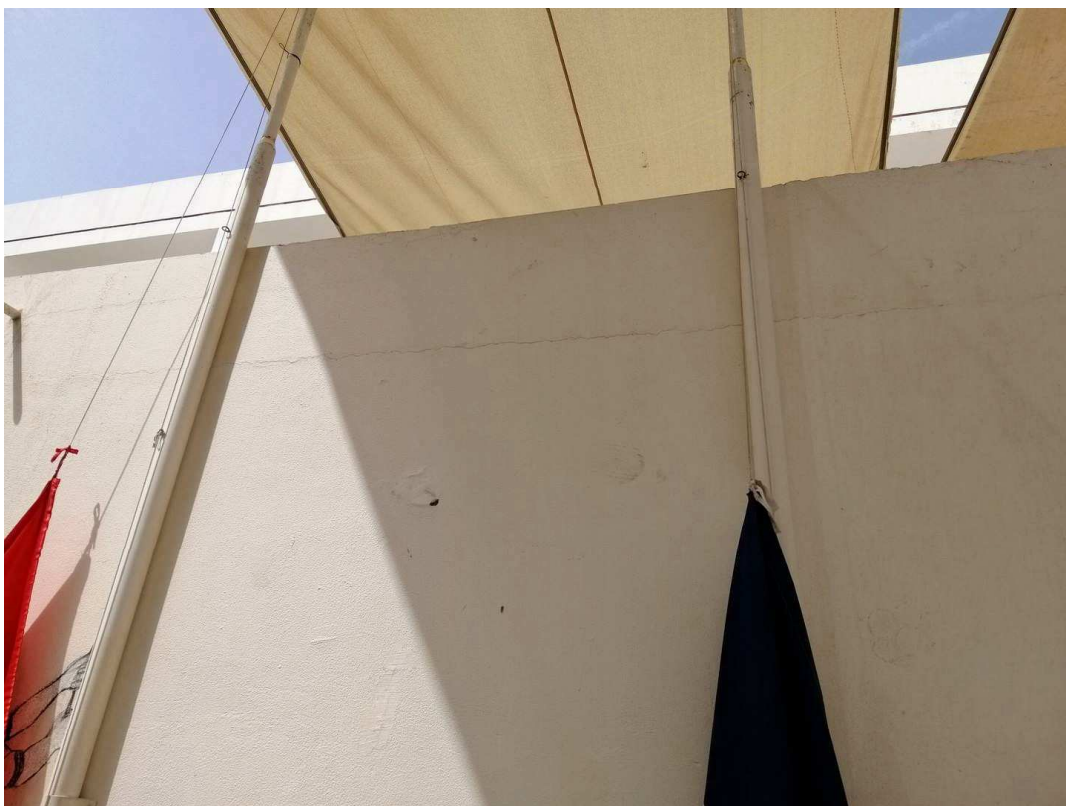
Figure 4-26 crack between block wall and concrete element

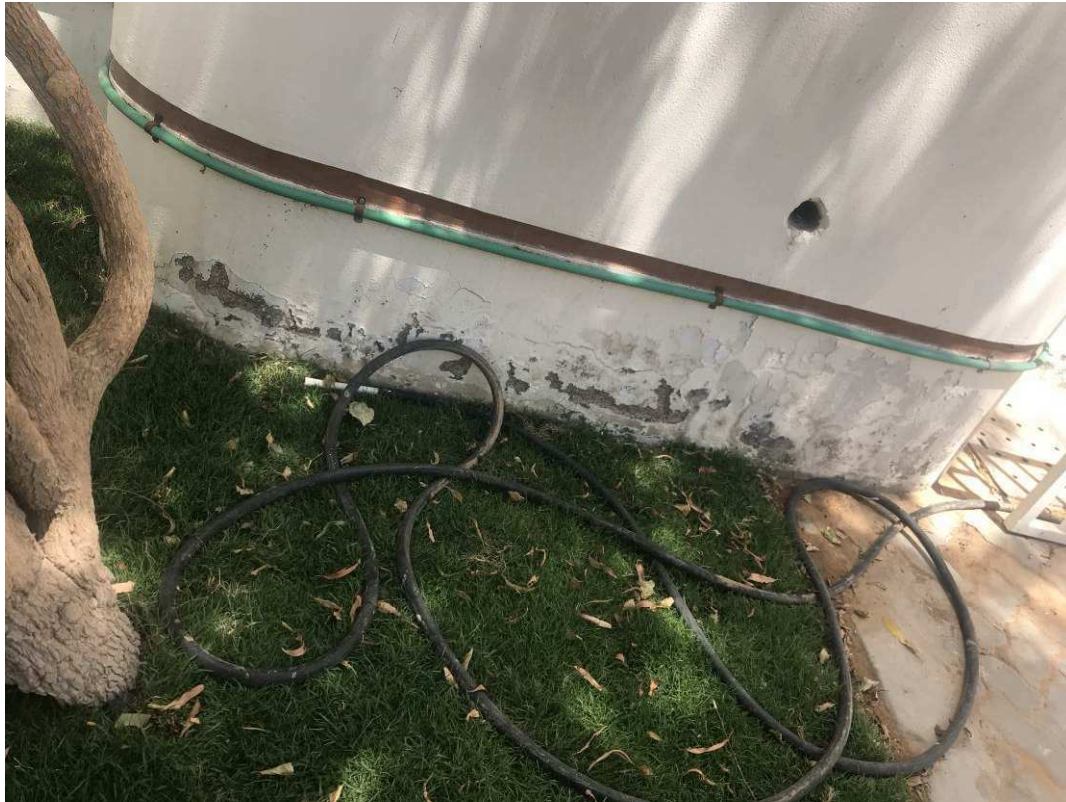
Figure 4-27 the building is surrounding by landscape

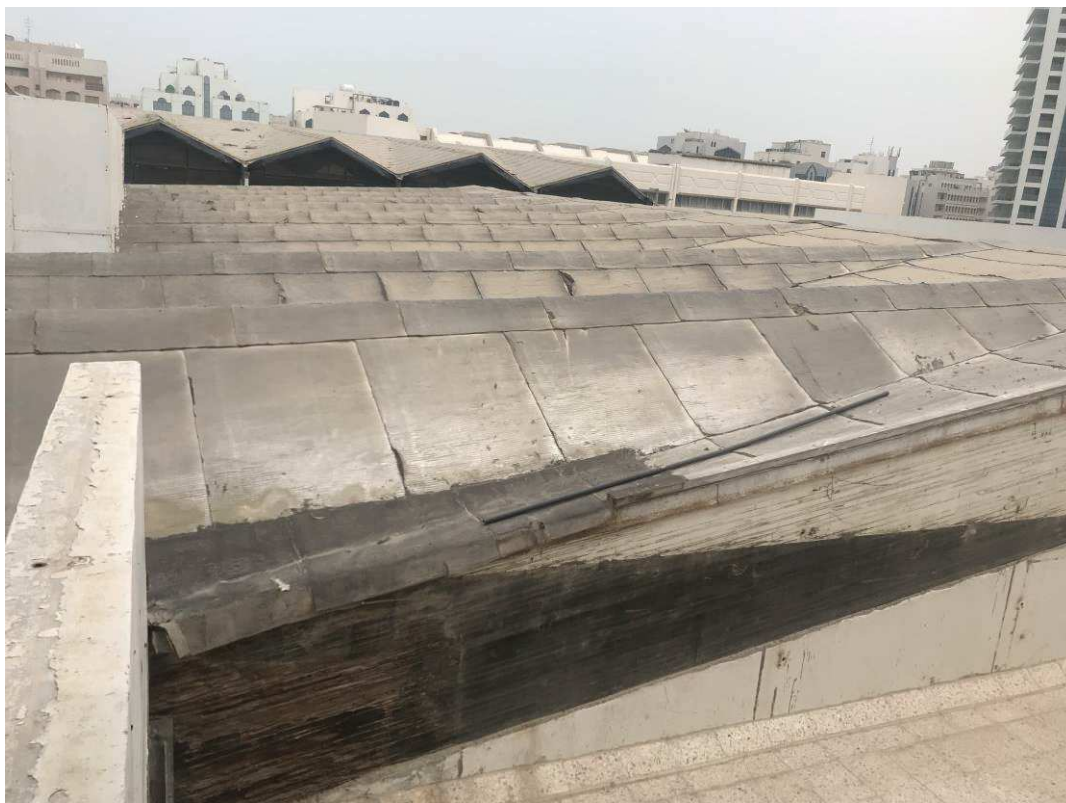
Figure 4-28 Wet rot damage in Wooden beam

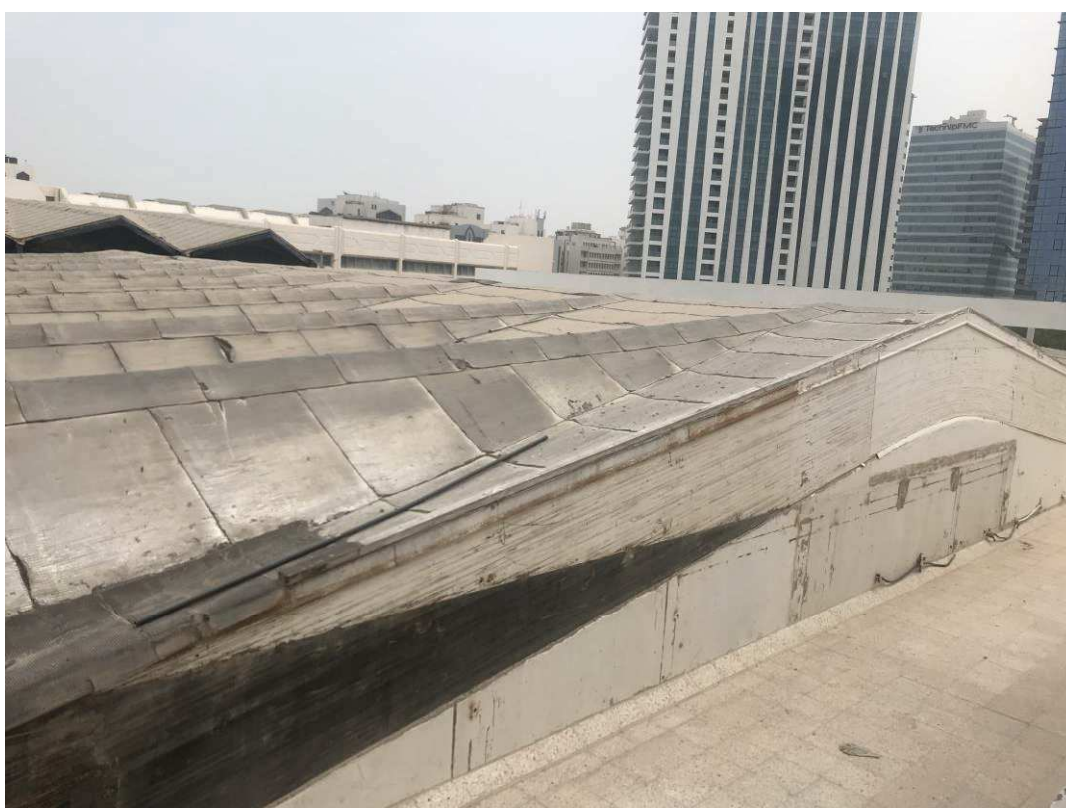
Figure 4-29 Wet rot damage in Wooden beam

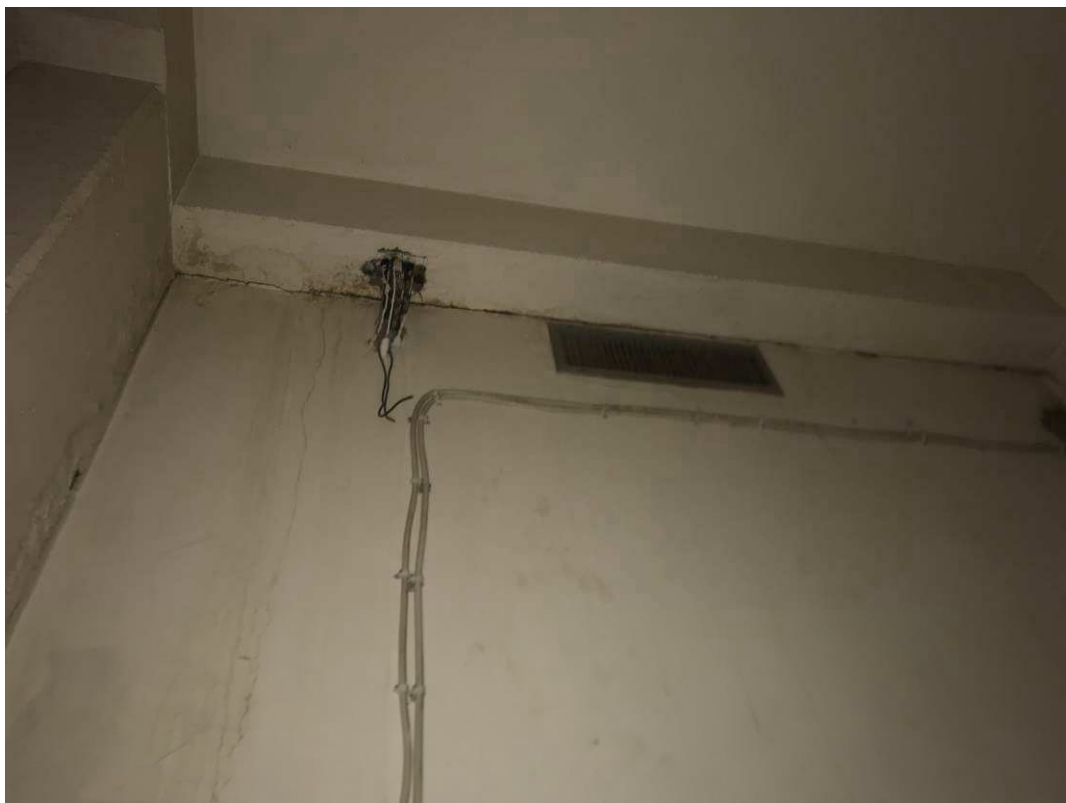
Figure 4-30 sign of previous leakage

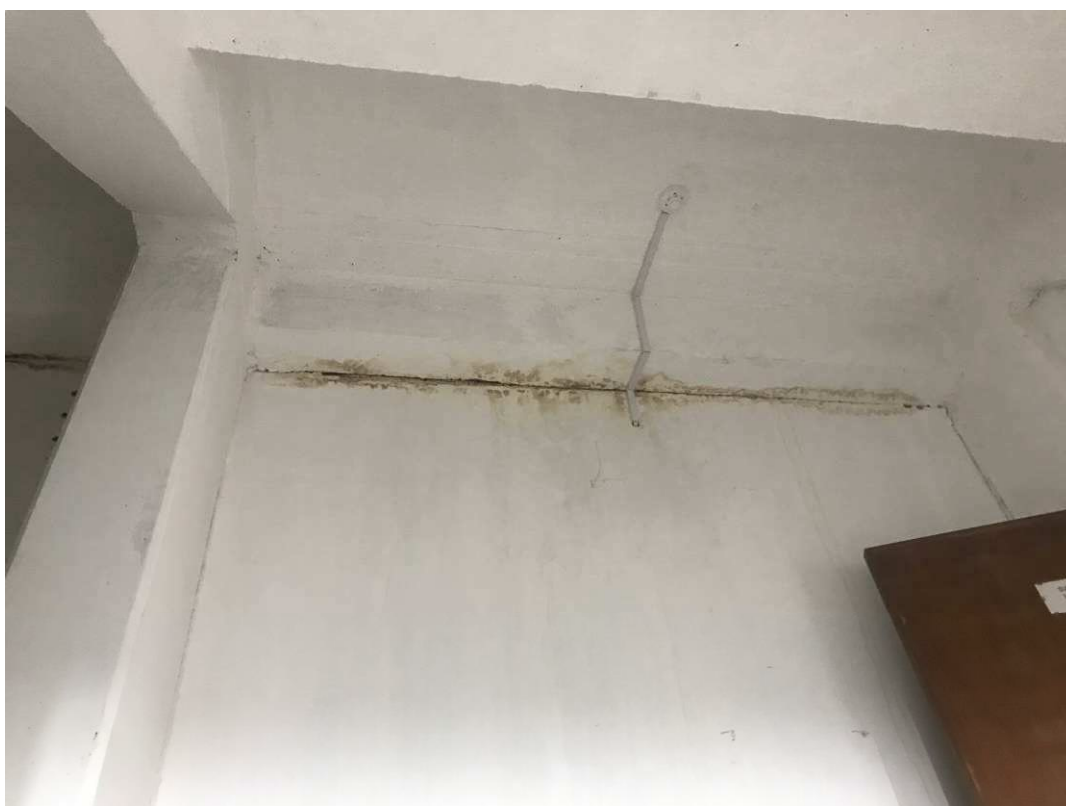
Figure 4-31 sign of previous leakage
