RENOVATION OF BLOCK B' FOR FRENCH SCHOOL (LYCEE LOUIS MASSIGNON)

CONCRETE REPAIRS AND STRUCTURAL REINFORCEMENT

**VOLUME 5 – Part 4 of 7
M/s eForce Inspection Consultancies
Report eForce/195/2019 dated January 28th, 2020**

**STRUCTURAL STUDY OF EXISTING STRUCTURE OF
THE GYMNASIUM, SWIMMING POOL AND AUDITORIUM
LYCÉE LOUIS MASSIGNON SCHOOL, ABU DHABI, UAE
(Phase 1: Assessment, Pre design and Scenarios)**

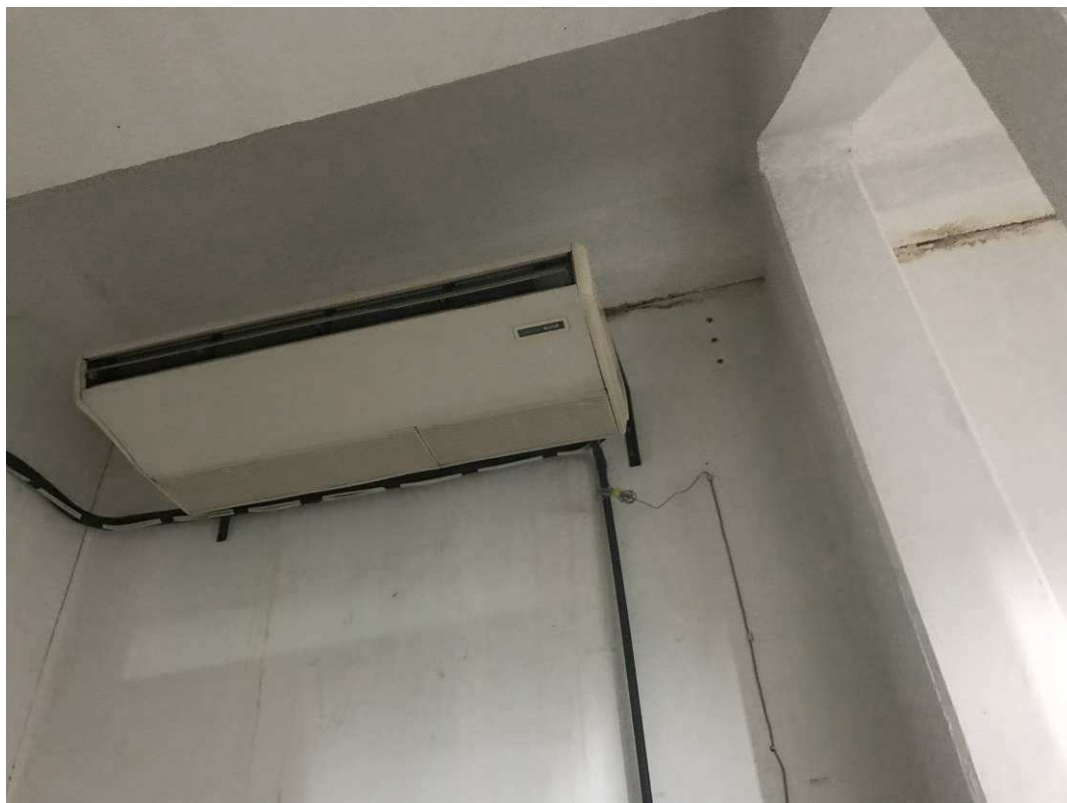
Figure 4-32 sign of previous leakage

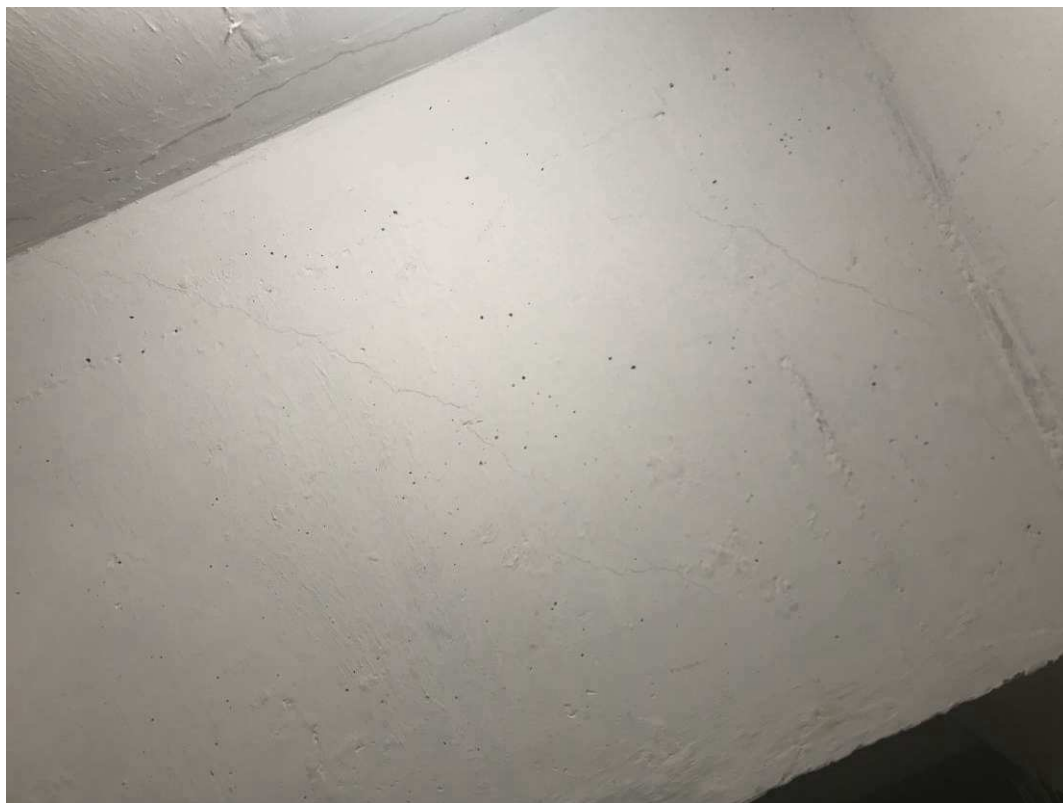
Figure 4-36 Cracks in concrete wall

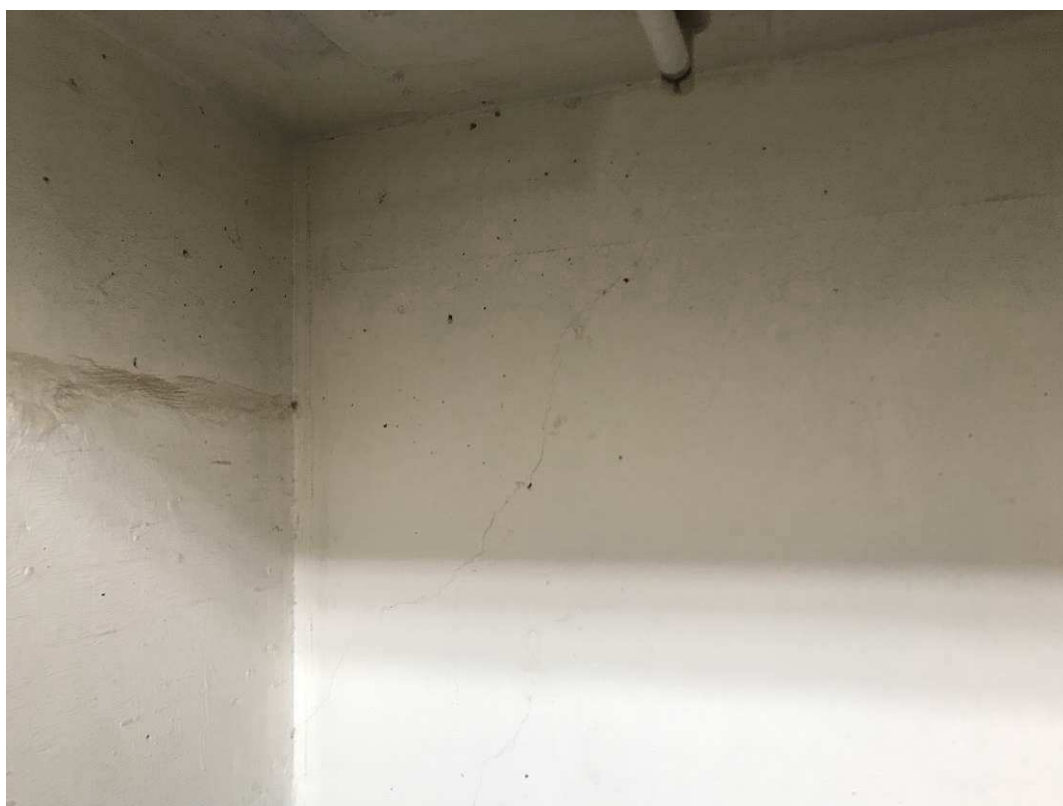
Figure 4-37 Cracks in concrete wall

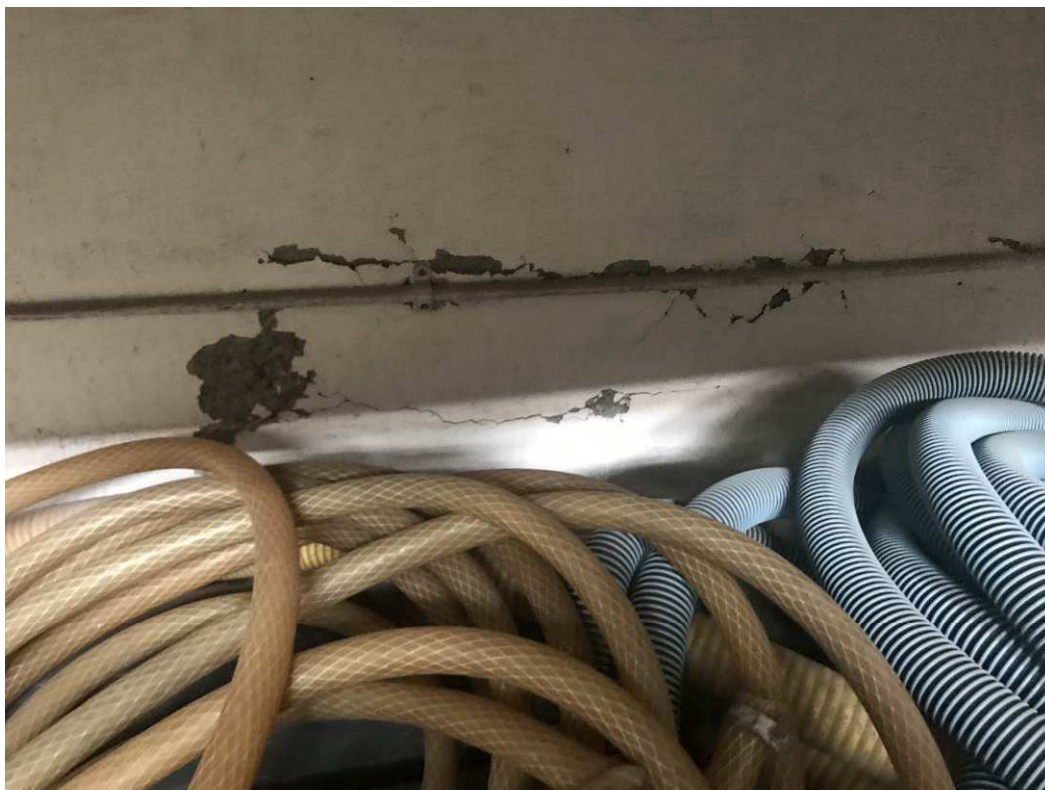
Figure 4-38 delamination in concrete wall

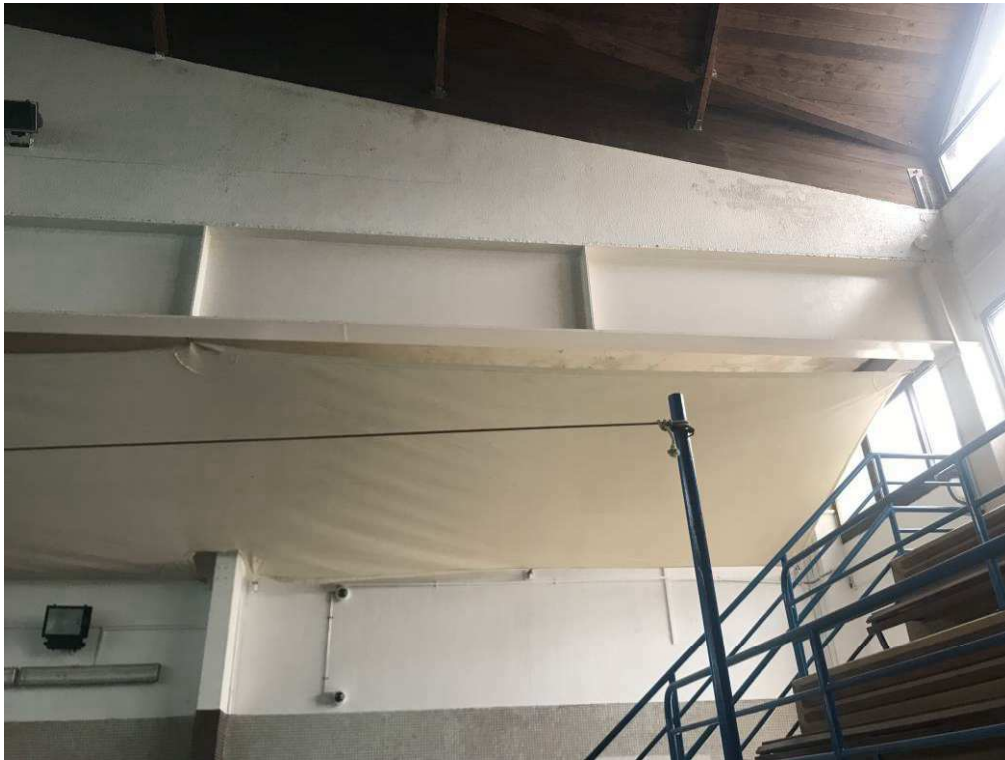
Figure 4-42 Dampness in slab soffit

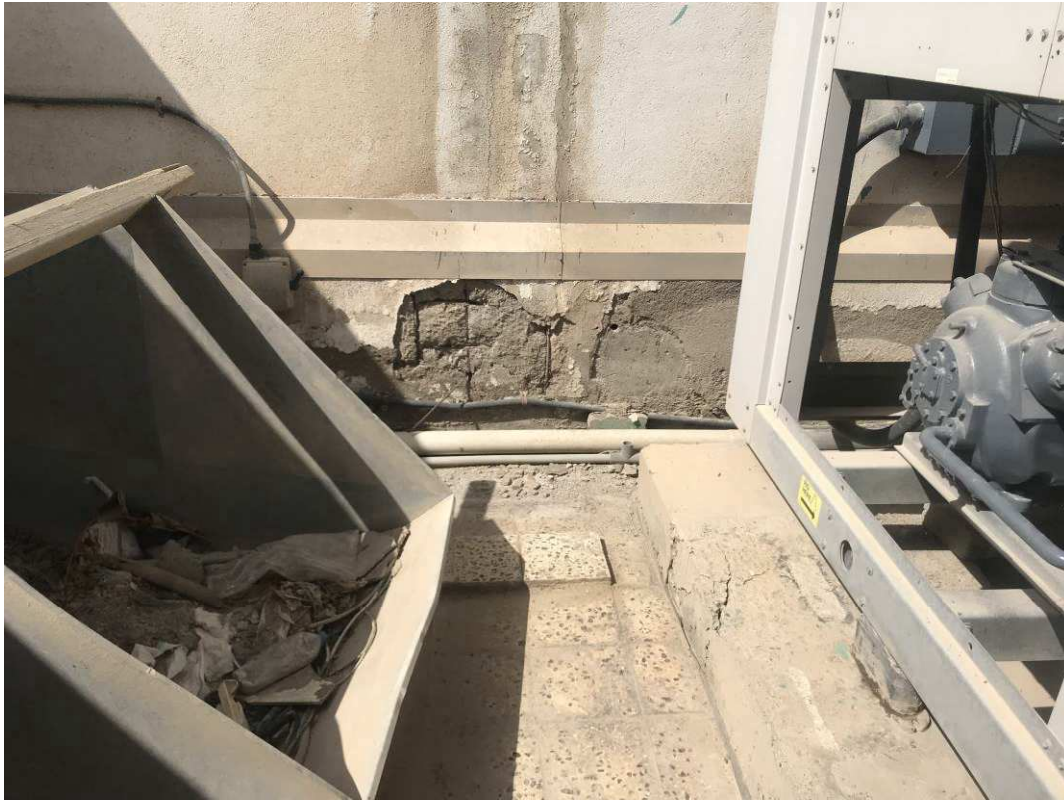
Figure 4-49 delamination and corrosion

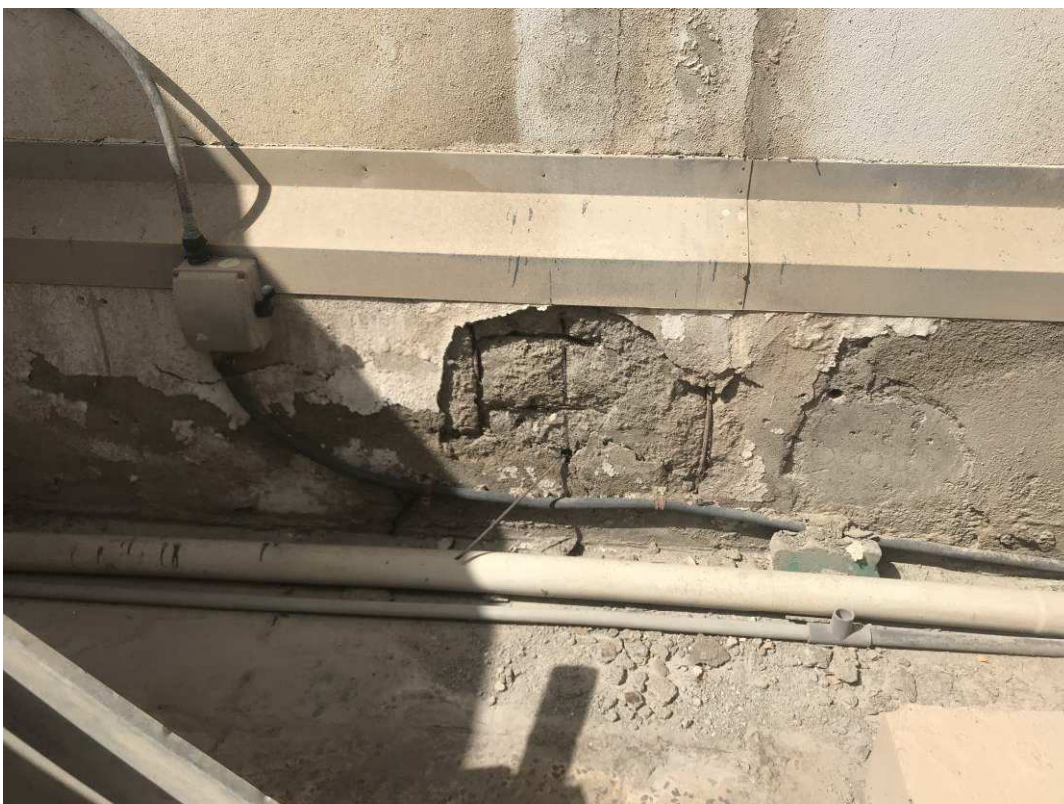
Figure 4-50 delamination and corrosion

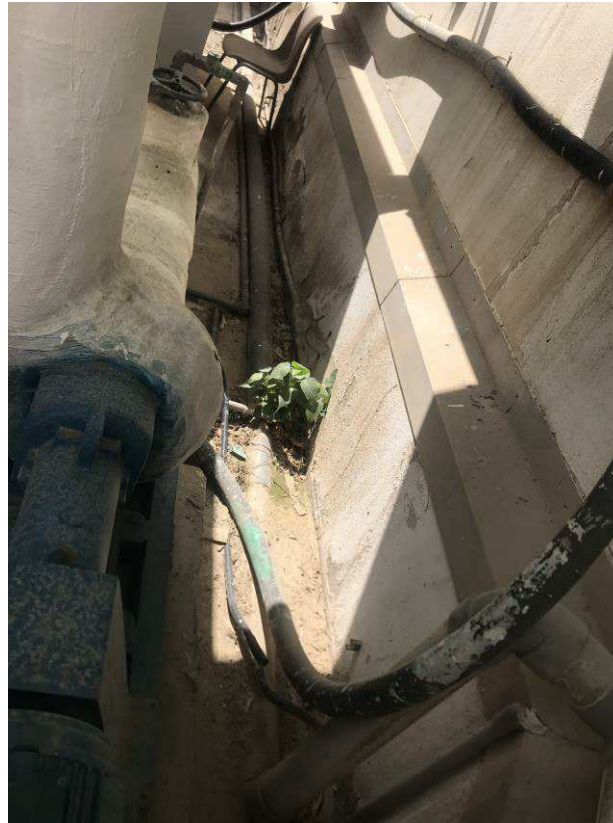
Figure 4-51 delamination and corrosion

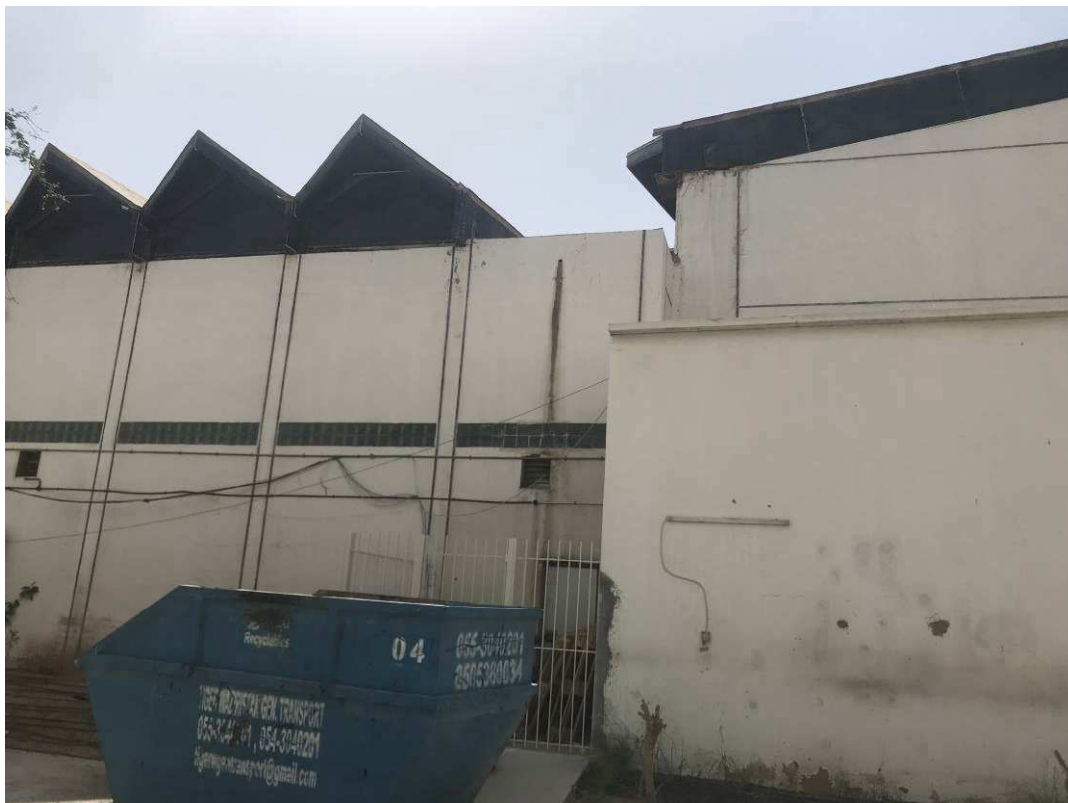
Figure 4-52 delamination and corrosion in column

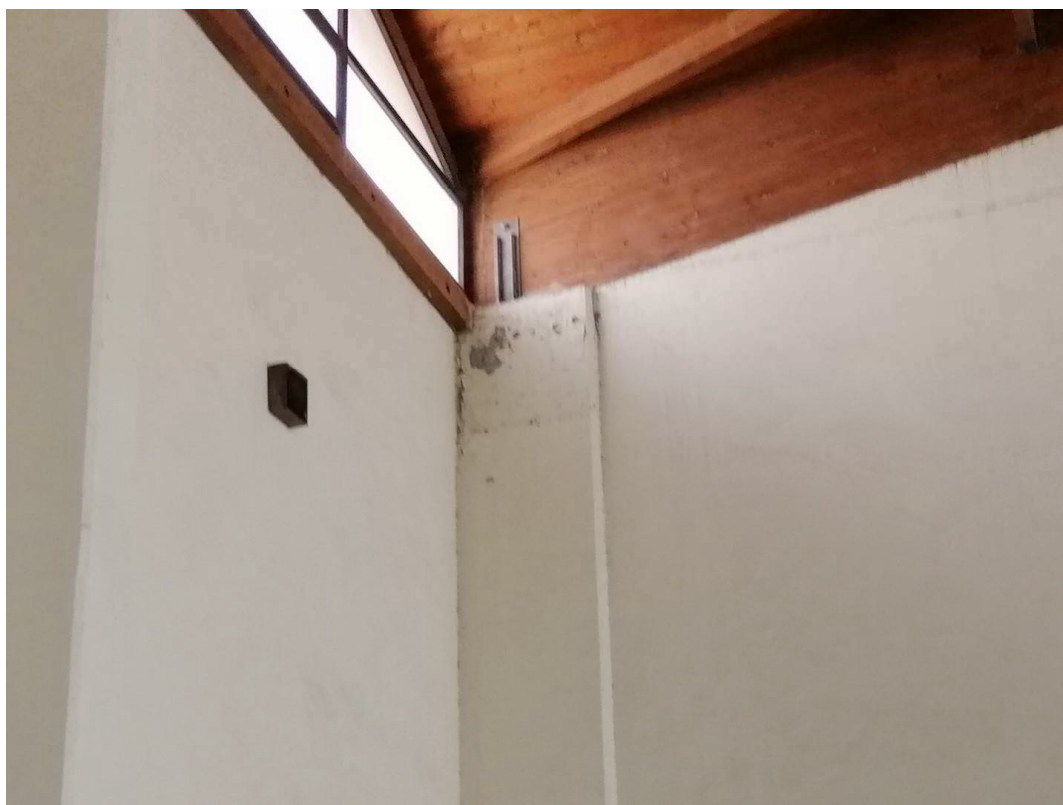
Figure 4-53 delamination and corrosion in column

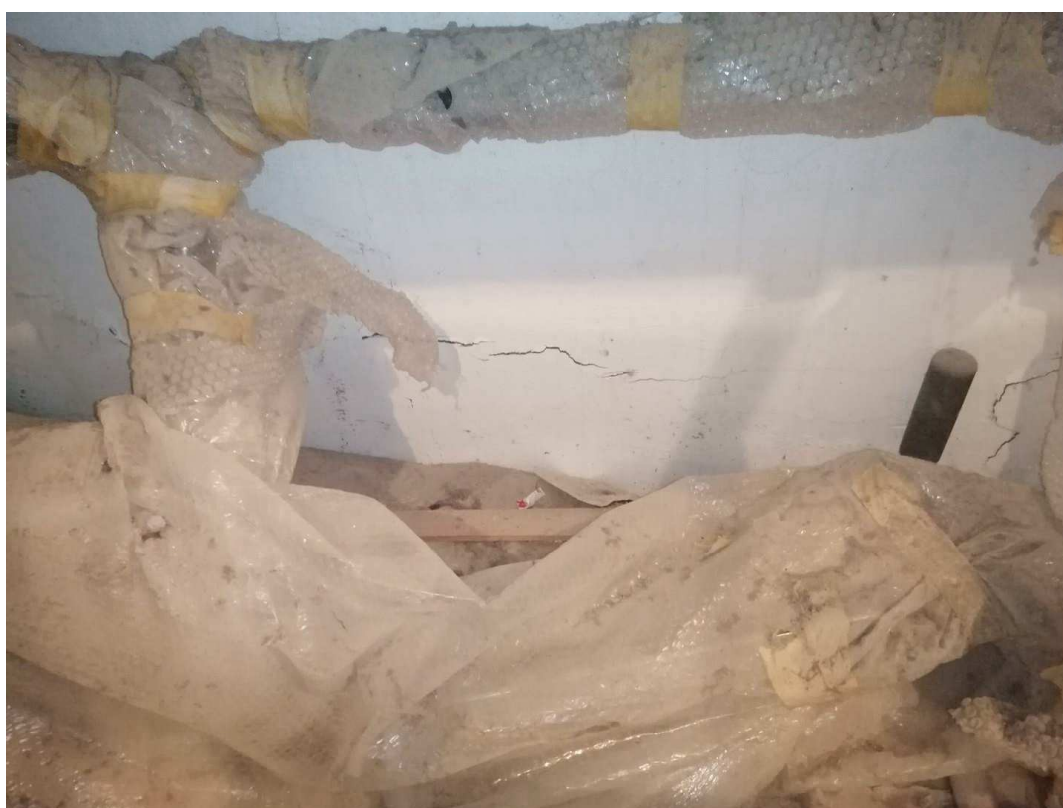
Figure 4-54 delamination and corrosion in wall

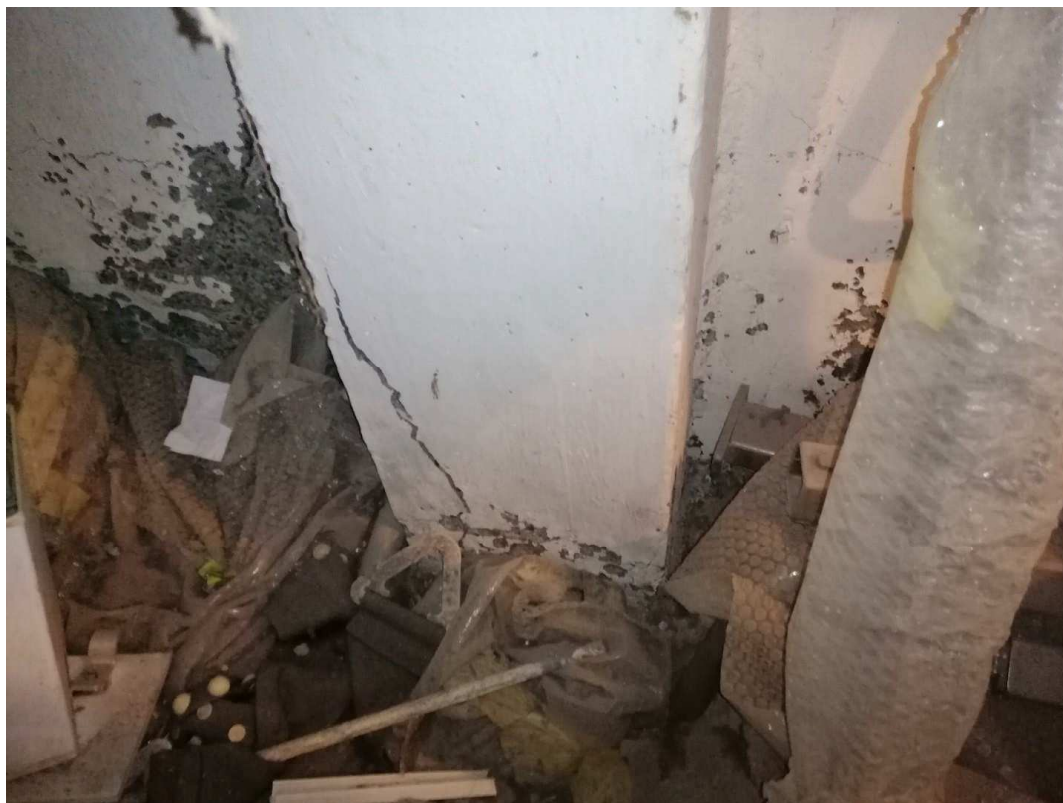
Figure 4-55 Cracks in column

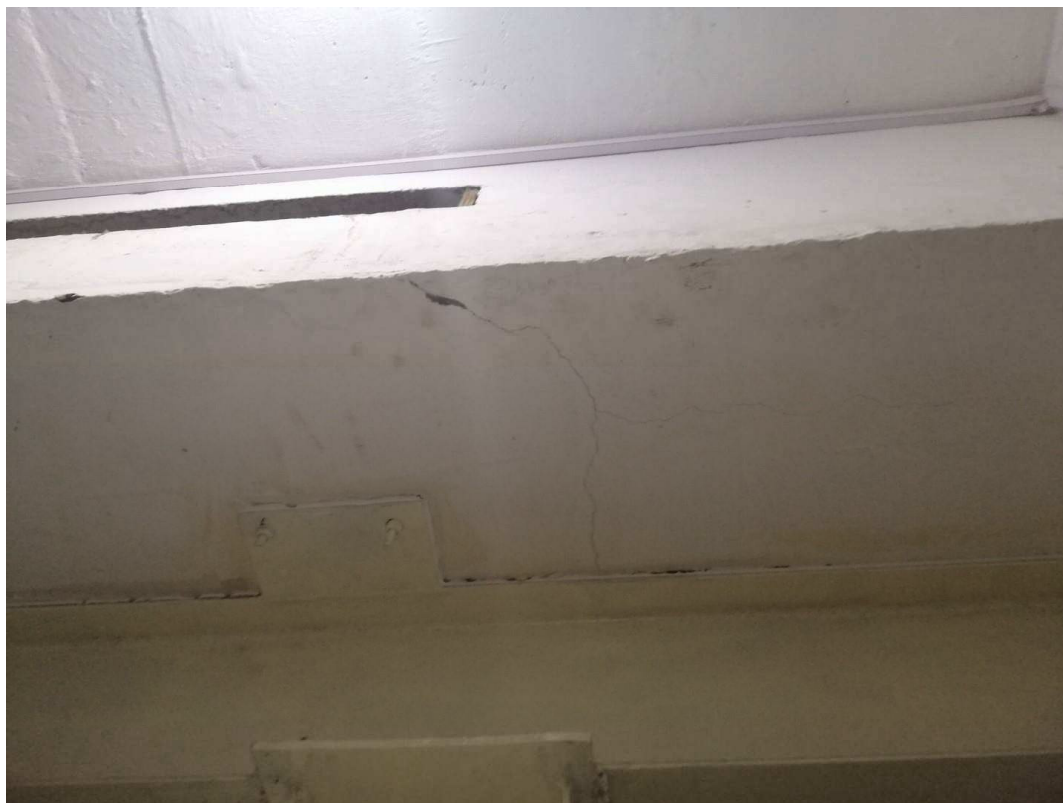
Figure 4-57 Cracks in stands

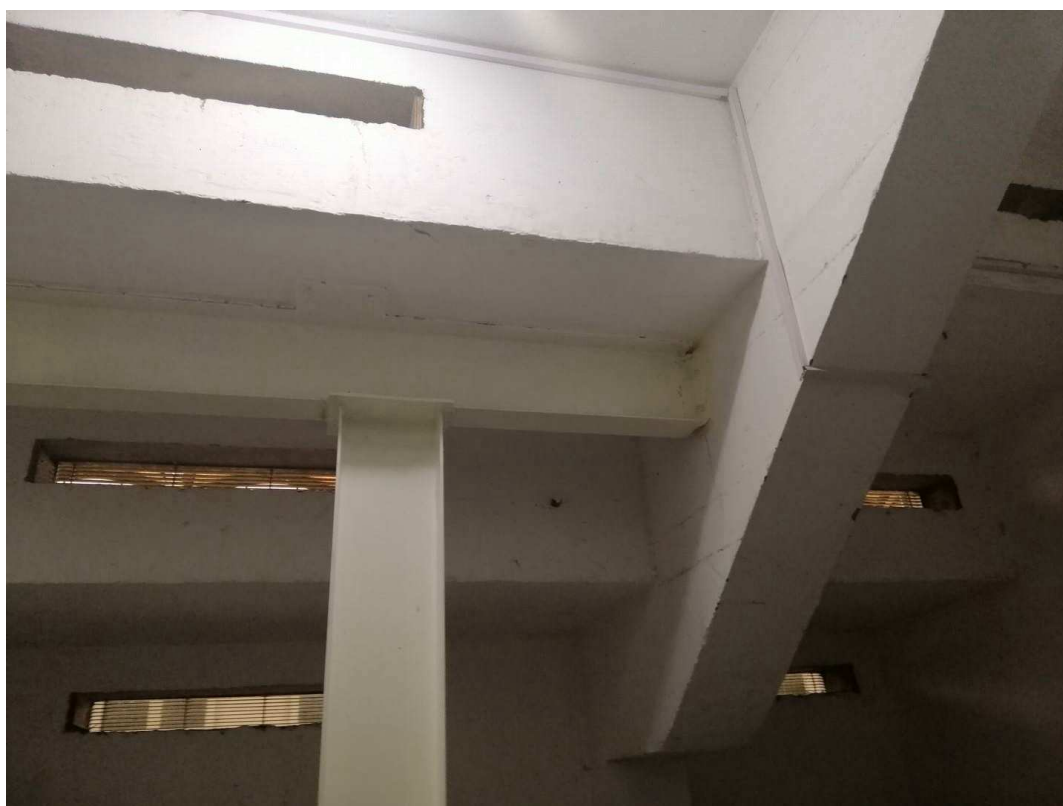
Figure 4-58 Cracks in main beam

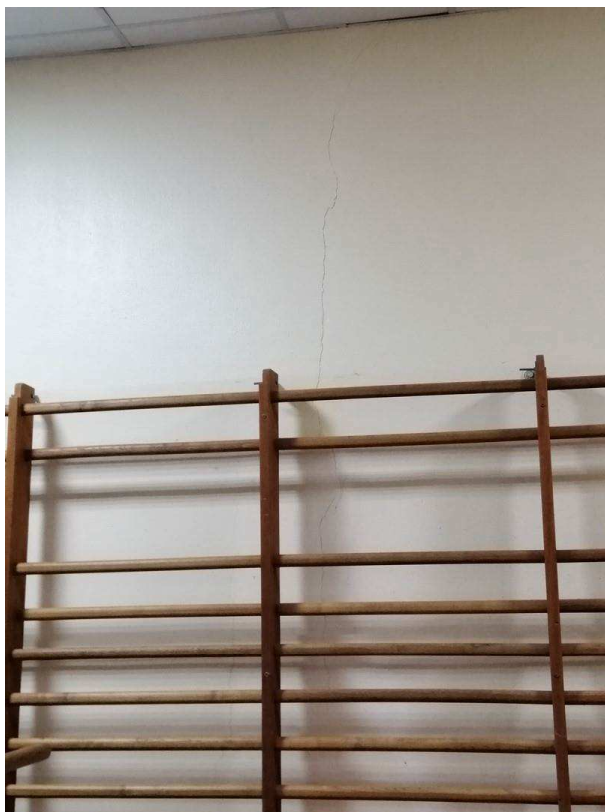
Figure 4-59 Cracks in Block wall

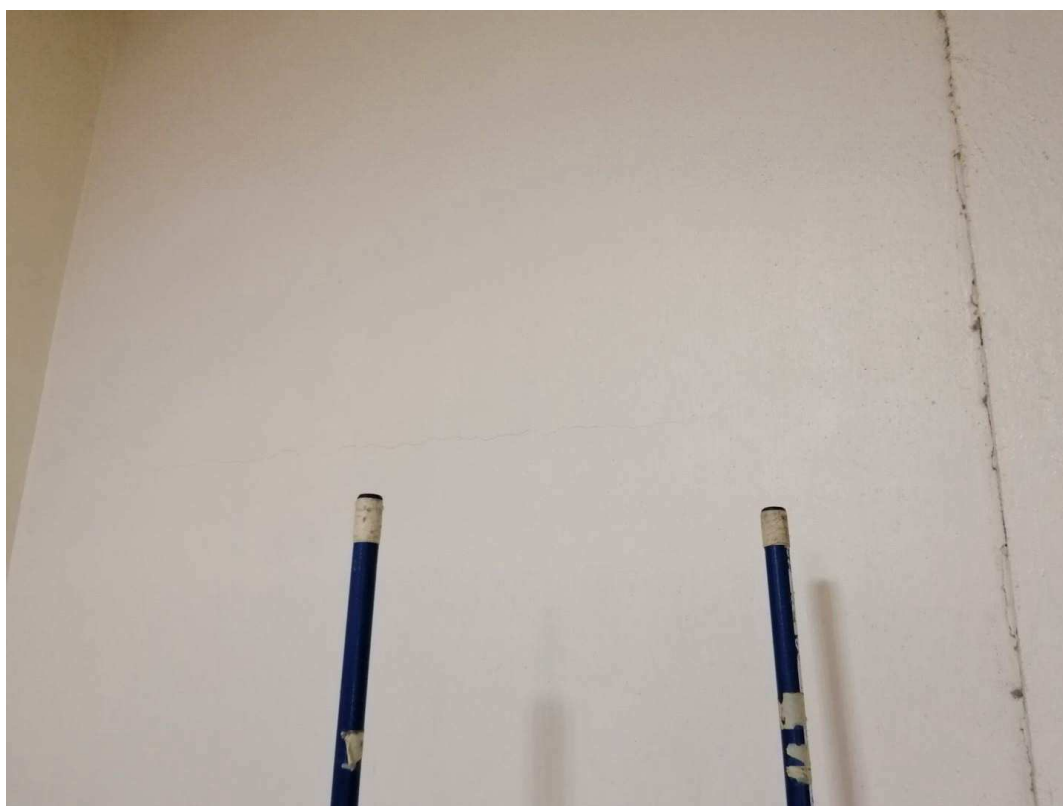
Figure 4-60 Cracks in Block wall

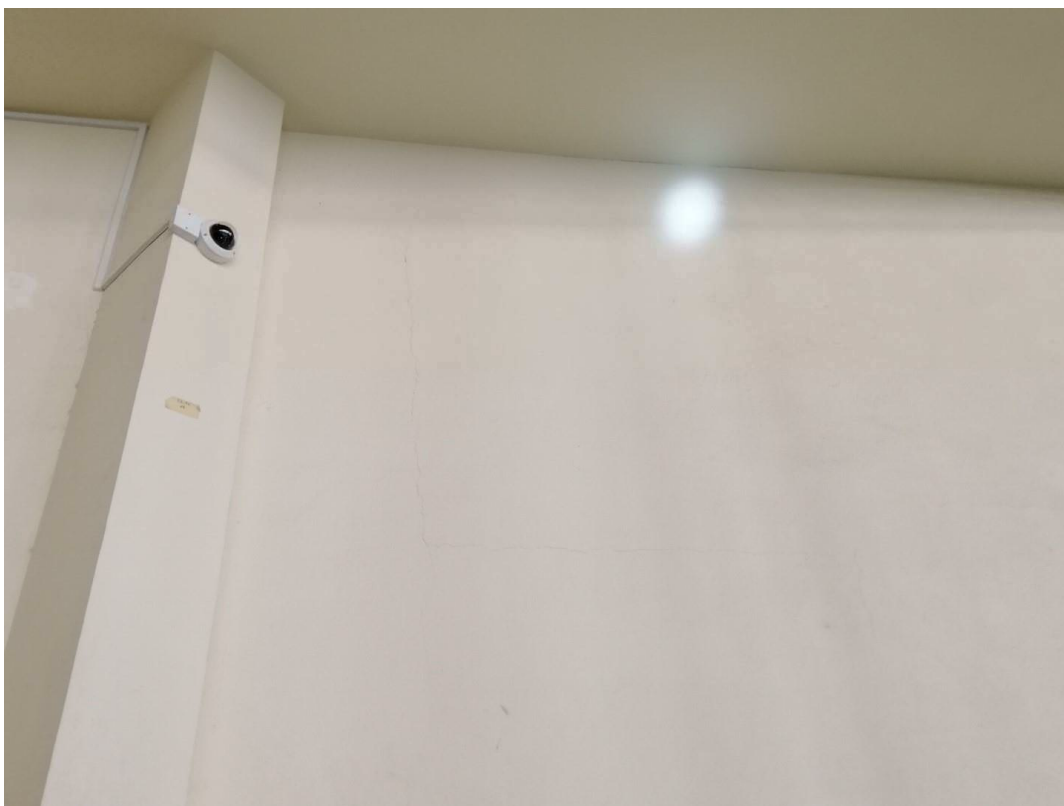
Figure 4-62 Cracks between Block wall and concrete element

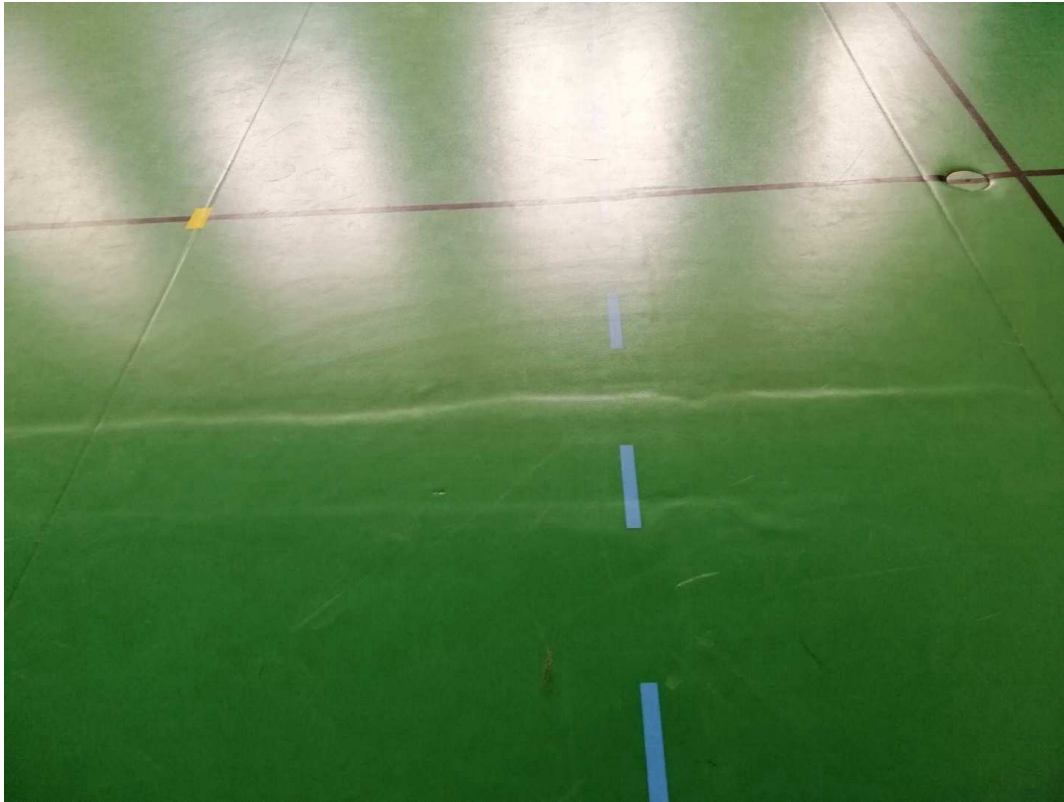
Figure 4-63 bulging in the floor

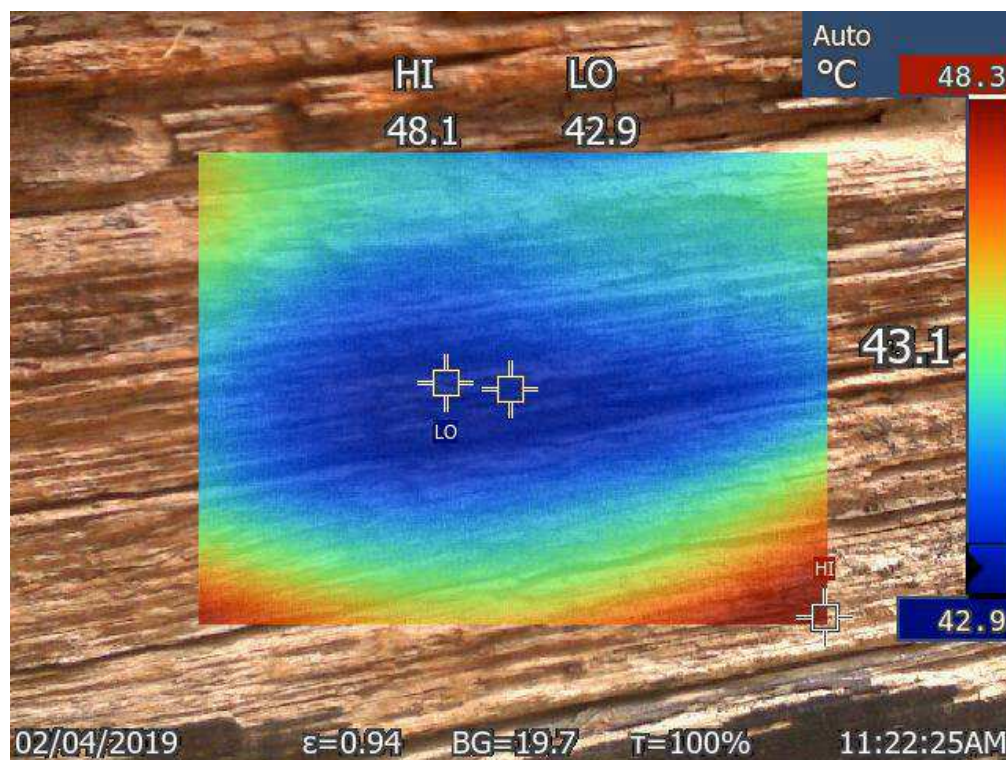
From thermal graphic test (figure 4-82 and figure 4-83) the wooden beam of the swimming pool is fully dried.

Figure 4-83 thermal image test over the damaged beam

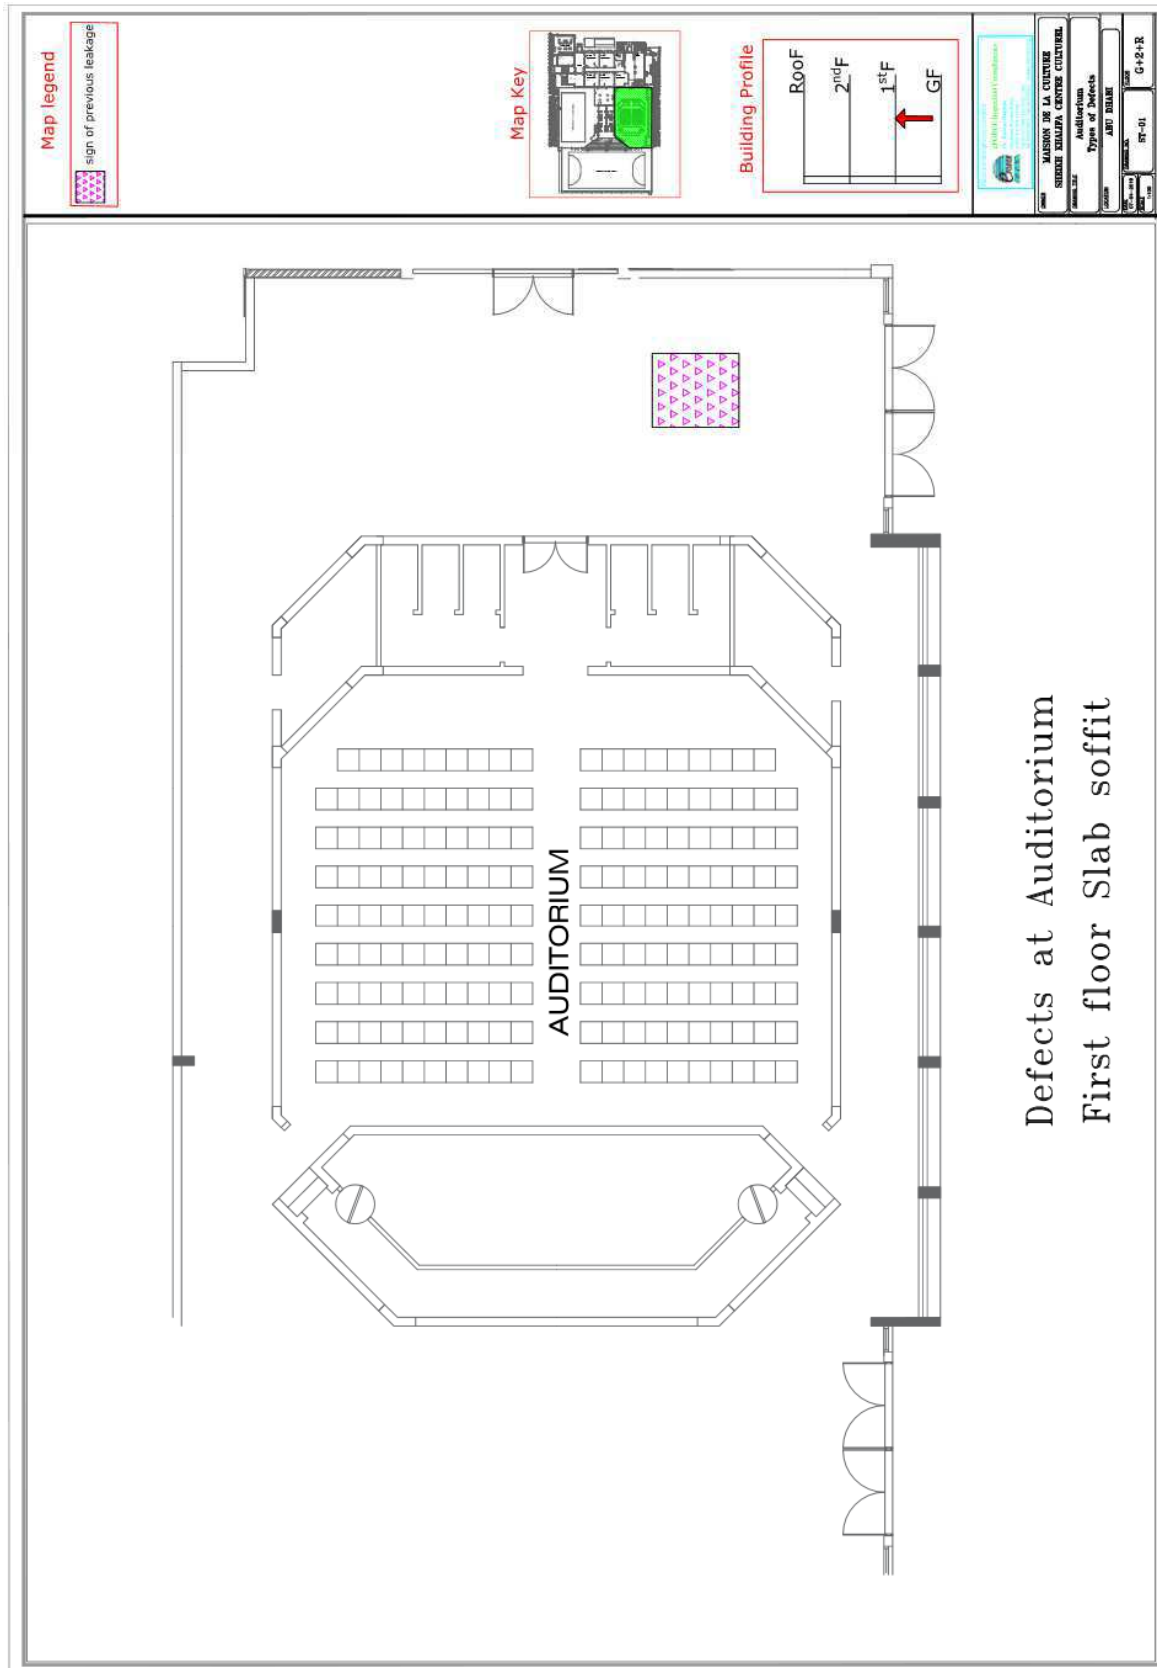
Figure A-2 Defects in auditorium slab soffit

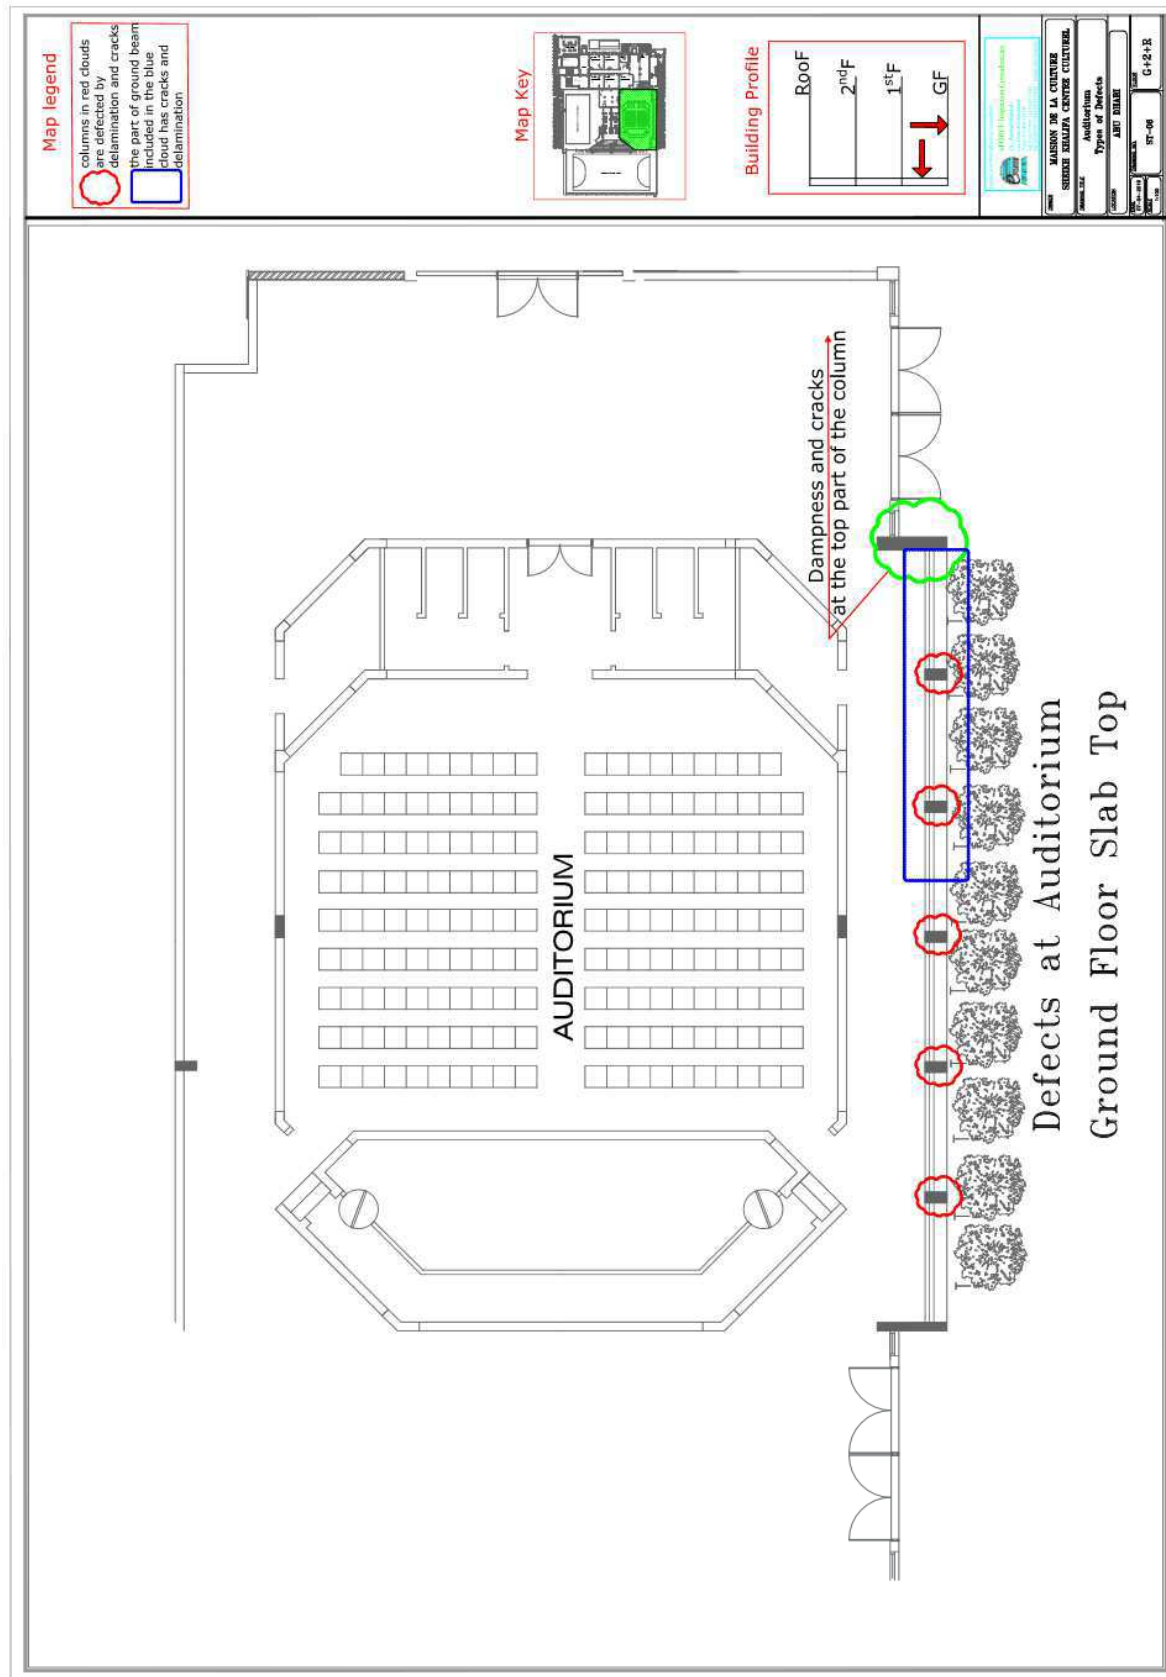
Figure A-3 Defects in auditorium slab top

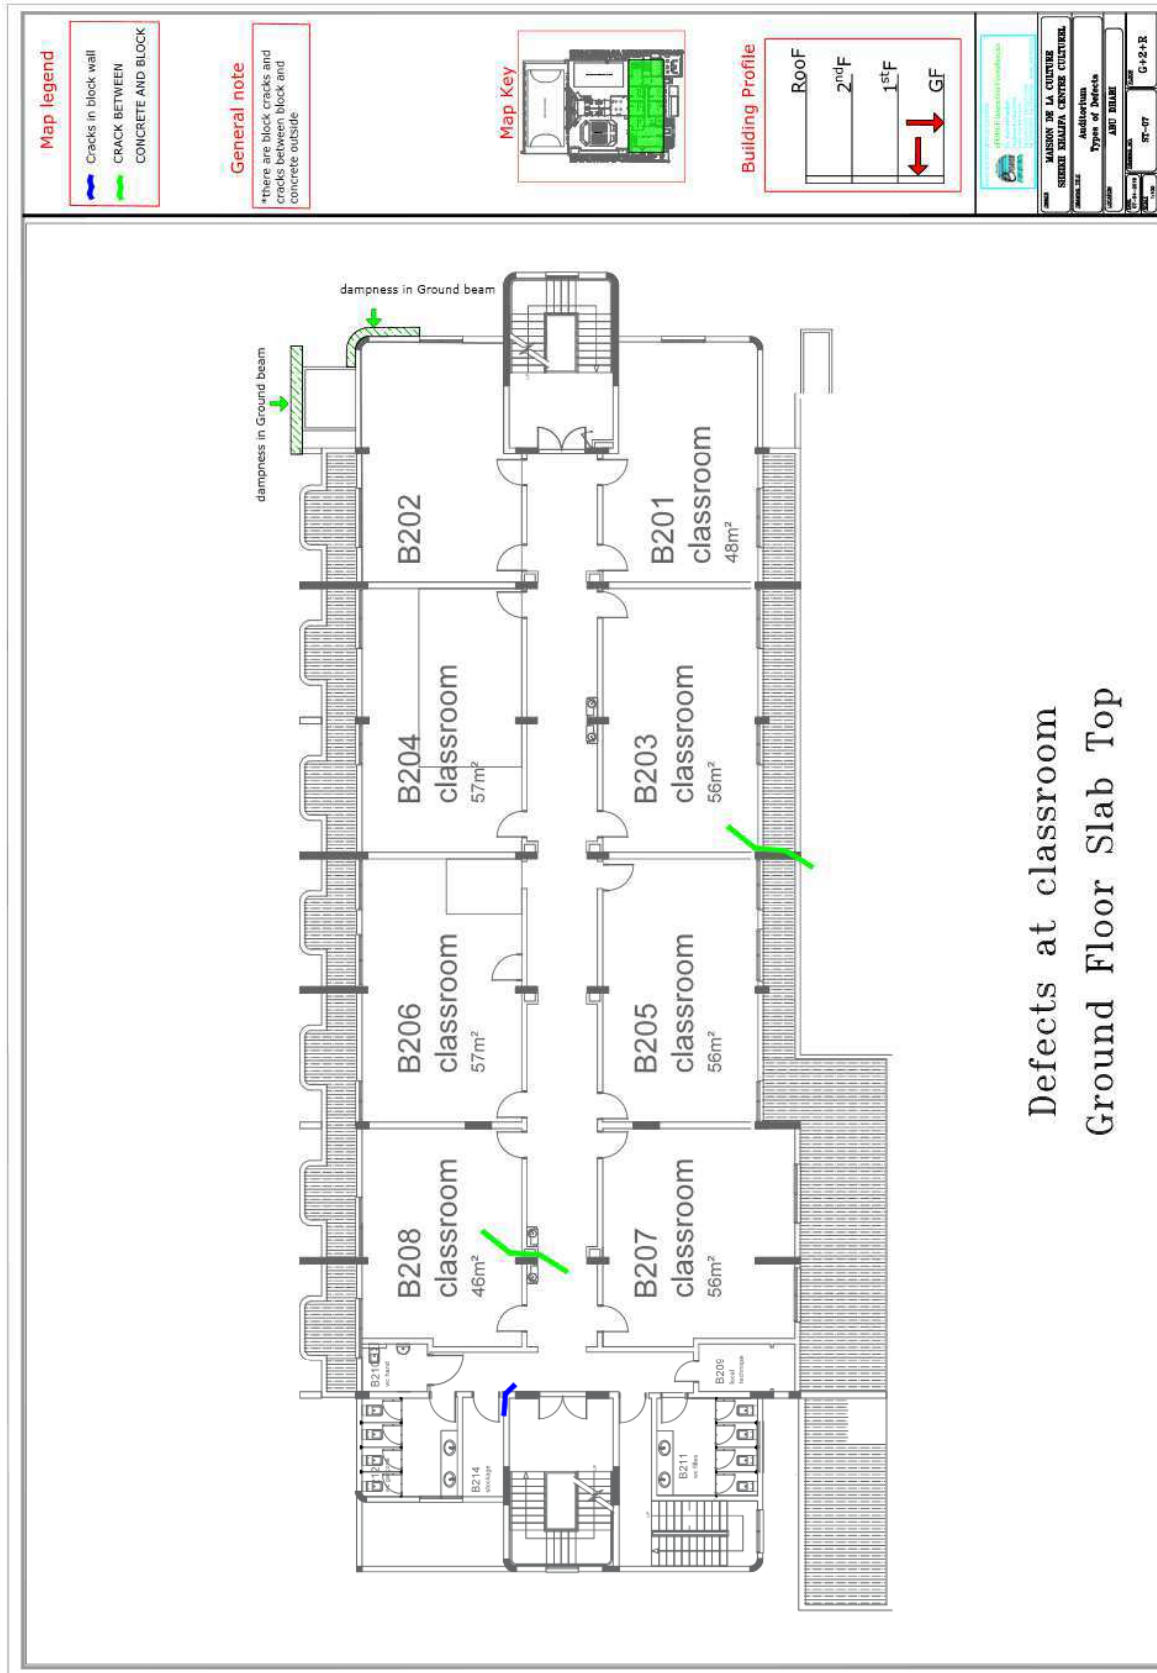
Figure A-4 defects in Classroom building in ground floor slab top
