RENOVATION OF BLOCK B' FOR FRENCH SCHOOL (LYCEE LOUIS MASSIGNON)

CONCRETE REPAIRS AND STRUCTURAL REINFORCEMENT

**VOLUME 5 – Part 4 of 7
M/s eForce Inspection Consultancies
Report eForce/195/2019 dated January 28th, 2020**

**STRUCTURAL STUDY OF EXISTING STRUCTURE OF
THE GYMNASIUM, SWIMMING POOL AND AUDITORIUM
LYCÉE LOUIS MASSIGNON SCHOOL, ABU DHABI, UAE
(Phase 1: Assessment, Pre design and Scenarios)**

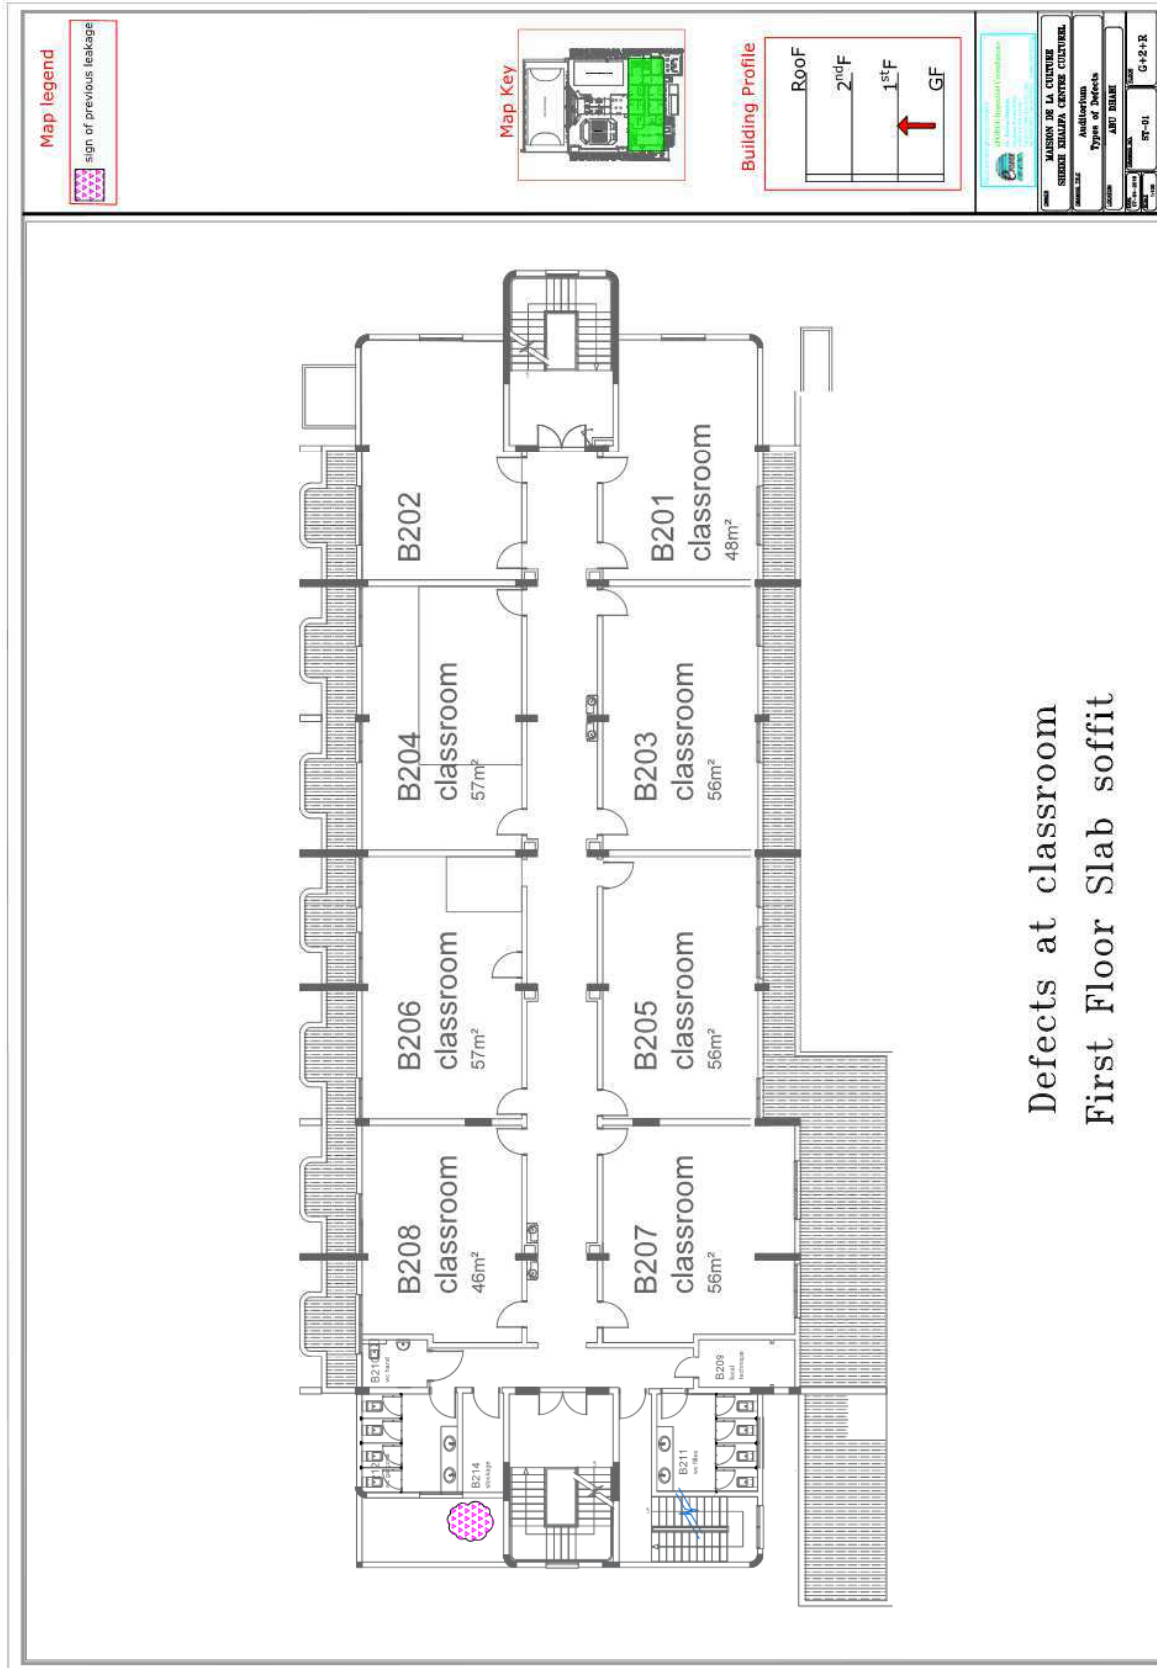
Figure A-5 defects in Classroom building in first floor slab soffit

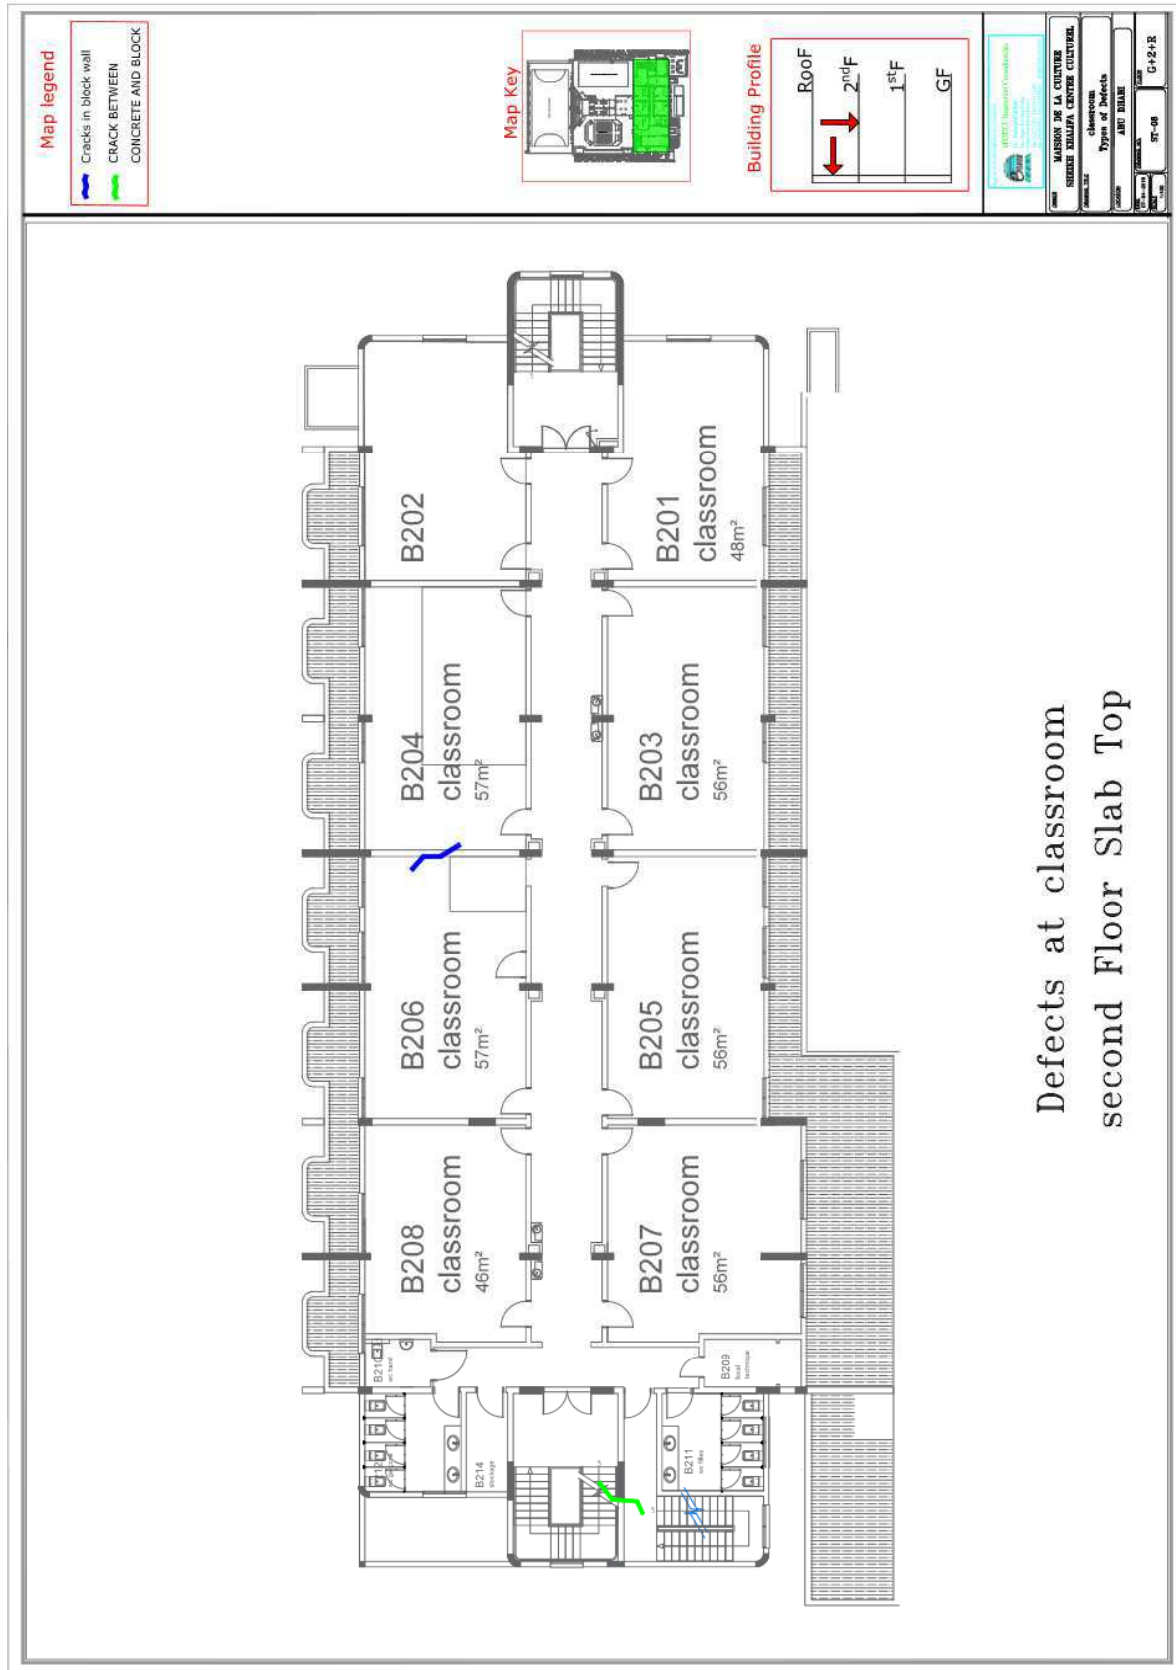
Figure A-6 defects in Classroom building in second floor slab top

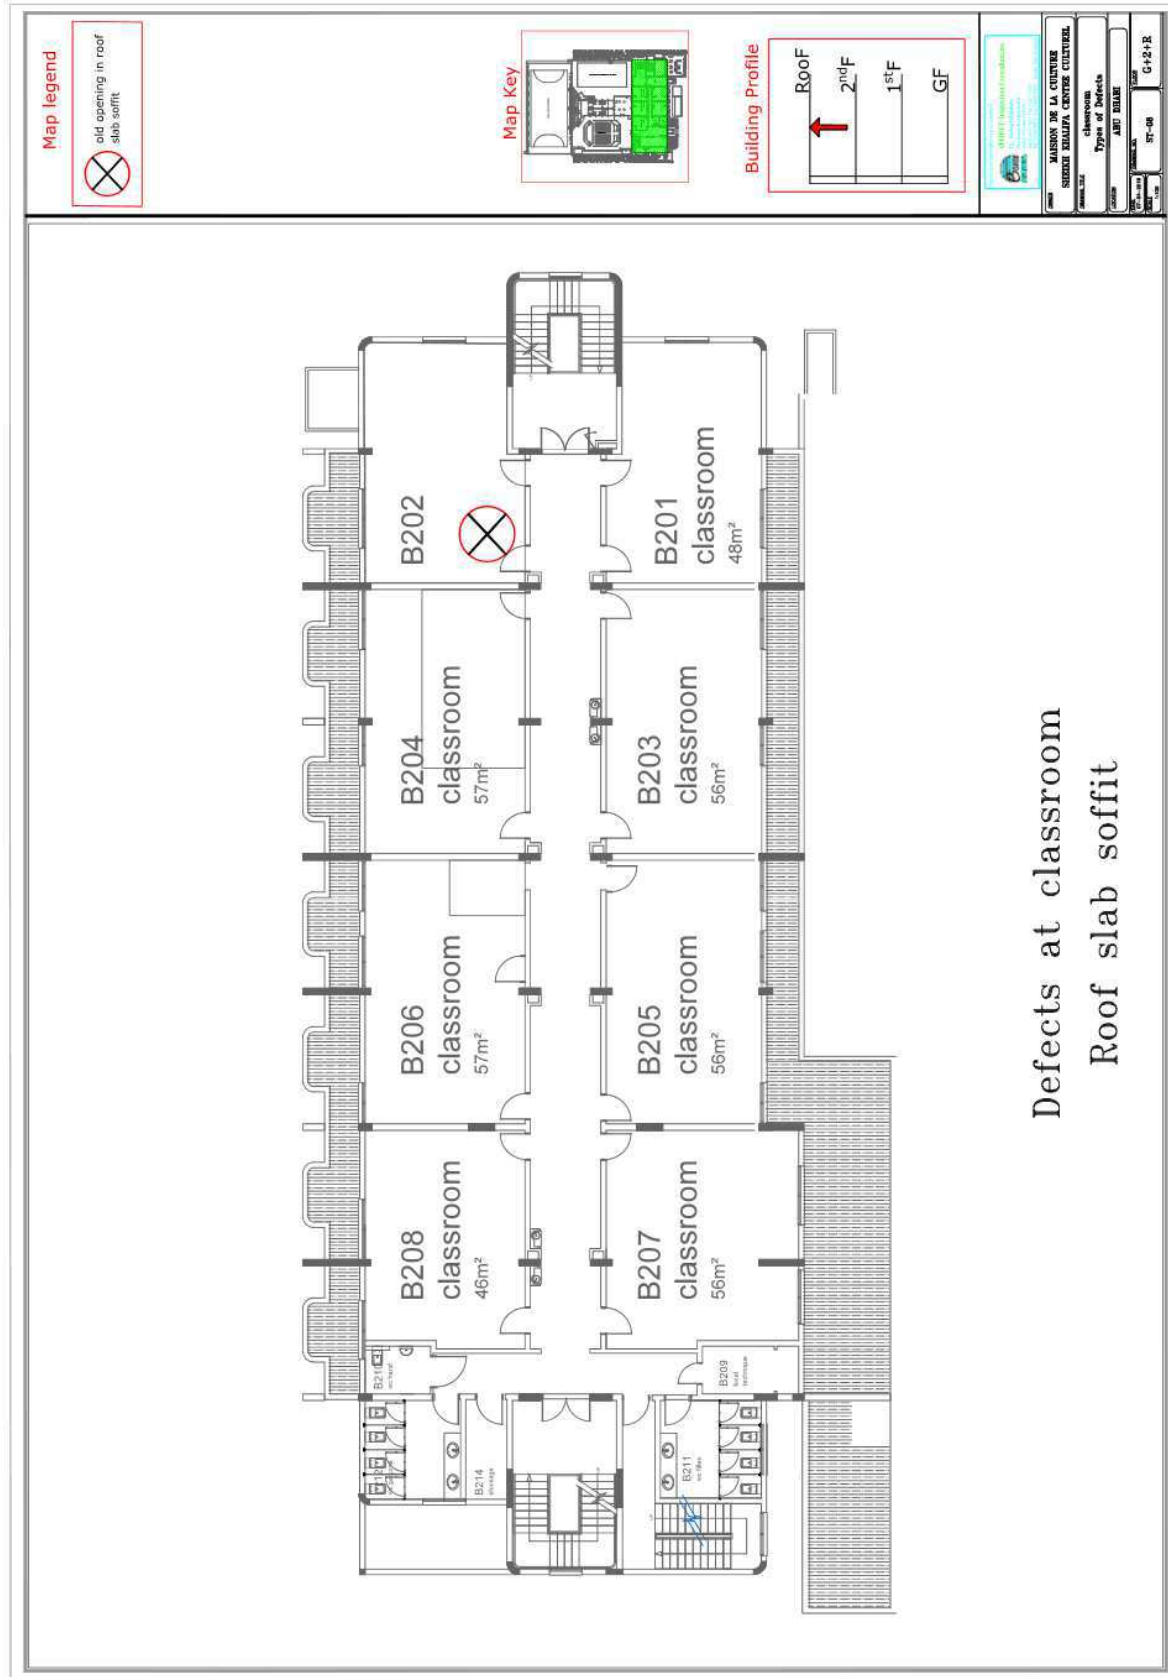
Figure A-7 defects in Classroom building in roof slab soffit

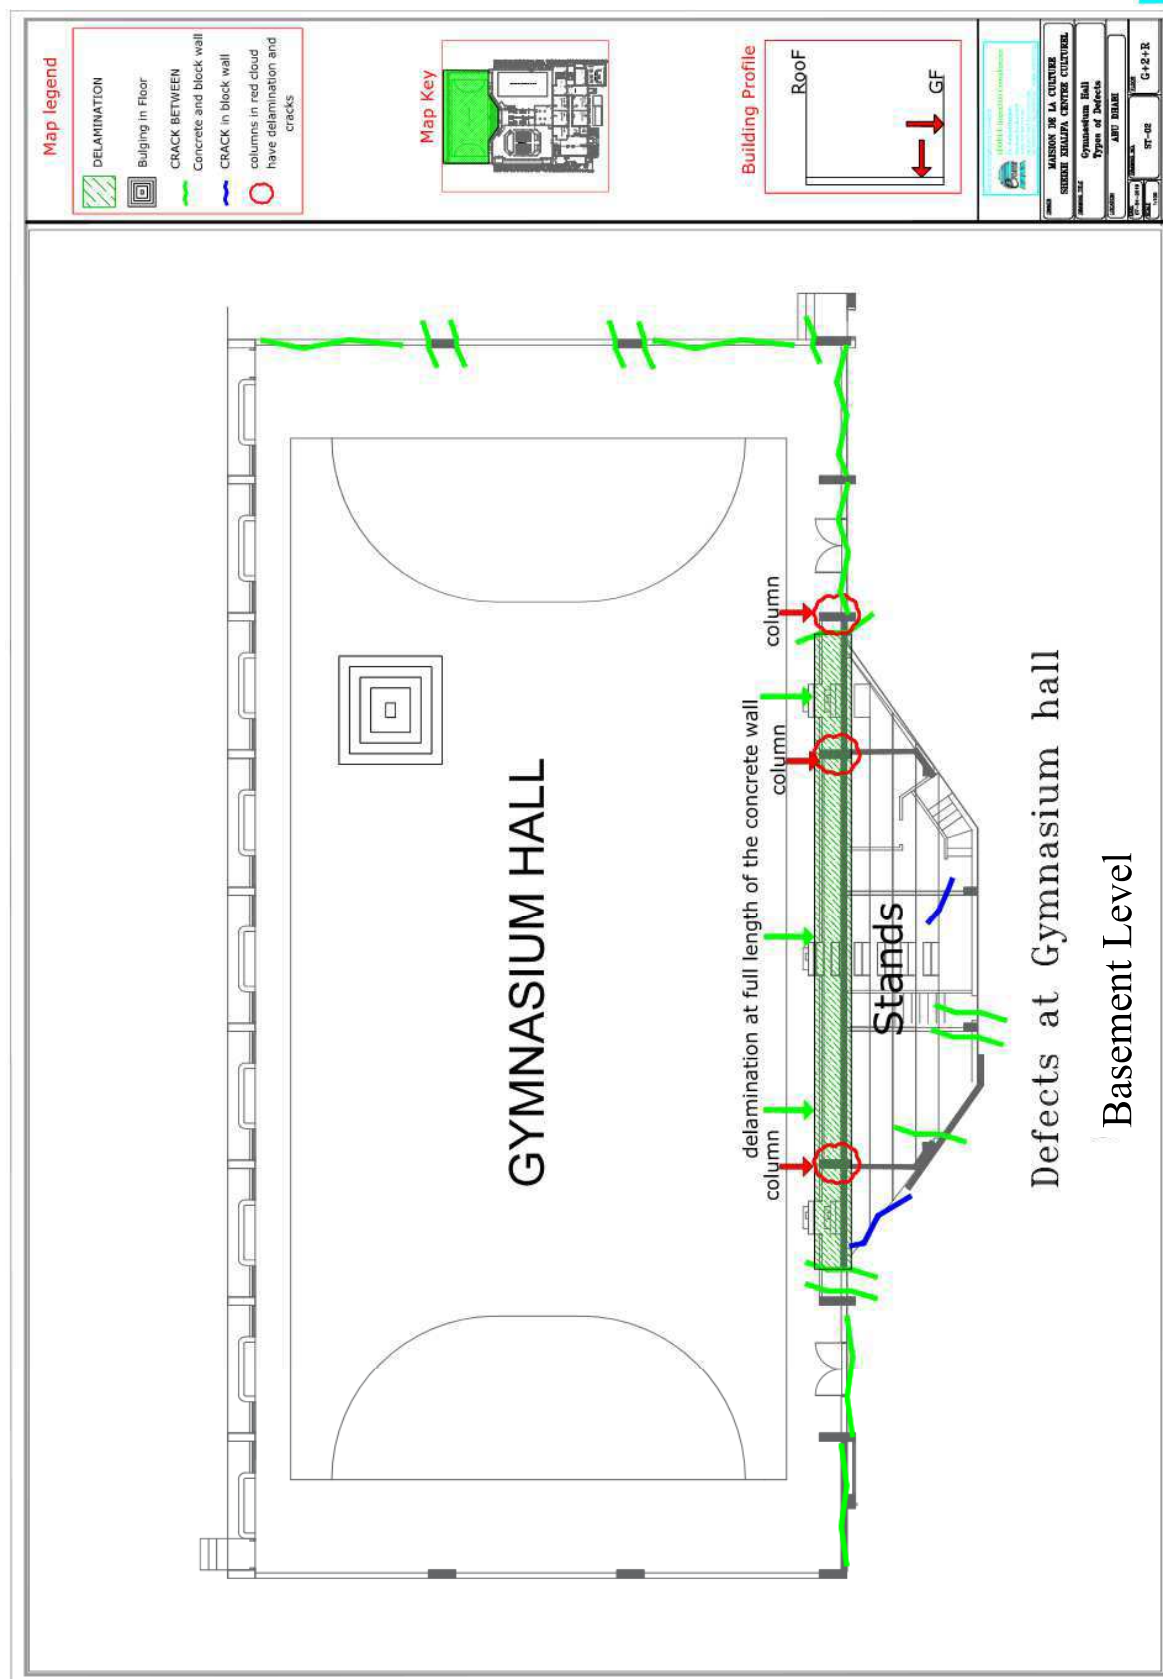
Figure A-8 defects in gymnasium in basement level

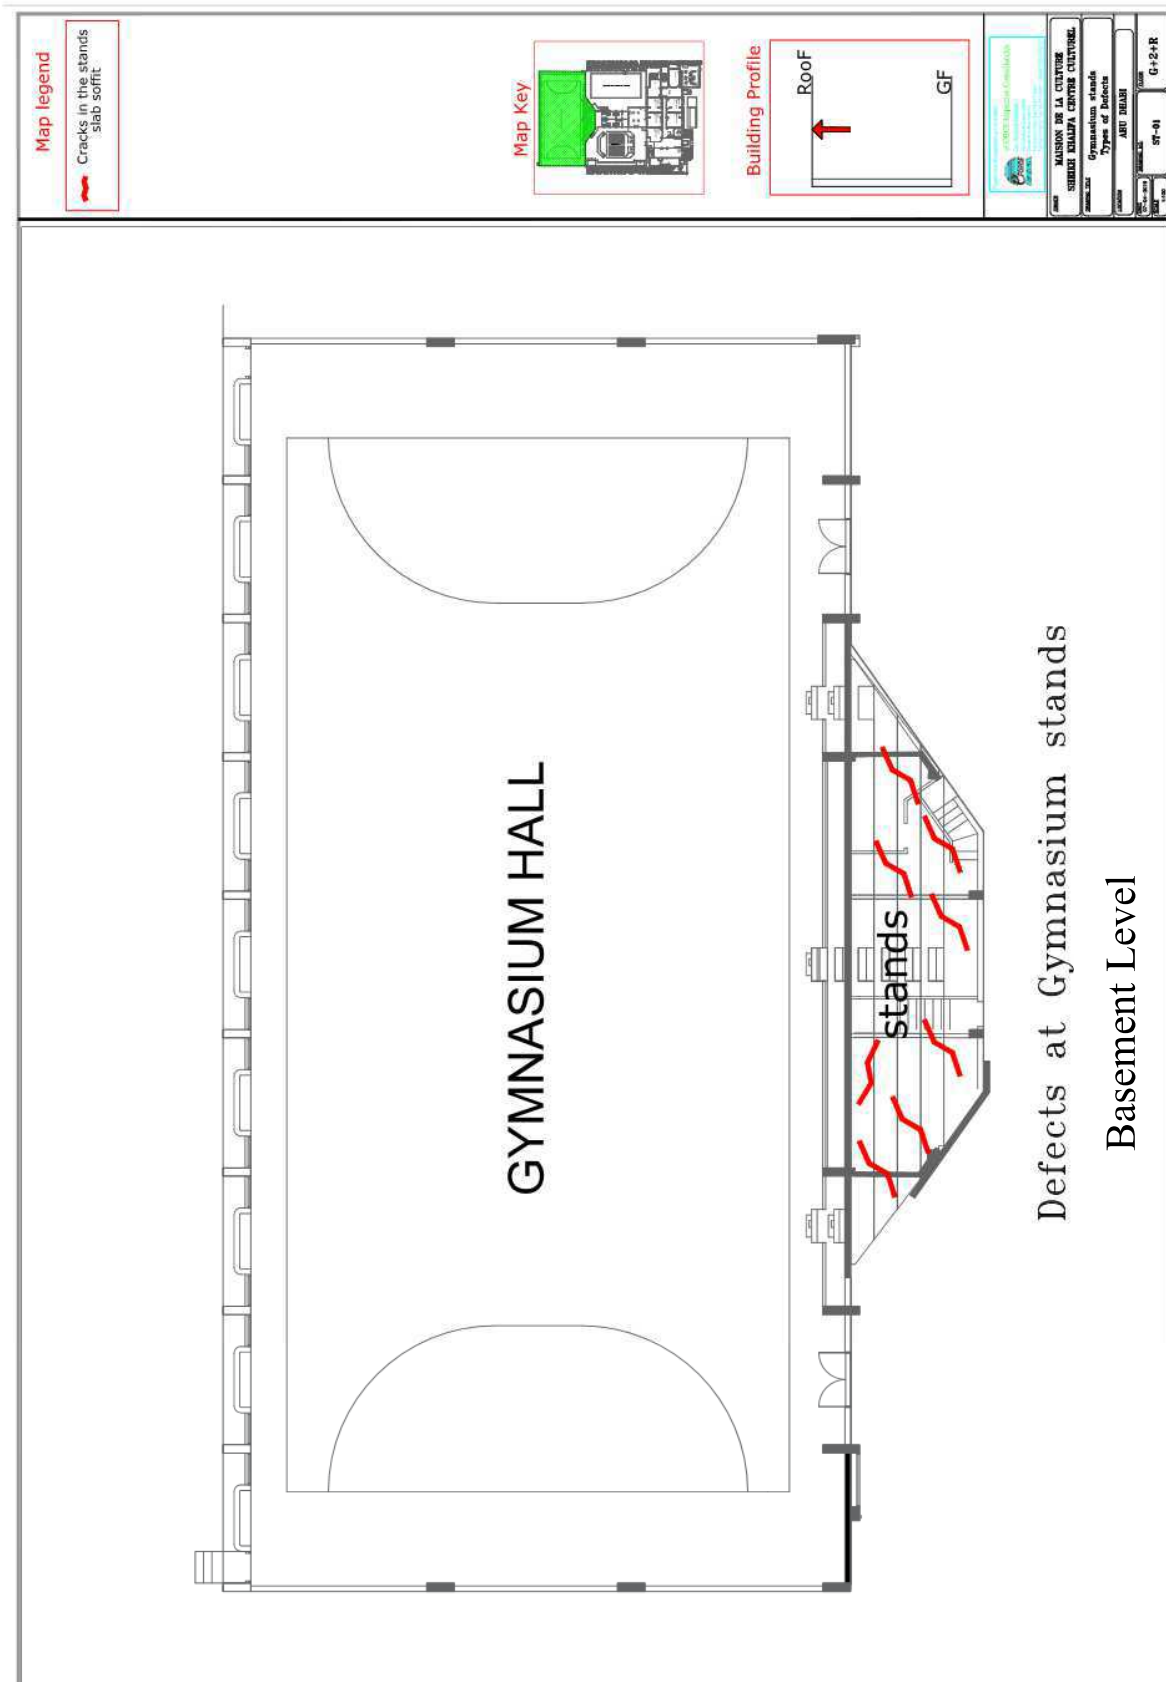
Figure A-9 defects in the basement soffit of the gymnasium

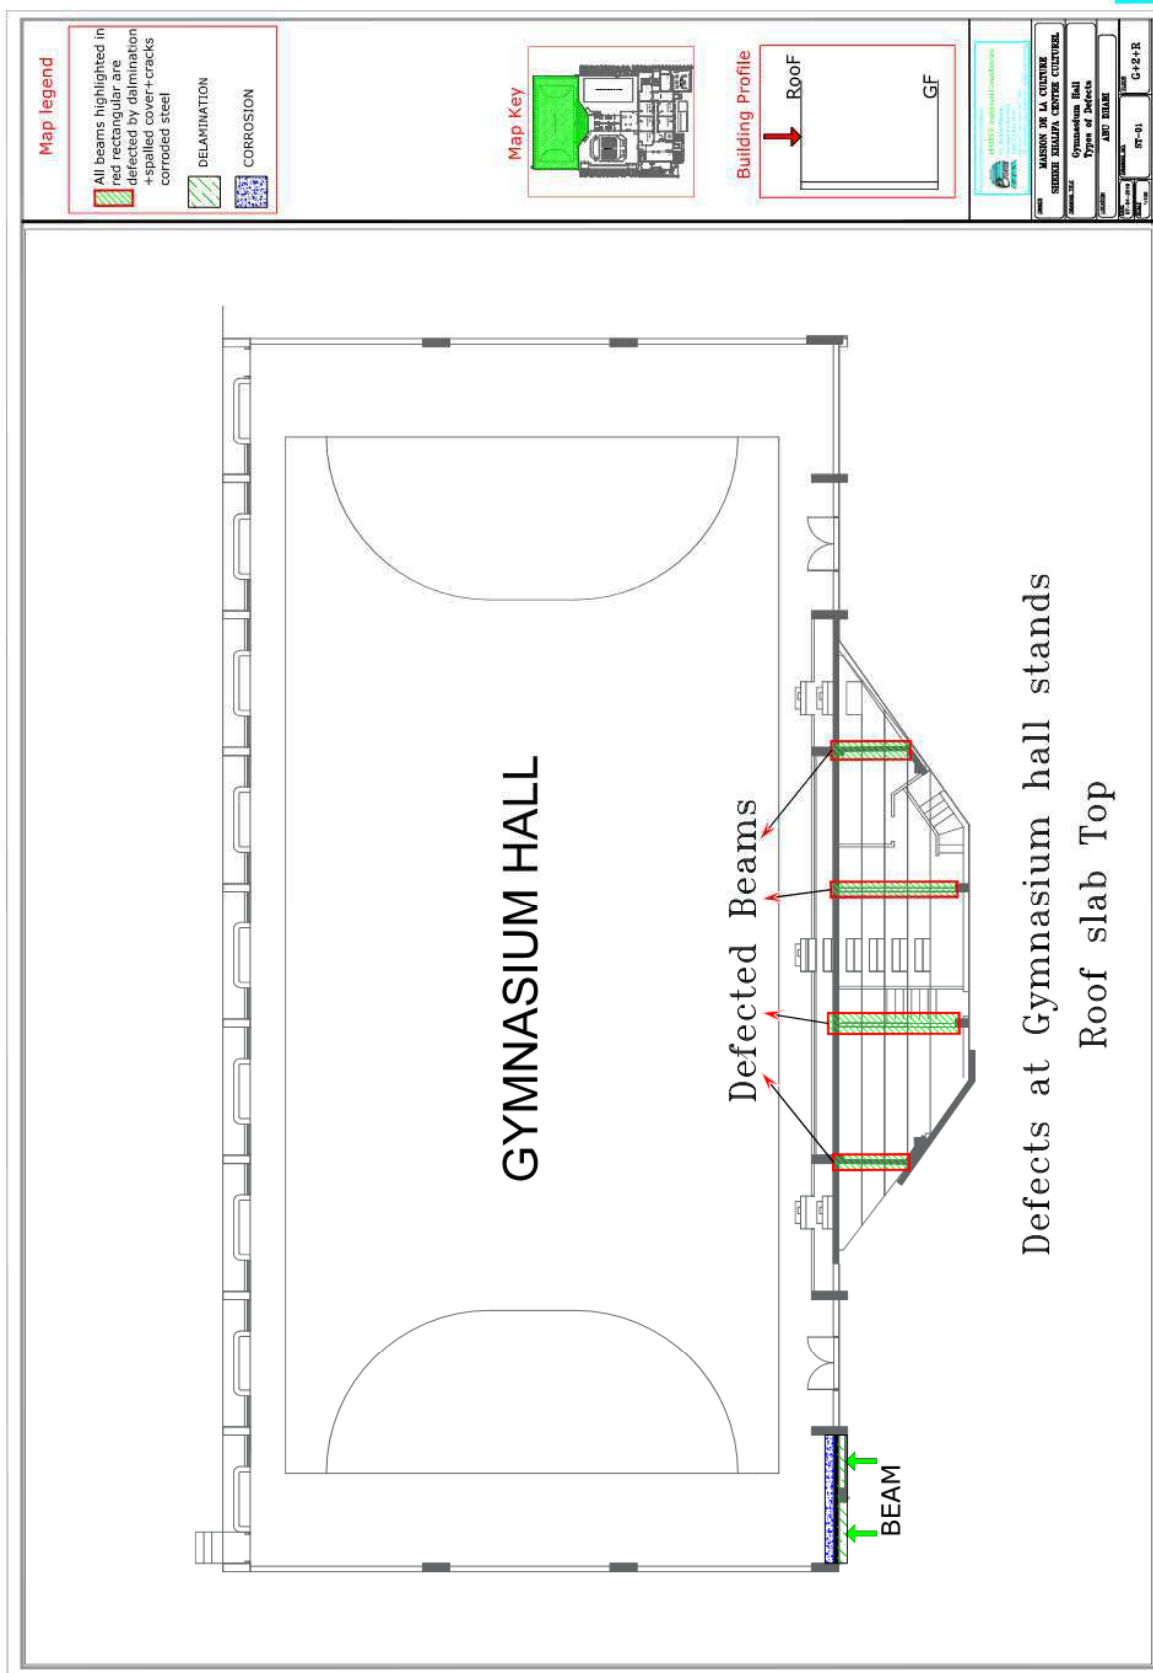
Figure A-10 Defects in gymnasium in roof level from top.

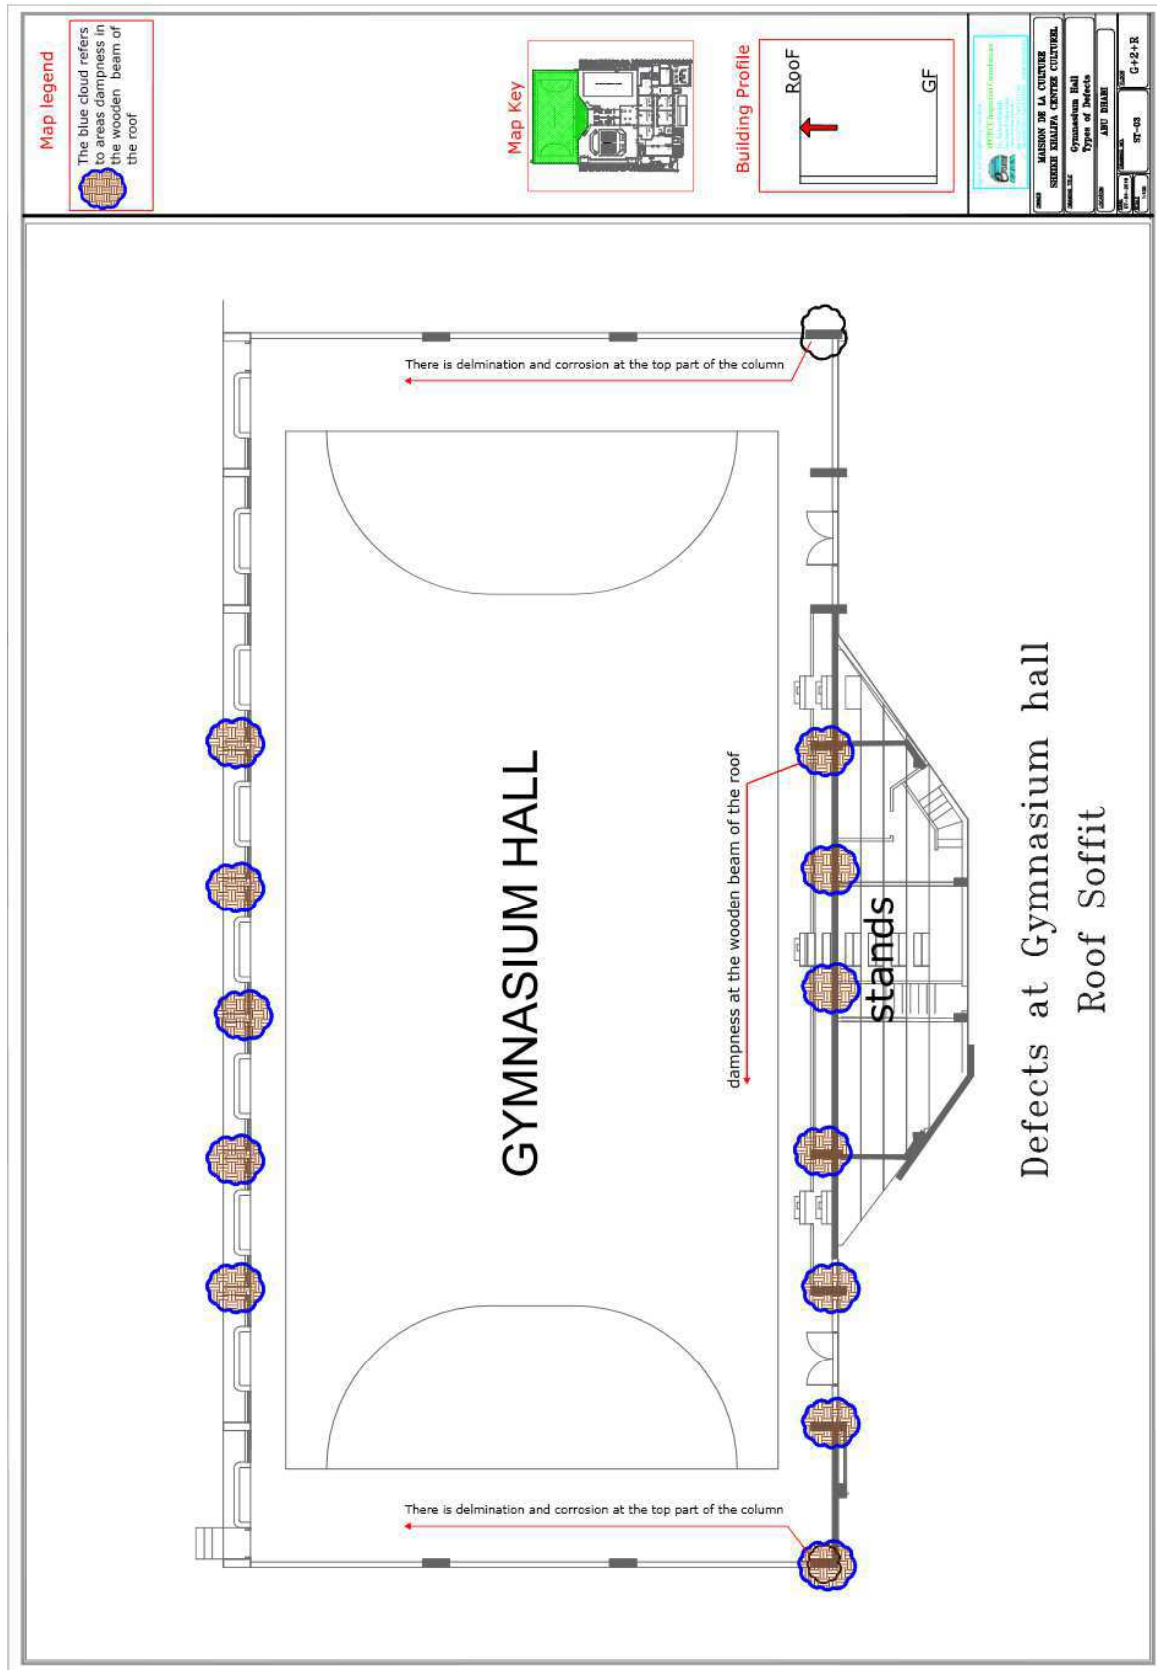
Figure A-11 Defects in gymnasium in roof level from soffit.

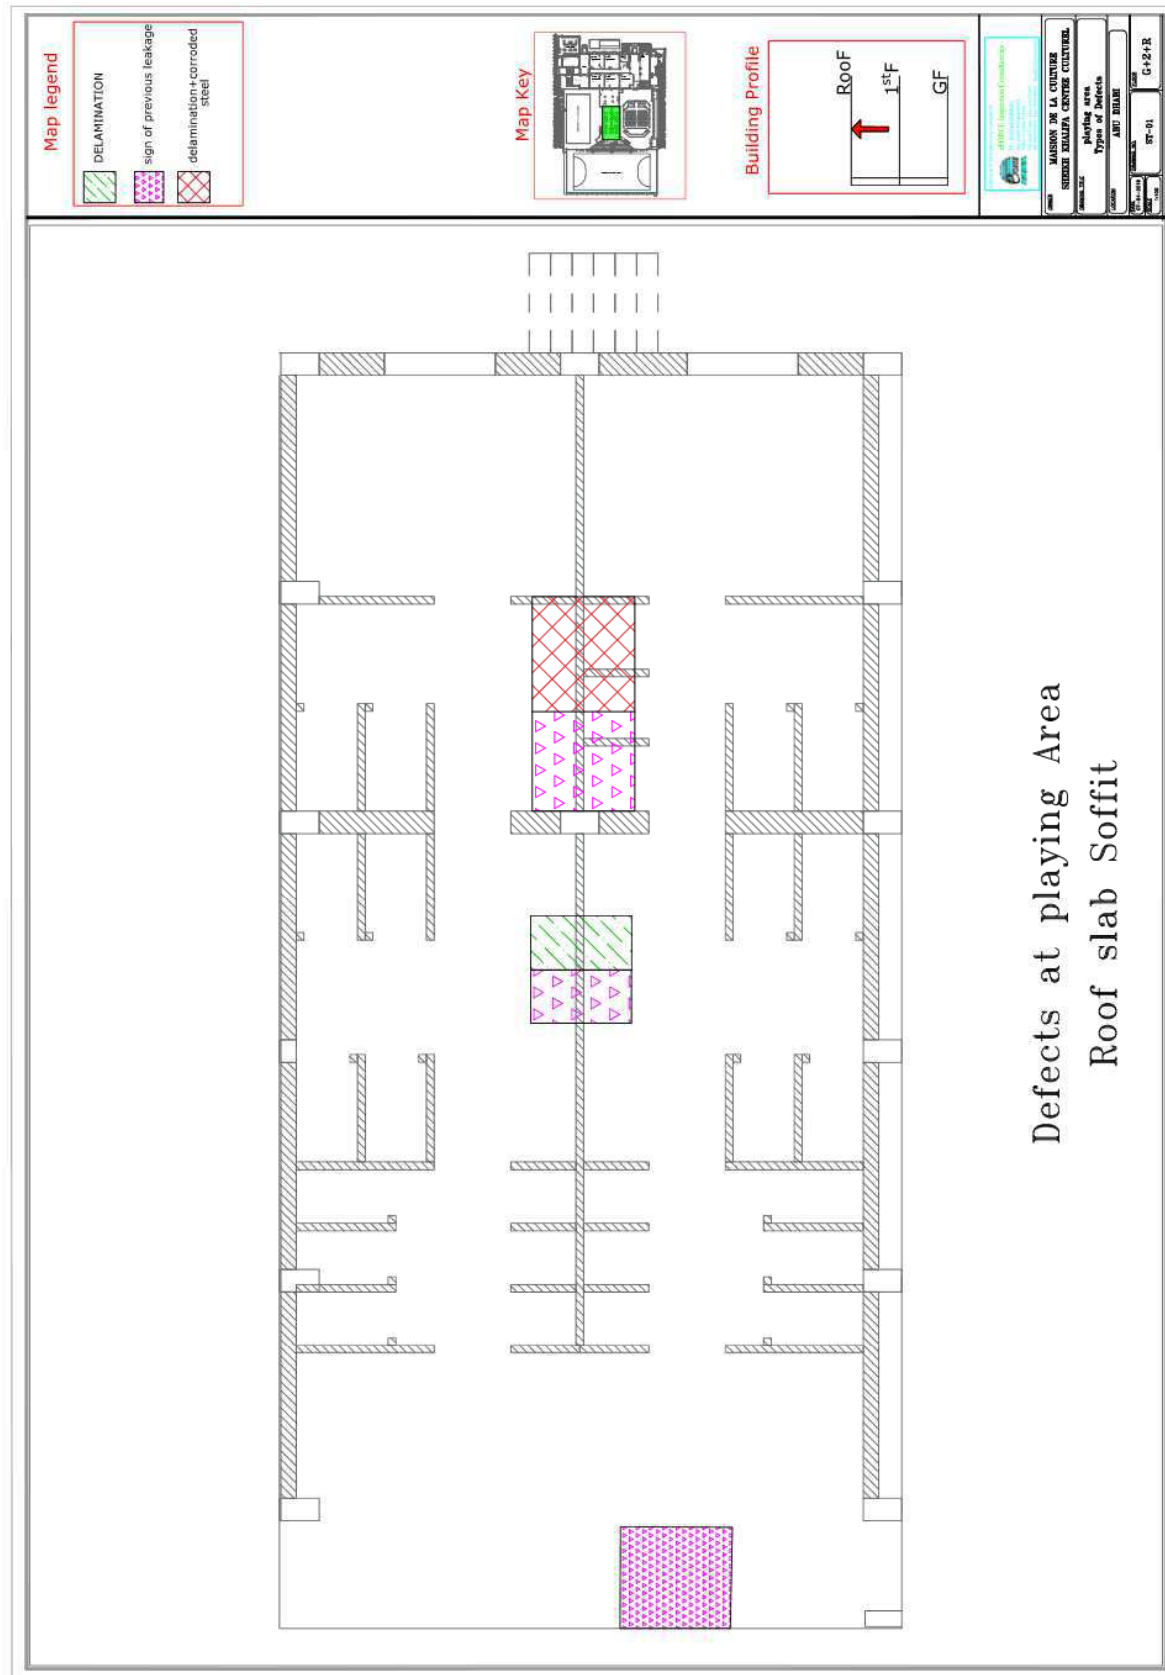
Figure A-12 Defects in playing area in roof slab soffit.

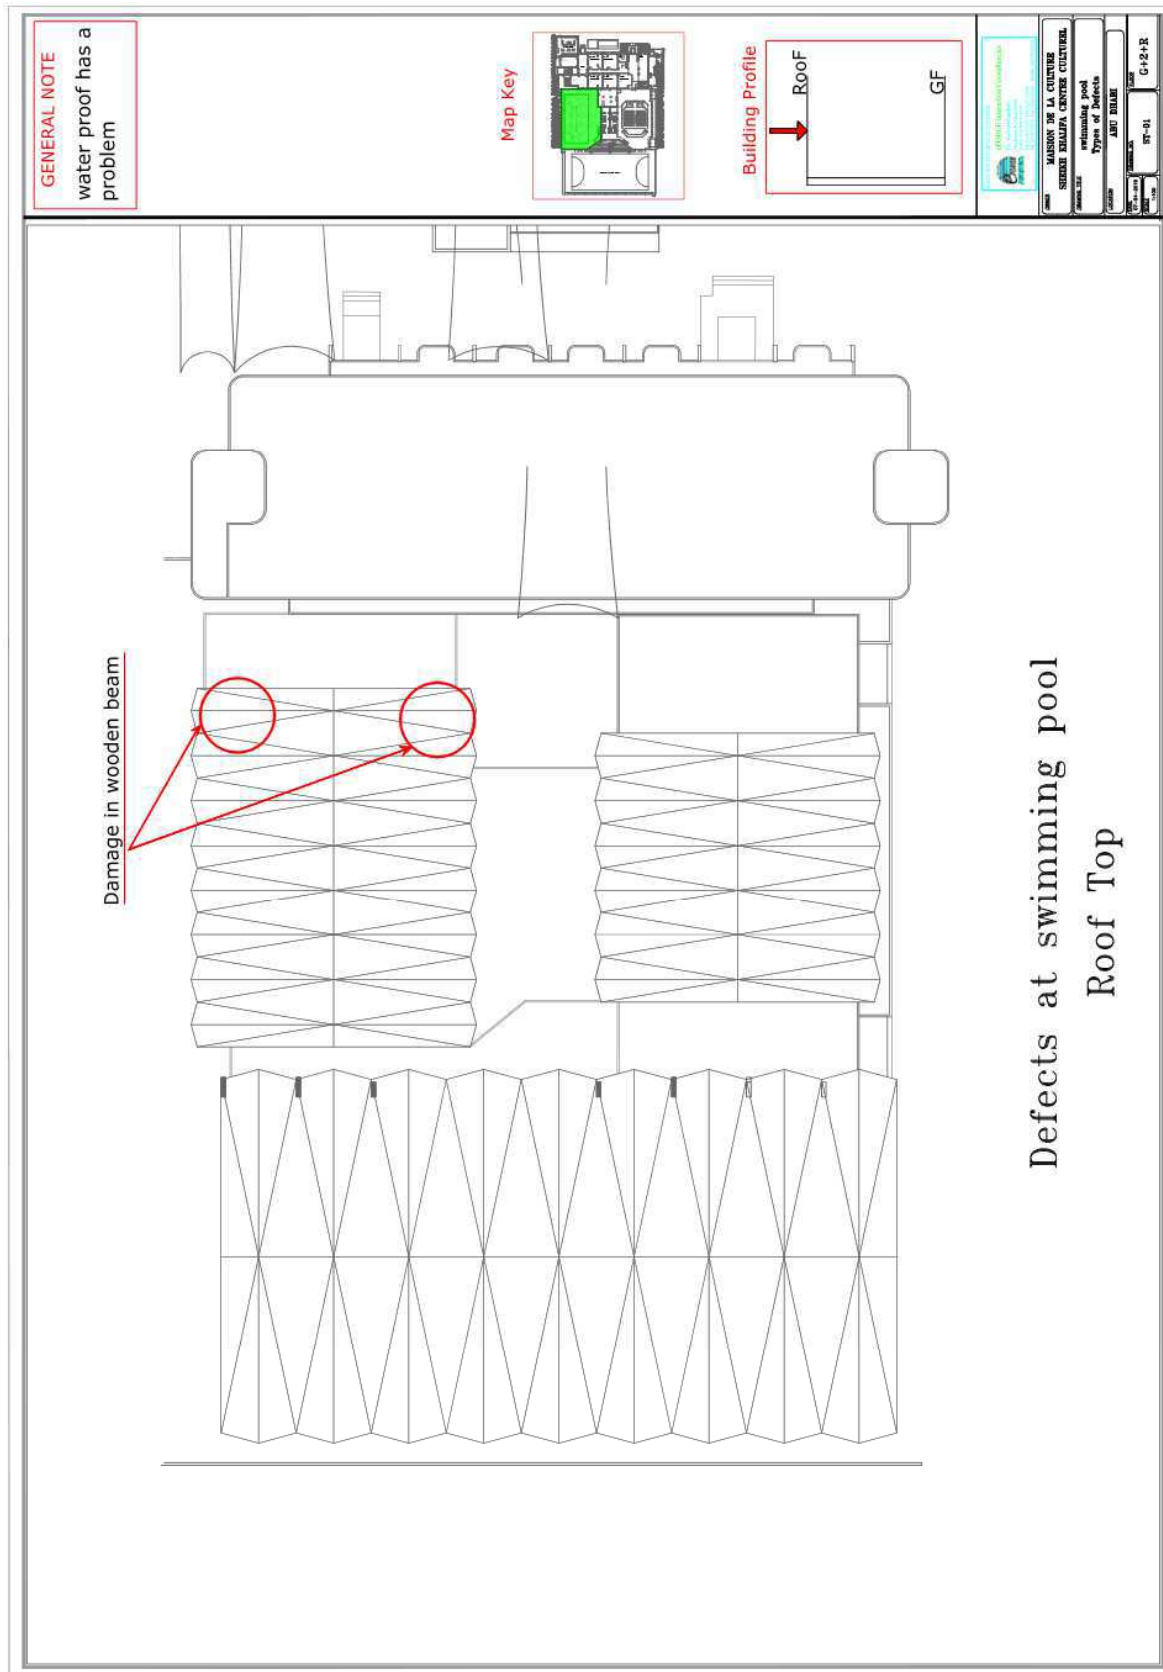
Figure A-13 Defects of swimming pool in roof level from top

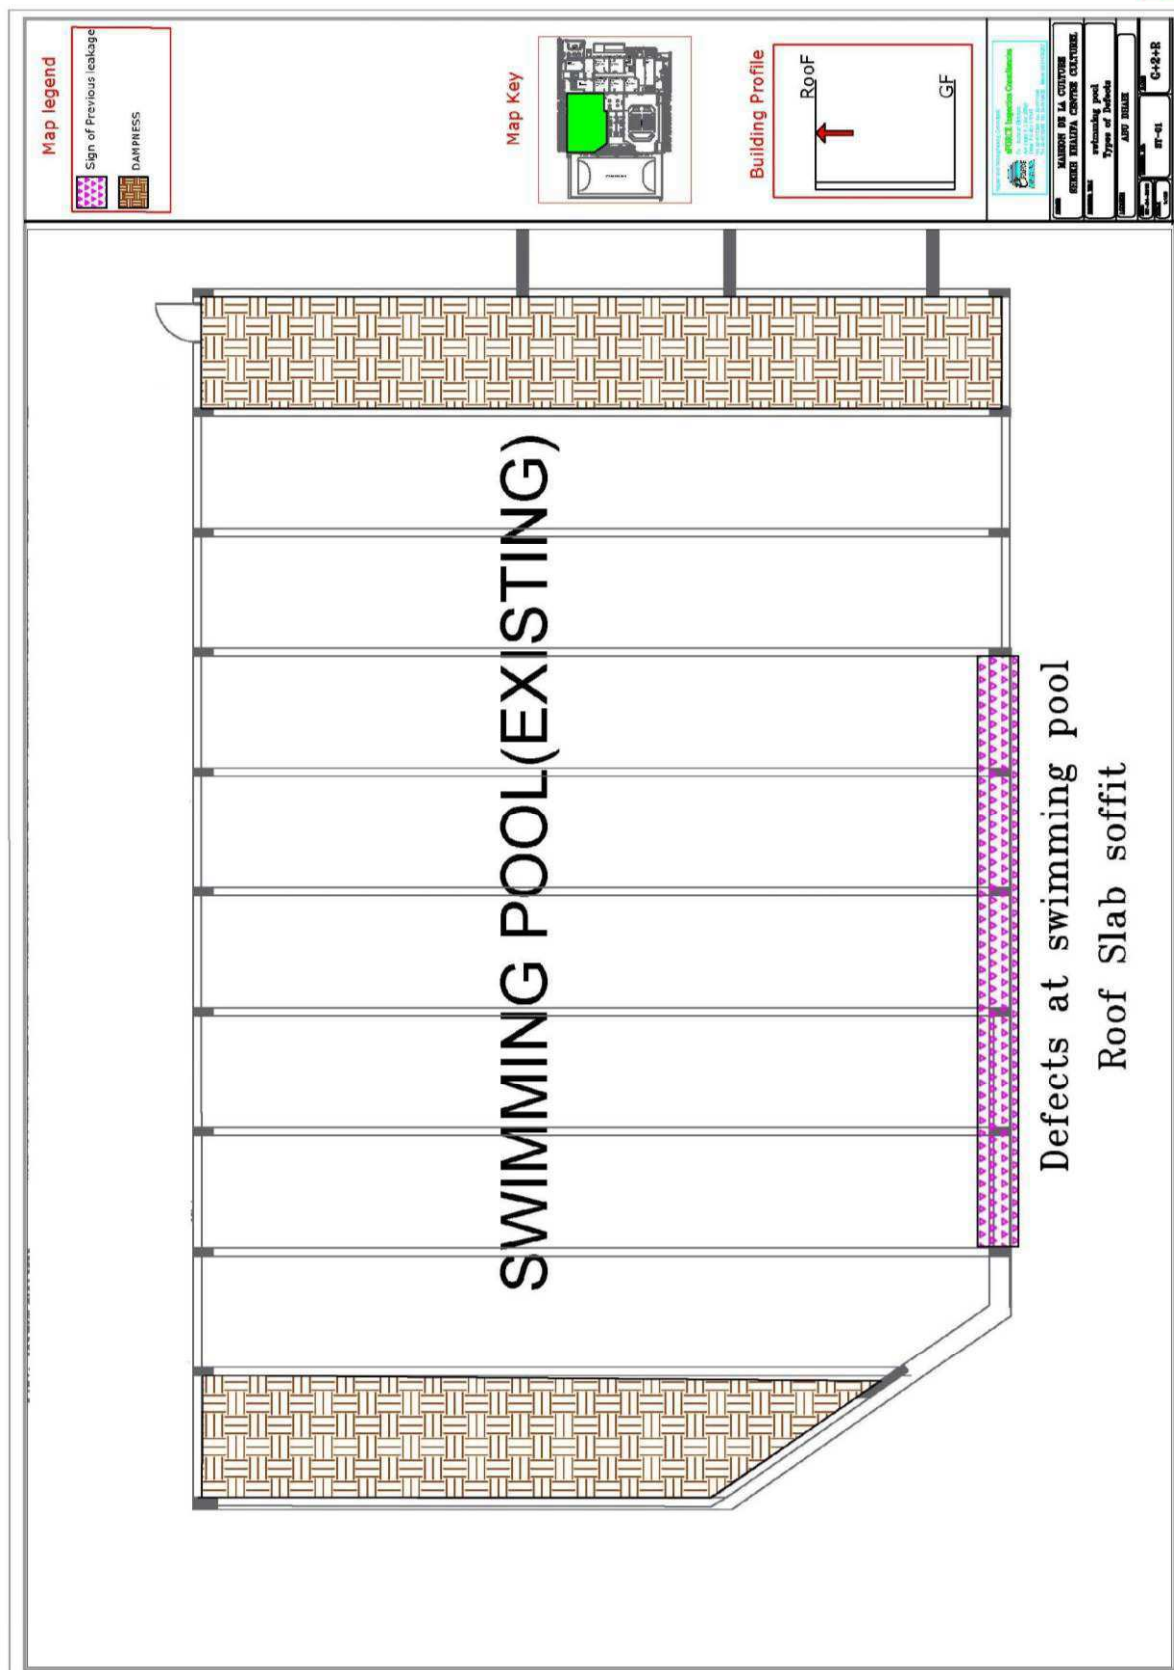
Figure A-14 defects in swimming pool roof slab soffit

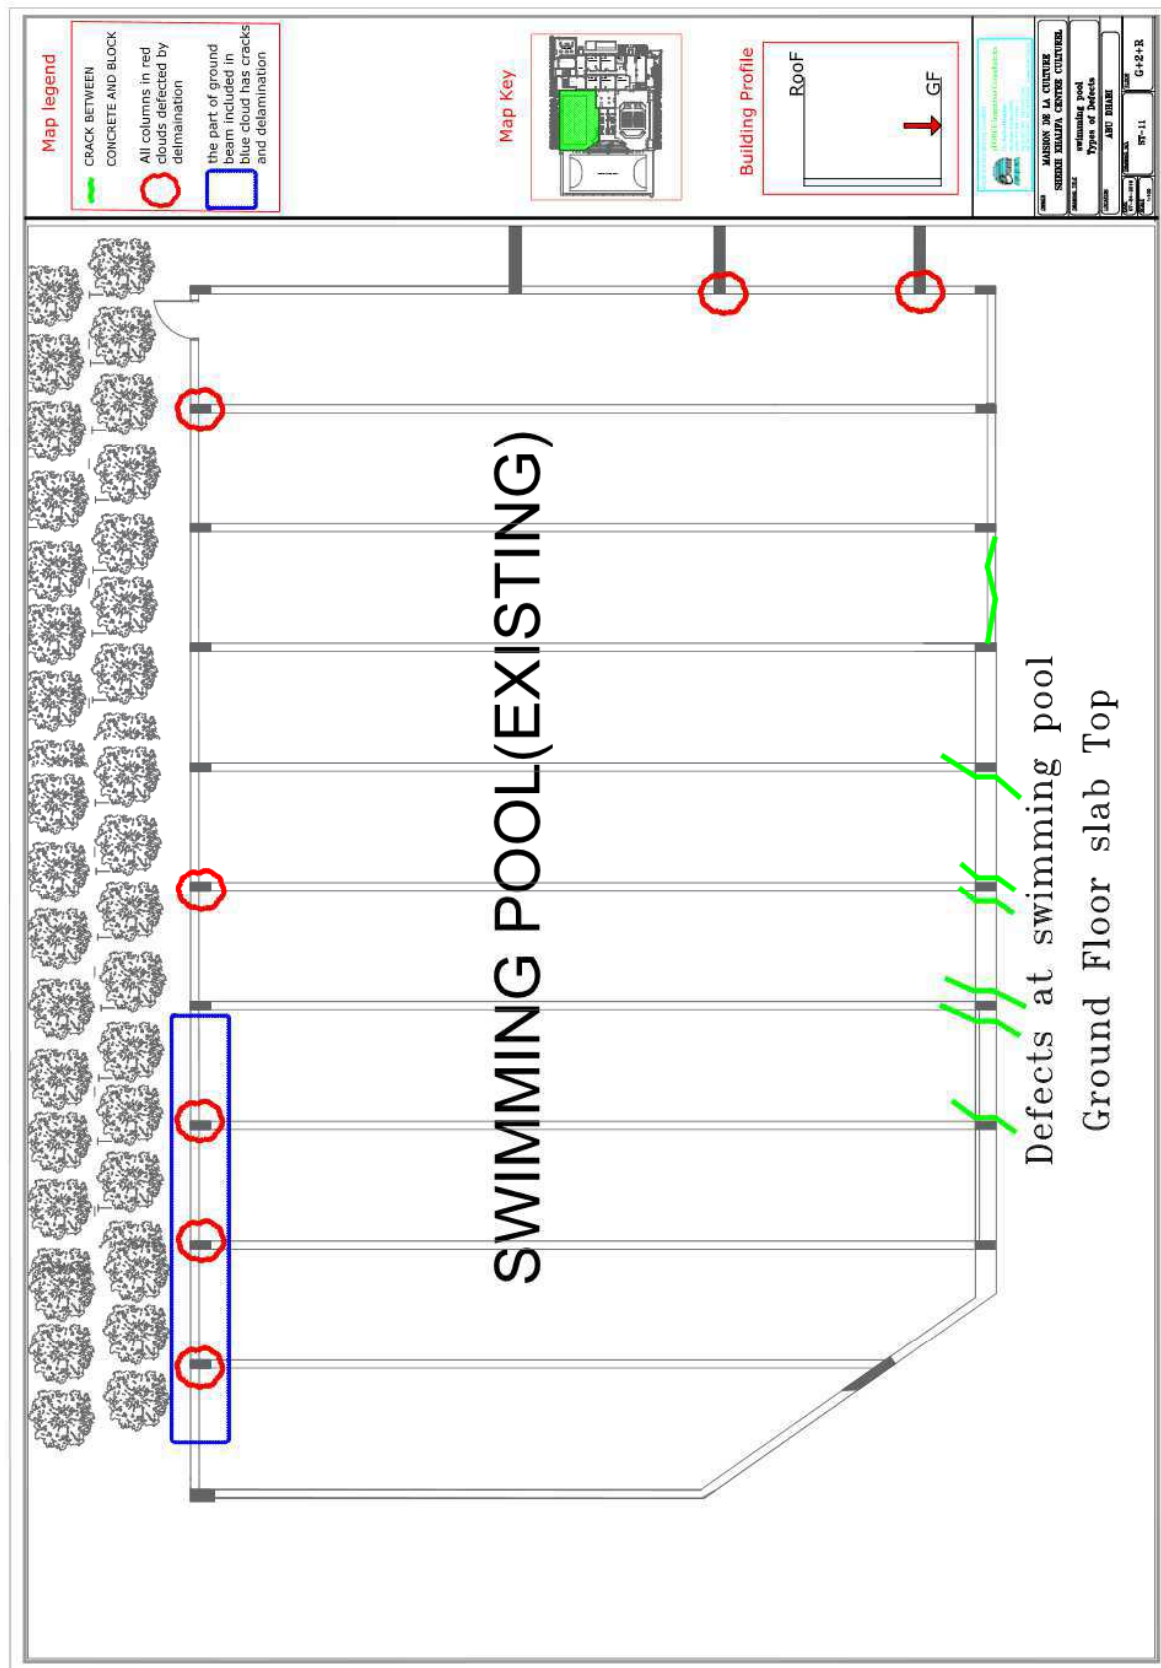
Figure A-15 defects in swimming pool ground slab top
