RENOVATION OF BLOCK B' FOR FRENCH SCHOOL (LYCEE LOUIS MASSIGNON)

CONCRETE REPAIRS AND STRUCTURAL REINFORCEMENT

Structure Condition Assessment (Concrete Part)

APAVE INTERNATIONAL – Abu Dhabi			
Inspector Name:	Christian LICARDO		
Inspection Date:	Dec 11 to 15, 2021	Report Number:	Auh.CI21.127-v1

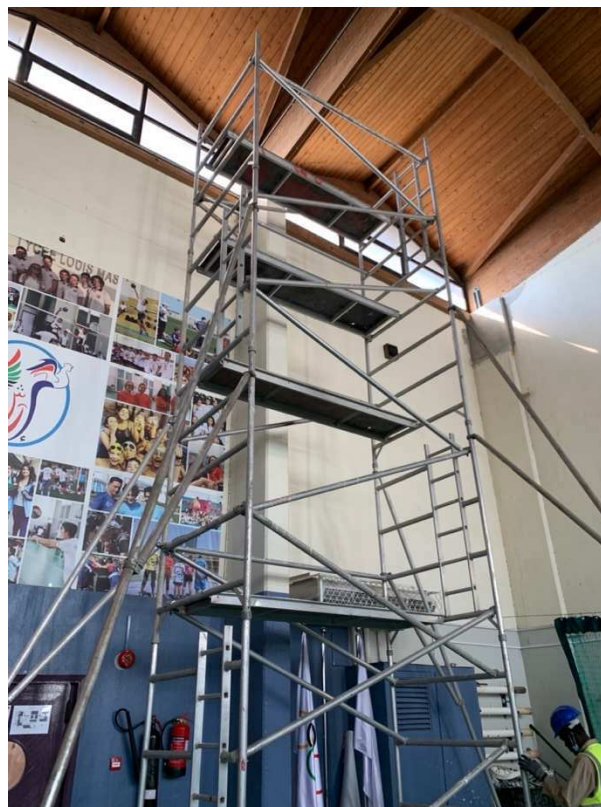
Figure 2 - Means of Access

The full visual inspection was conducted using different access tools in order to assess the condition of the structures properly. Scaffoldings and ladders, whenever practically possible to set-up, allows inspection at a close-up distance. For the locations where access is difficult, binocular has been utilized in order to assess the concrete conditions. In addition, false ceilings have been temporarily removed at selected locations in order to expose the concrete conditions of the beams and slabs soffits which are covered by the false ceilings.

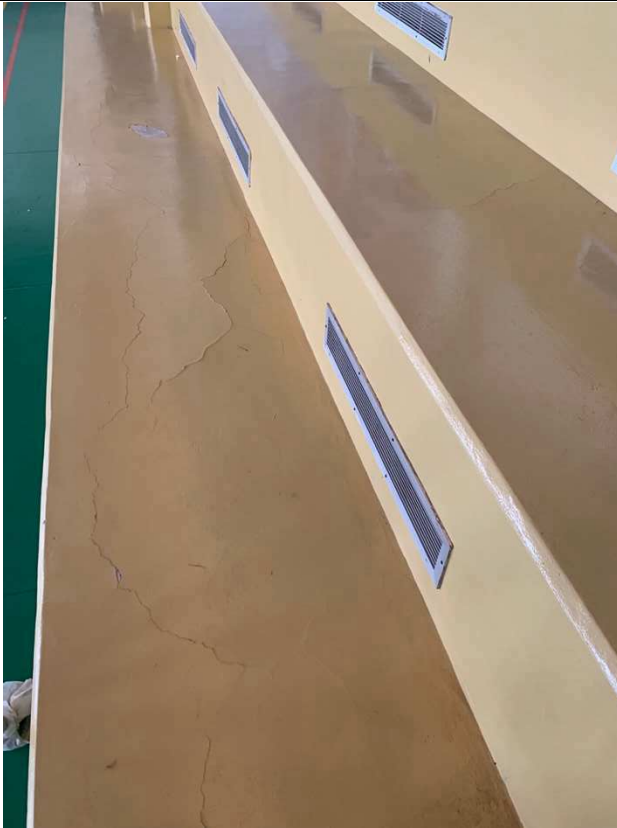
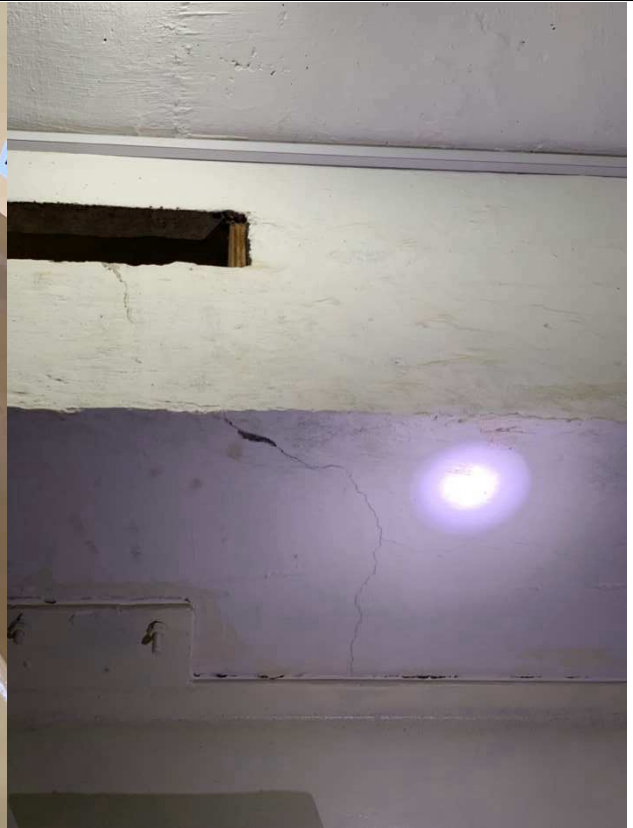
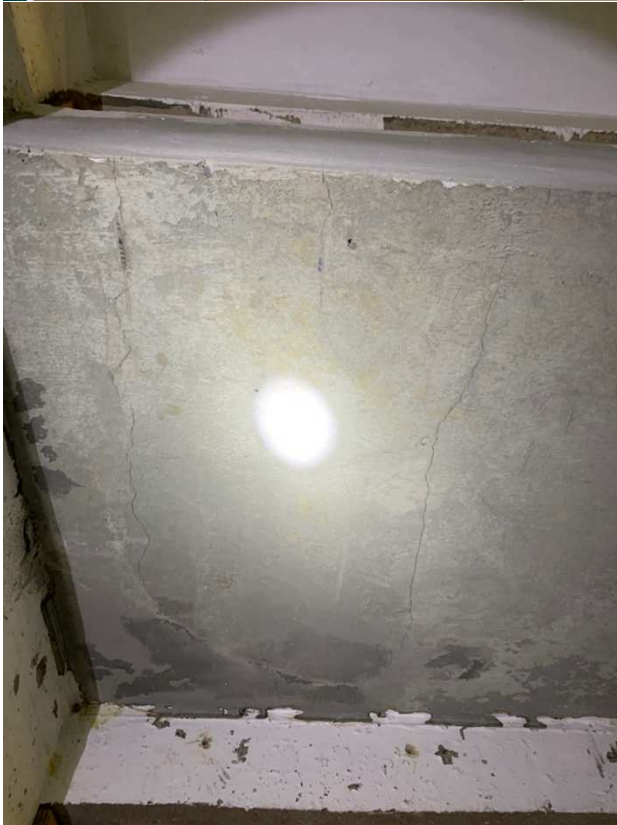
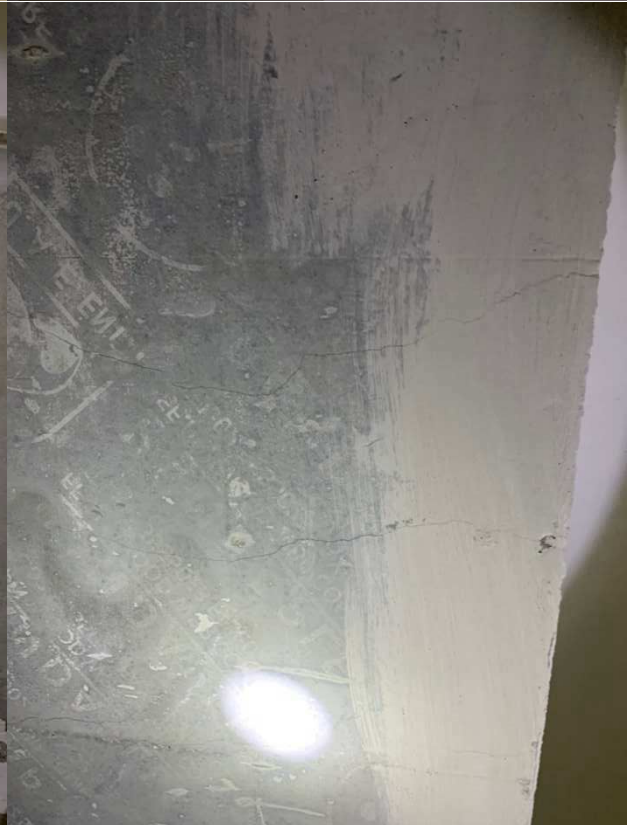
Obs.No.	Location	Defect	Recommendation
1	Gymnasium Building (multiple locations as shown in defect location)	-Horizontal cracks on wall -Crack width was not measured as some fixtures does not allow close-up inspection of the defect.	- to be visually monitored yearly to check any visually observable abnormalities
2	Gymnasium Building (on the bleacher)	-Vertical cracks on wall -crack meters have been installed (Gauge number: LLM_APV_04 and LLM_APV_05)	-crack meter movement to be monitored every 6 months
3	Gymnasium Building (bleacher)	Cracks on the Bleacher -the cracks are appearing on both bottom and upper phase of concrete bleachers -crack gauges have been installed (Gauge Number: LLM_APV_06 and LLM_APV_07)	-to be repaired & crack meter movement to be monitored every 6 months
4	Gymnasium Building (as shown in the defect location)	-Vertical Crack in junction between column and beam -crack width = 0.45mm	-to be repaired

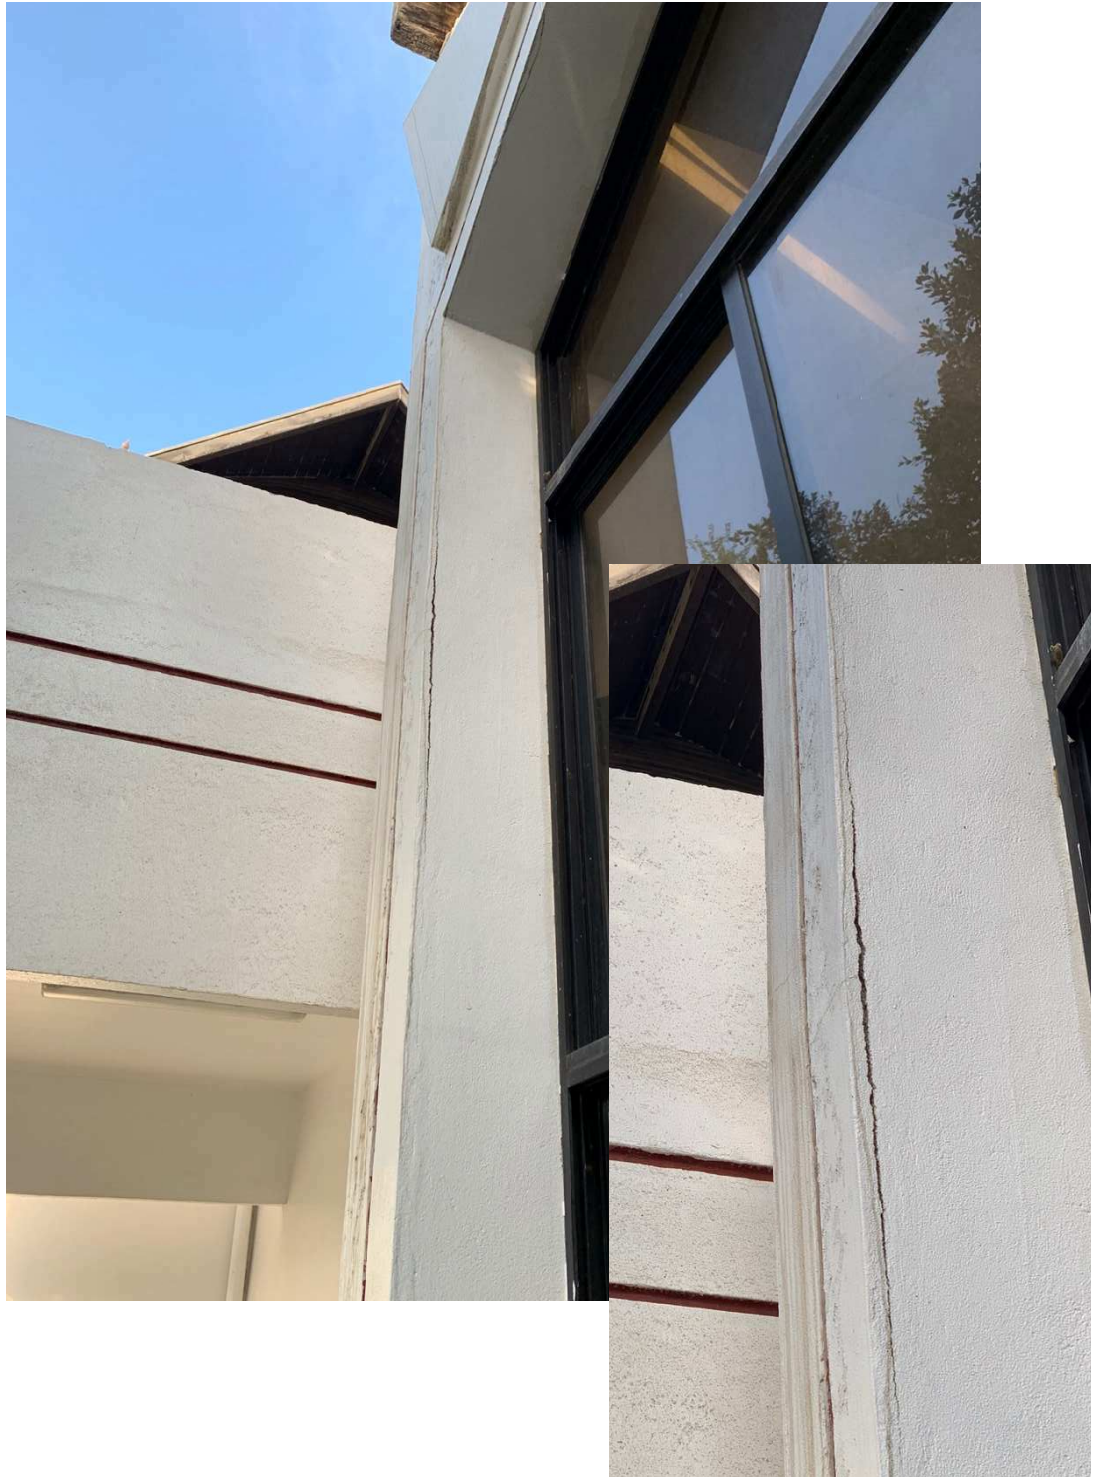
9	Concrete spalling	Auditorium Building (as shown in defect location)	-to be repaired
10	Auditorium Building (as shown in defect location)	Crack on wall underneath the wooden girder	-to be repaired

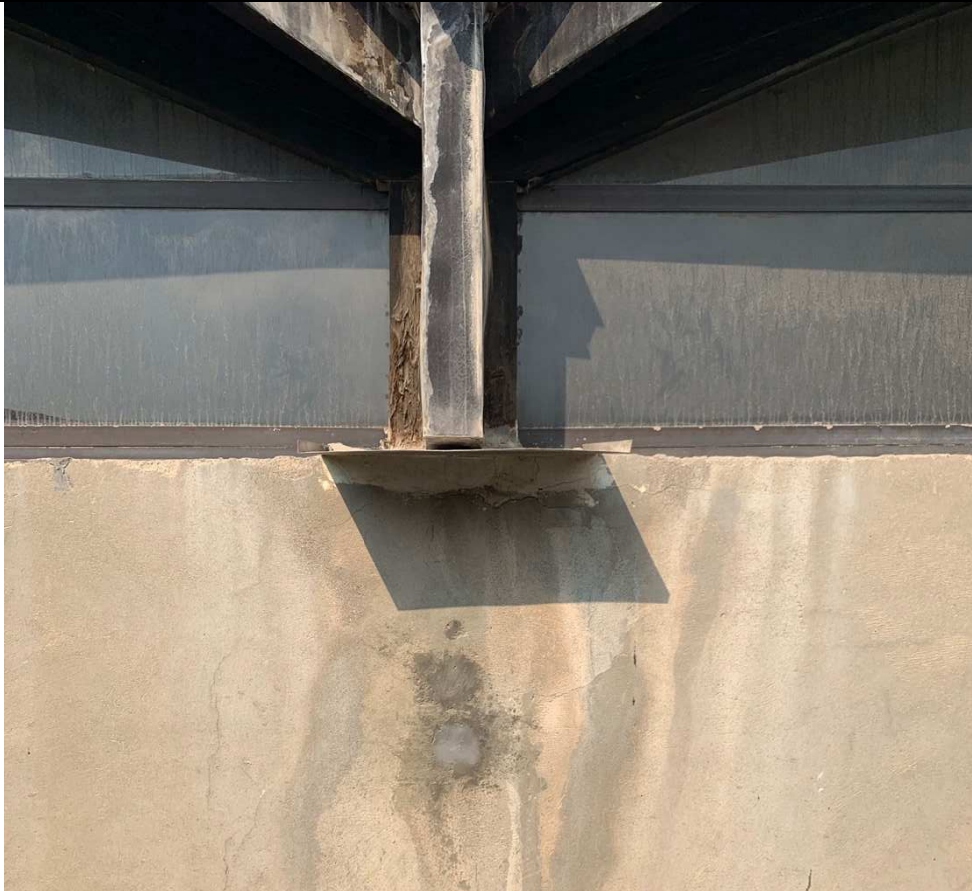
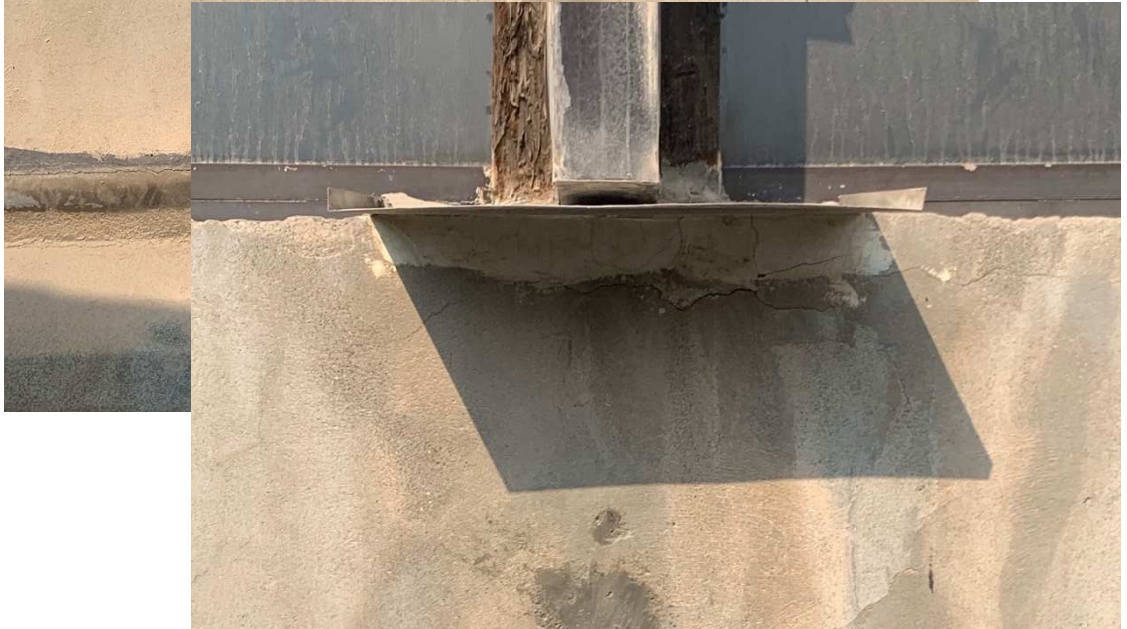
Obs.No.	Location	Defect	Recommendation
		-vertical crack on wall width <0.2mm	
11	Gymnasium Building (roof)	-Cracks on wall and column which is supporting the wooden girder -multiple cracks, w=0.5mm	-to be repaired
12	Gymnasium Building (roof)	-Cracks at junction between wall and column/beam	-to be repaired
13	Gymnasium Building (roof)	-Cracks, Exposed Corroded Rebar and concrete scalling on diagonal beams	-to be repaired
14	Gymnasium Building (roof)	Concrete Spalling and Exposed Corroded Rebars	-to be repaired
15	Gymnasium Building (roof)	Concrete Spalling, cracks in junction between column and wall, poor protective paint condition	-to be repaired
16	Auditorium Building (roof – as shown in defect location)	-Crack in between wall and beam -multiple cracks ranging from >0.2mm to 0.4mm	-to be repaired
17	Auditorium Building (roof – as shown in defect location)	-Vertical Crack on wall w=0.35mm	-to be visually monitored yearly to check any visually observable abnormalities

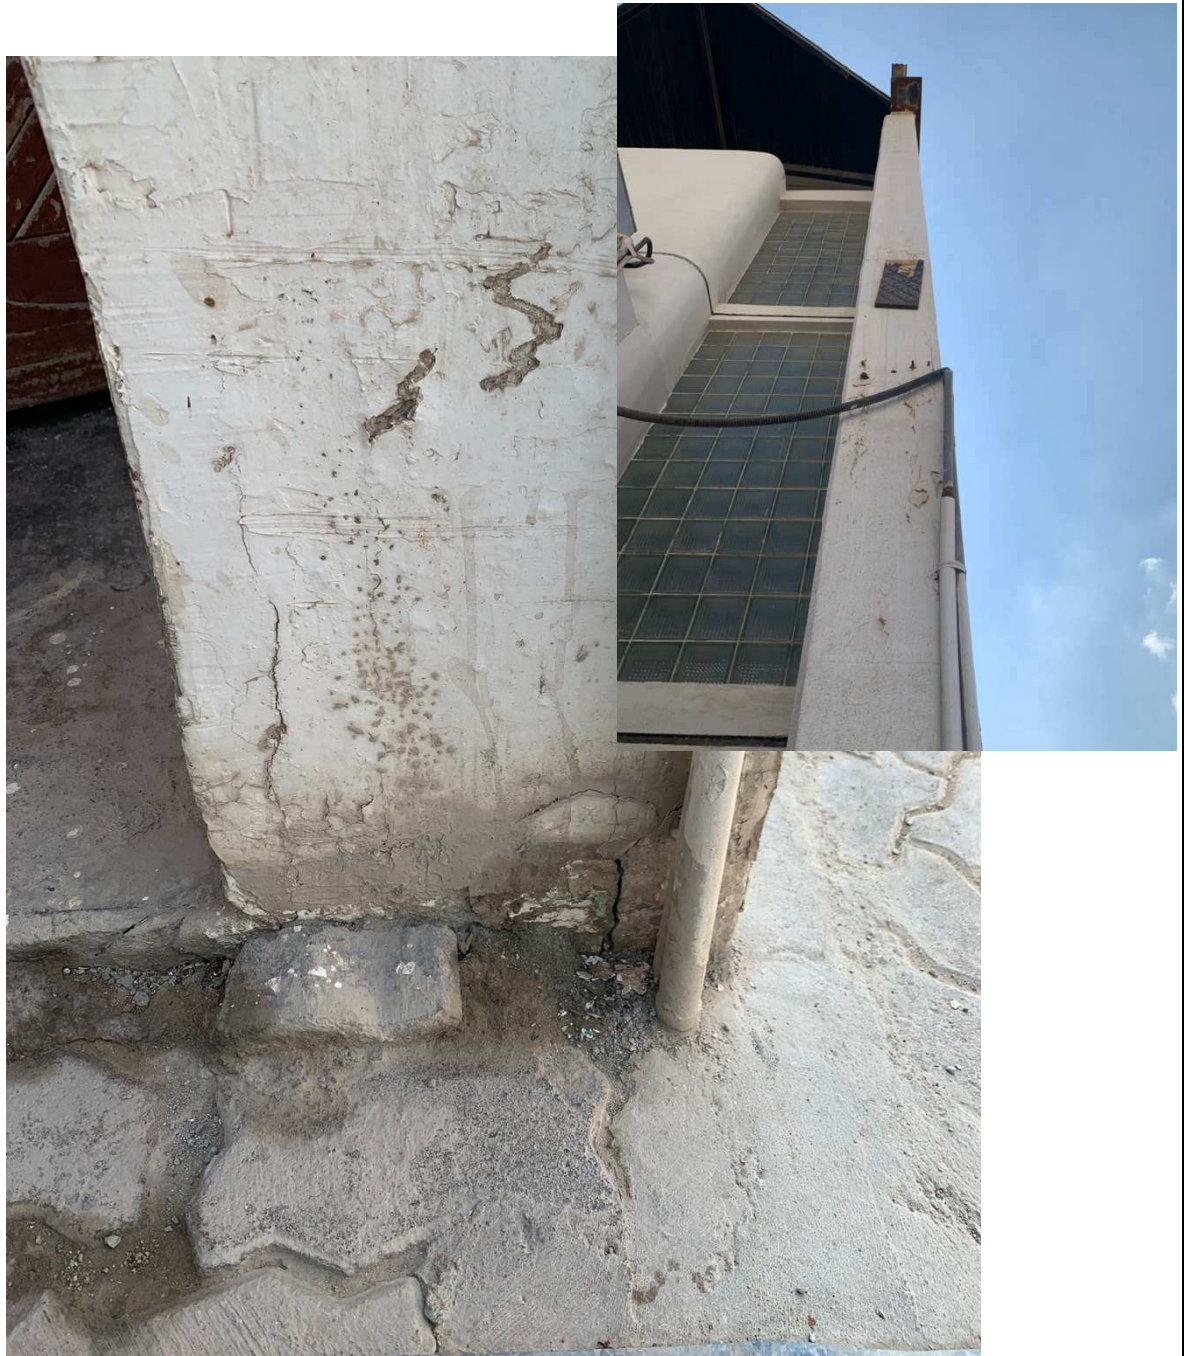
46	Gymnasium Building (corner column at the exit towards the road)	-Concrete spalling / crack, w=0.4mm	-to be repaired
47	Gymnasium Building (corner column at the exit towards the road)	Concrete crack at the junction between column and wall , w=0.3mm	-to be visually monitored yearly to check any visually observable abnormalities

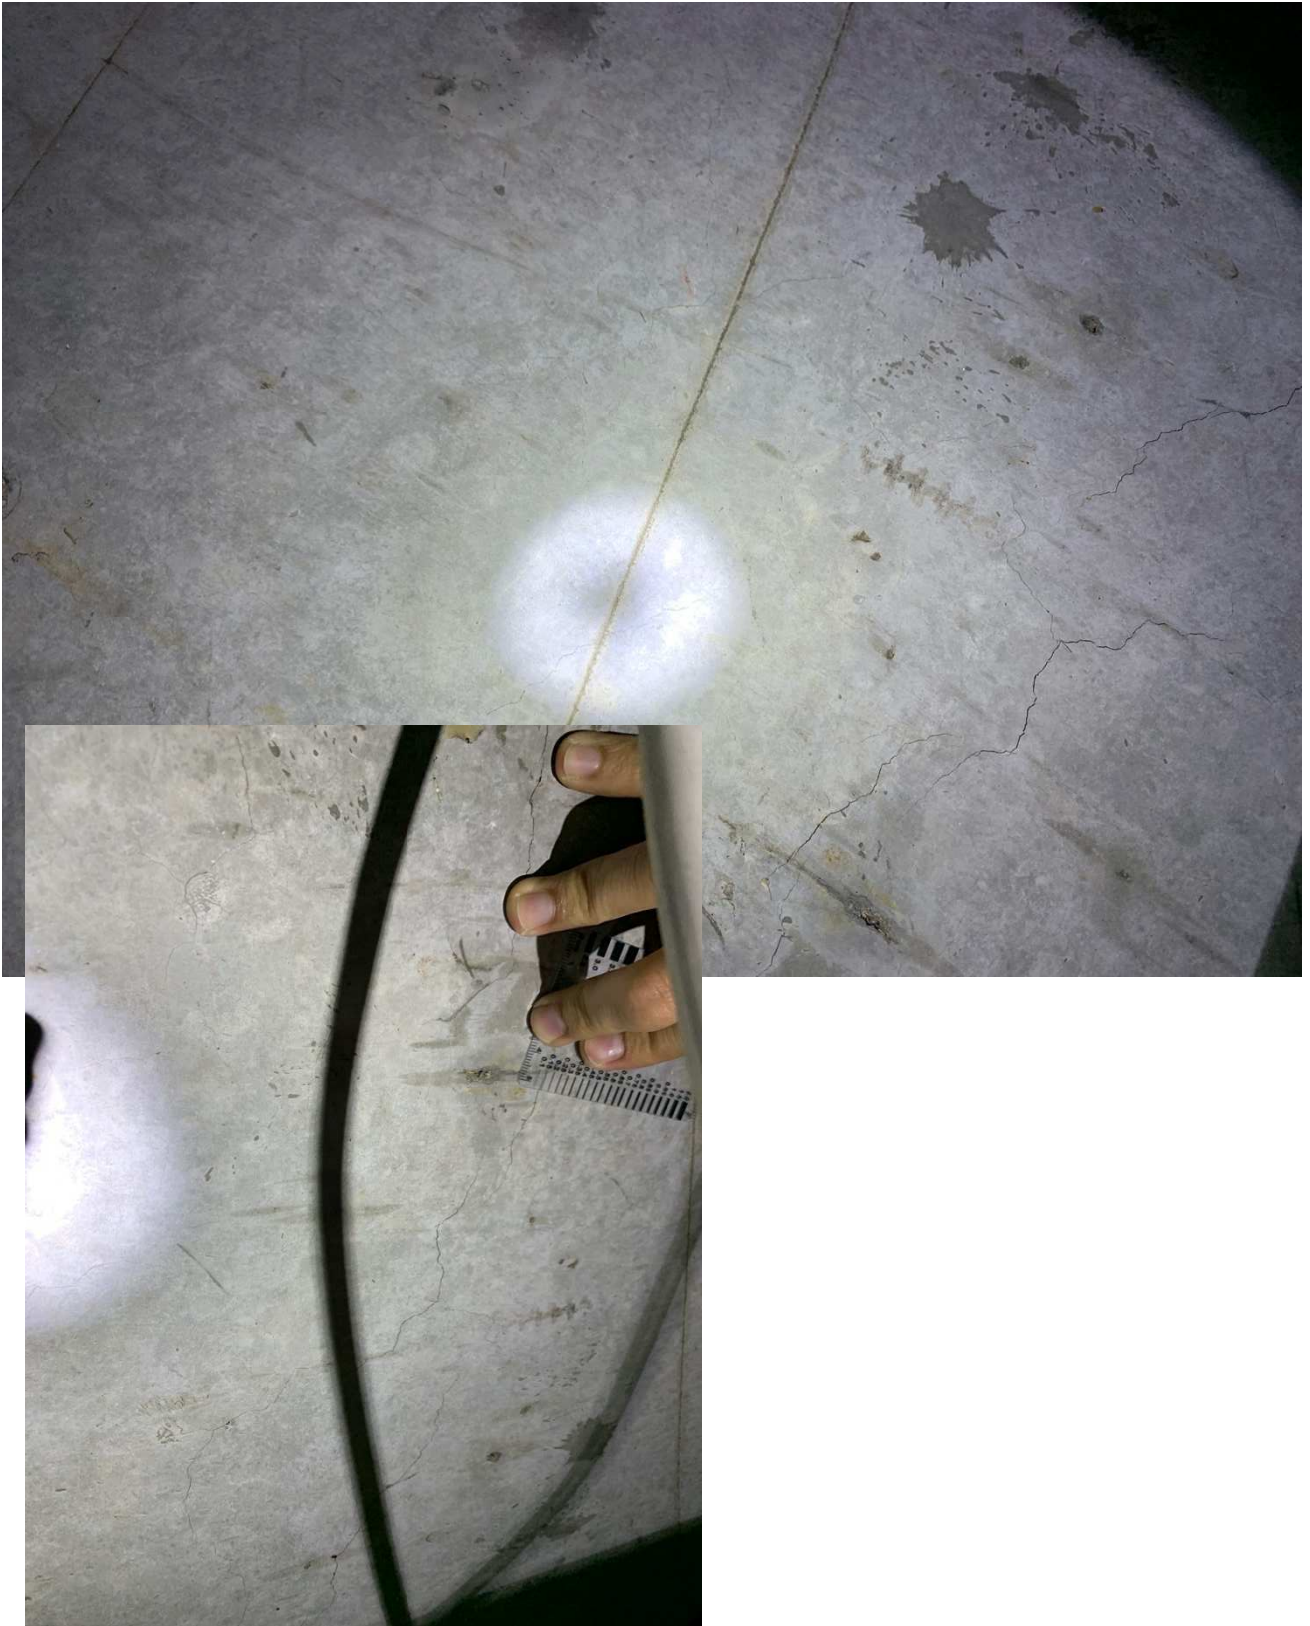
55	Auditorium Building (female toilet)	Crack on ceiling and beam, width<0.2mm	-to be monitored yearly

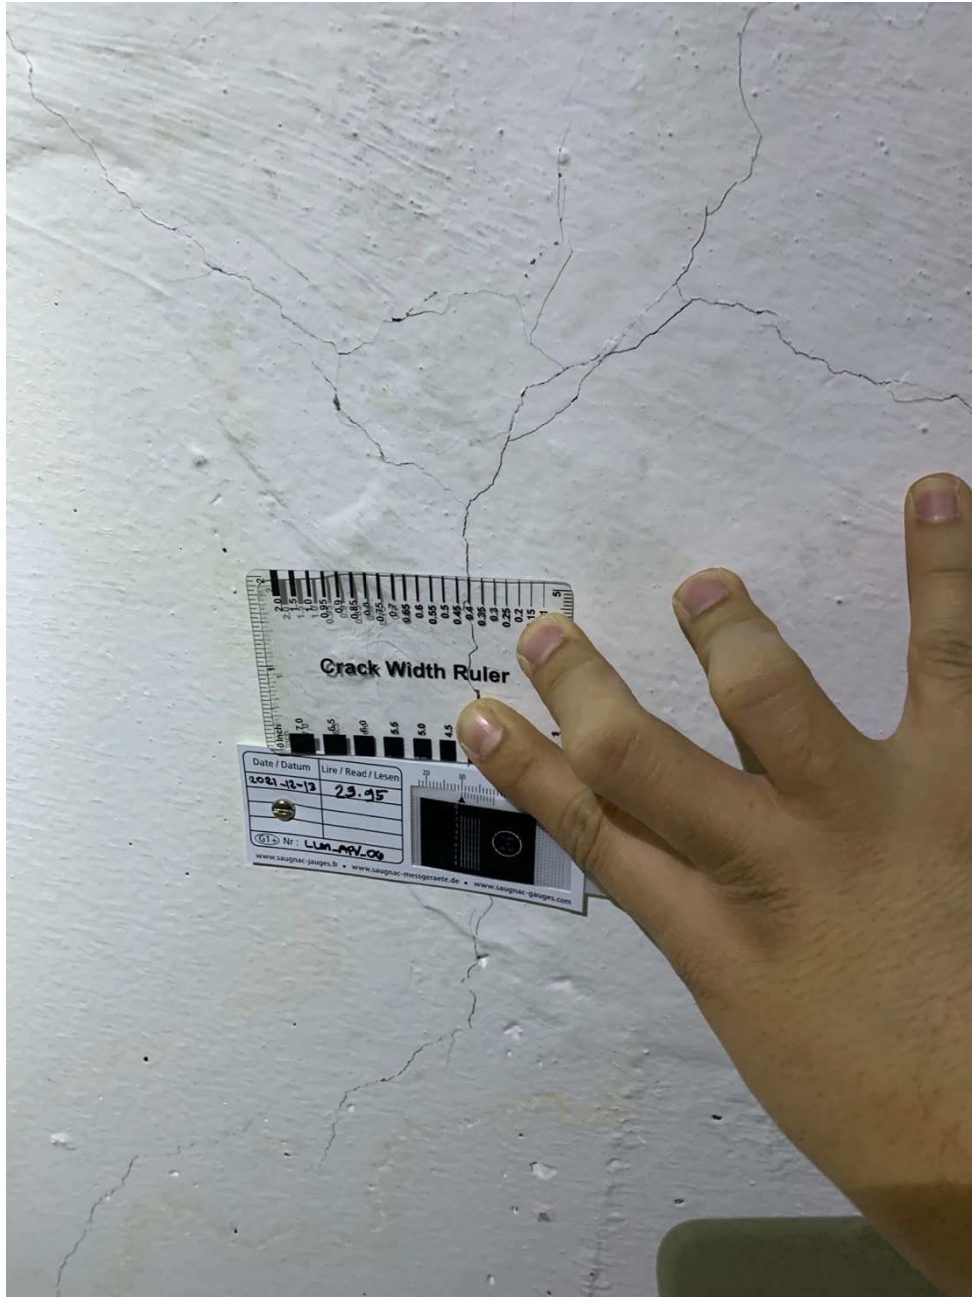
G. No.	Location	Crack Gauge Monitor		Crack Width Measurement		Remarks
		Current Reading	Deviation	Current Measurement	Deviation	
6	Gymnasium Building	29.95	-	0.40 mm	-	-Refer to obs.no.3 -It has been noticed that the bleacher was recently repaired. However, even after repair, new cracks are appearing. Crack gauge meter has been installed in this crack to monitor its development.
7	Gymnasium Building	29.05	-	0.95 mm	-	-Refer to obs.no.3 -It has been noticed that the bleacher was recently repaired. However, even after repair, new cracks are appearing. Crack gauge meter has been installed in this crack to monitor its development.
8	Gymnasium Building	30.60	-	0.60 mm	-	-Refer to obs.no.41 -the crack is appearing at the same level in a room affecting the wall and columns. This is on the same location of the bleacher where cracks are being monitored.
9	Auditorium Building	28.60	-	0.75 mm	-	Refer to obs.no.21 -The cracks are appearing on wall and ceiling at the same line/location. A crack gauge meter has been installed to further monitor the development of these cracks
