RENOVATION OF BLOCK B' FOR FRENCH SCHOOL (LYCEE LOUIS MASSIGNON)

CONCRETE REPAIRS AND STRUCTURAL REINFORCEMENT

**VOLUME 5 – Part 5 of 7
M/s eForce Inspection Consultancies
Report eForce/1588/2023 dated October 17th, 2023**

**VISUAL INSPECTION OF THE GYMNASIUM, SWIMMING POOL AND
AUDITORIUM LYCÉE LOUIS MASSIGNON SCHOOL, ABU DHABI, UAE
(Preliminary report)**

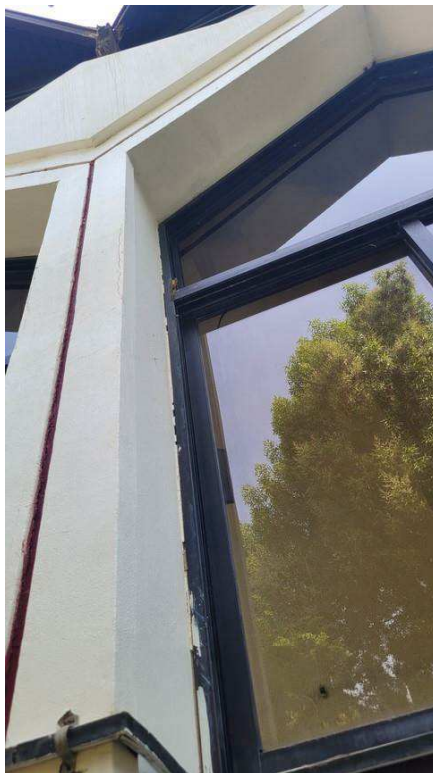
- Figure 4-2 Delamination in column

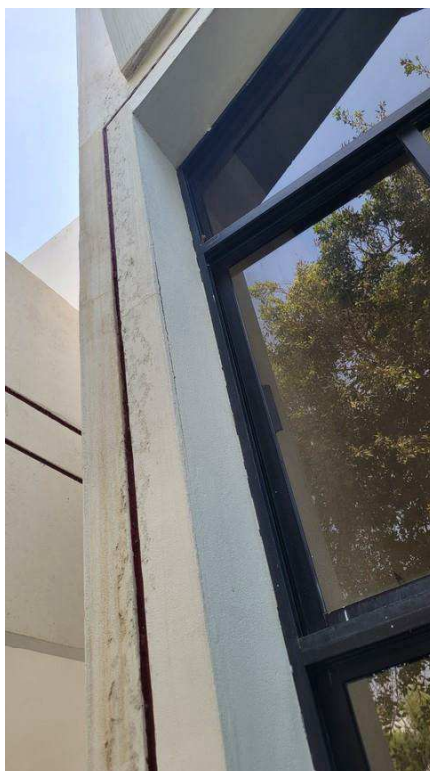
- Figure 4-4 previous leakage in column

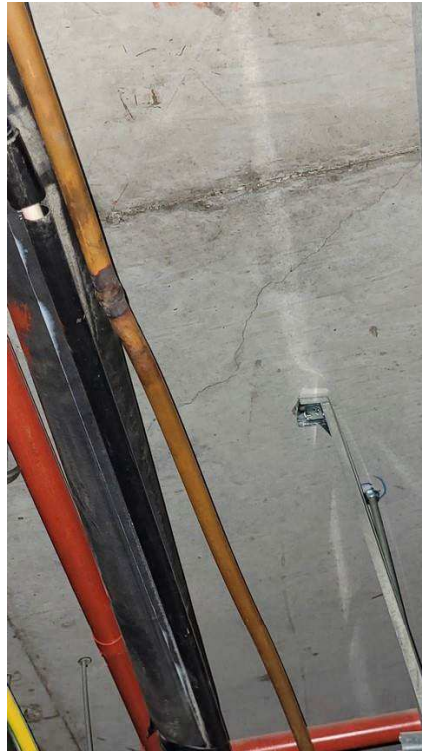
Figure 4-7 Cracks in slab soffit

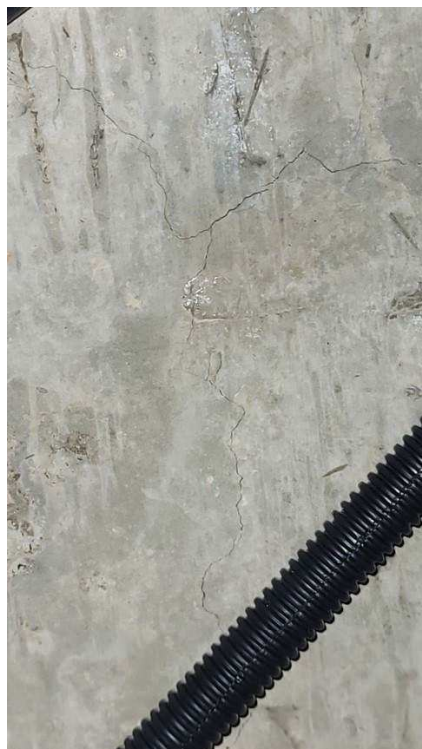
Figure 4-8 Cracks in slab soffit

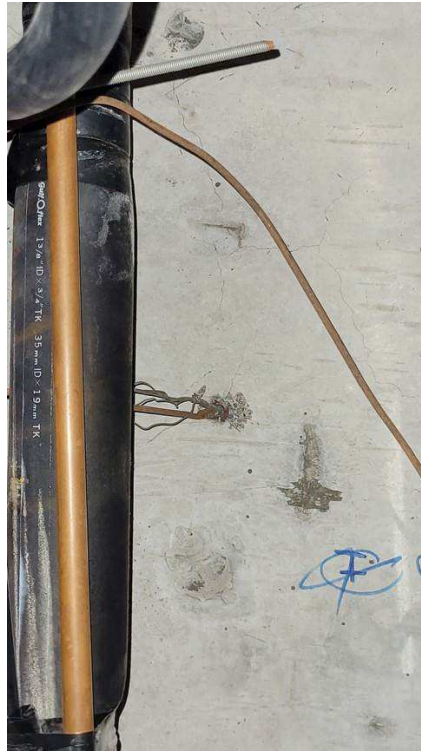
Figure 4-9 Cracks in slab soffit

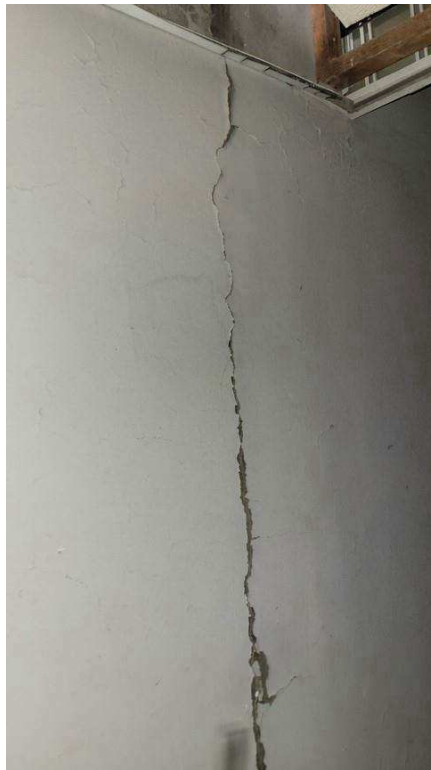
Figure 4-12 Crack between block wall and concrete element

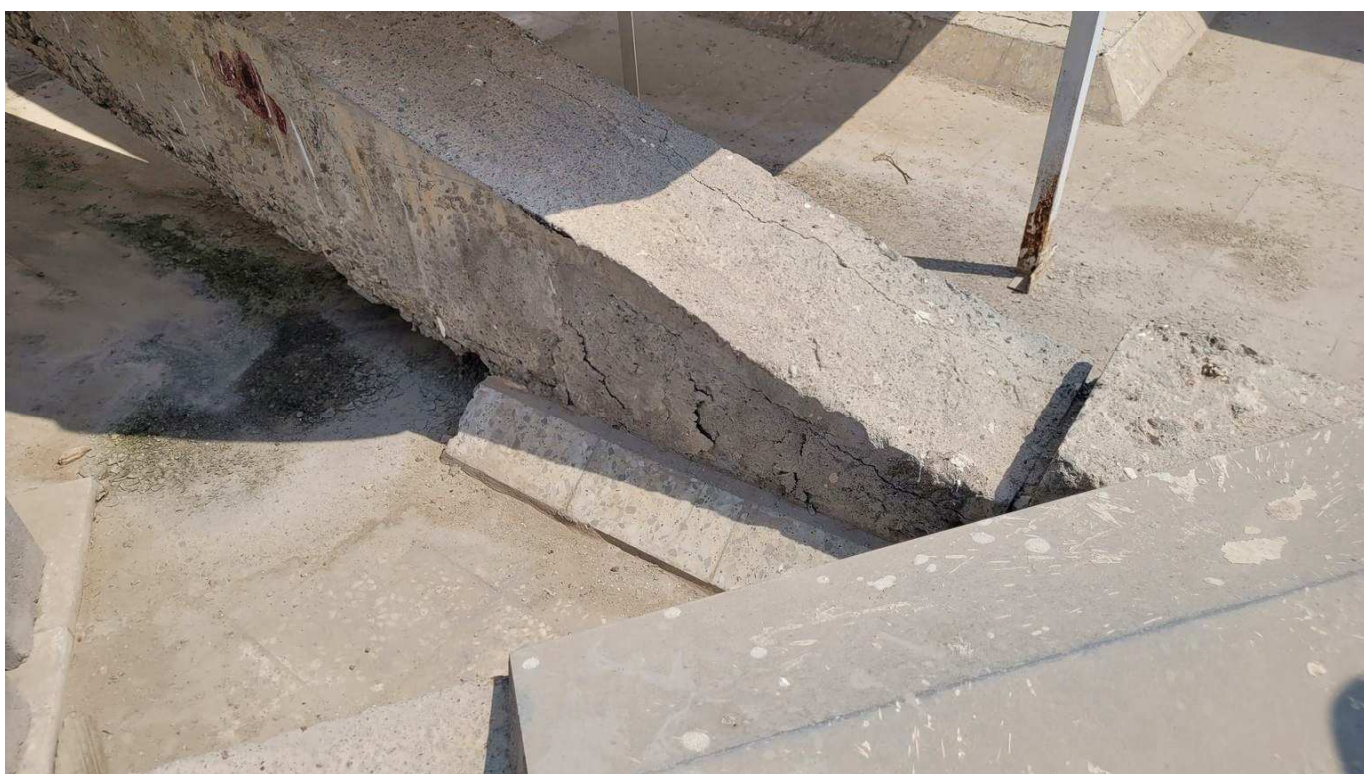
Figure 4-30 delamination in beam of the roof

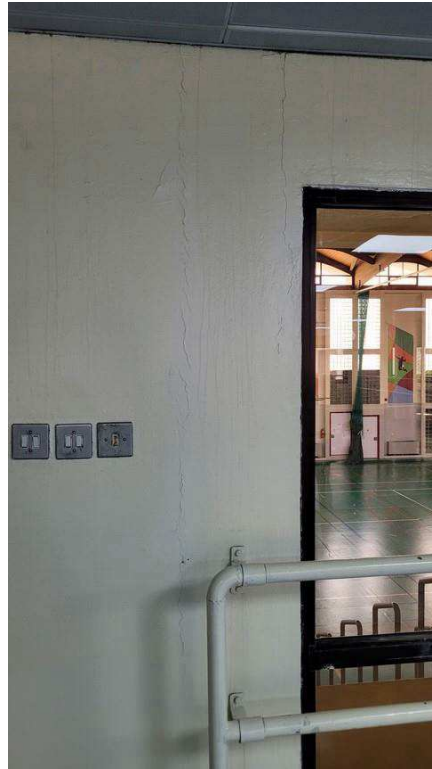
Figure 4-35 cracks between block wall and concrete element

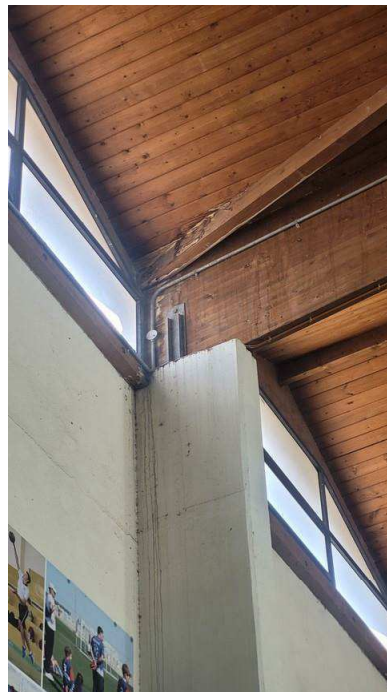
Figure 4-36 previous leakage in column and wooden roof

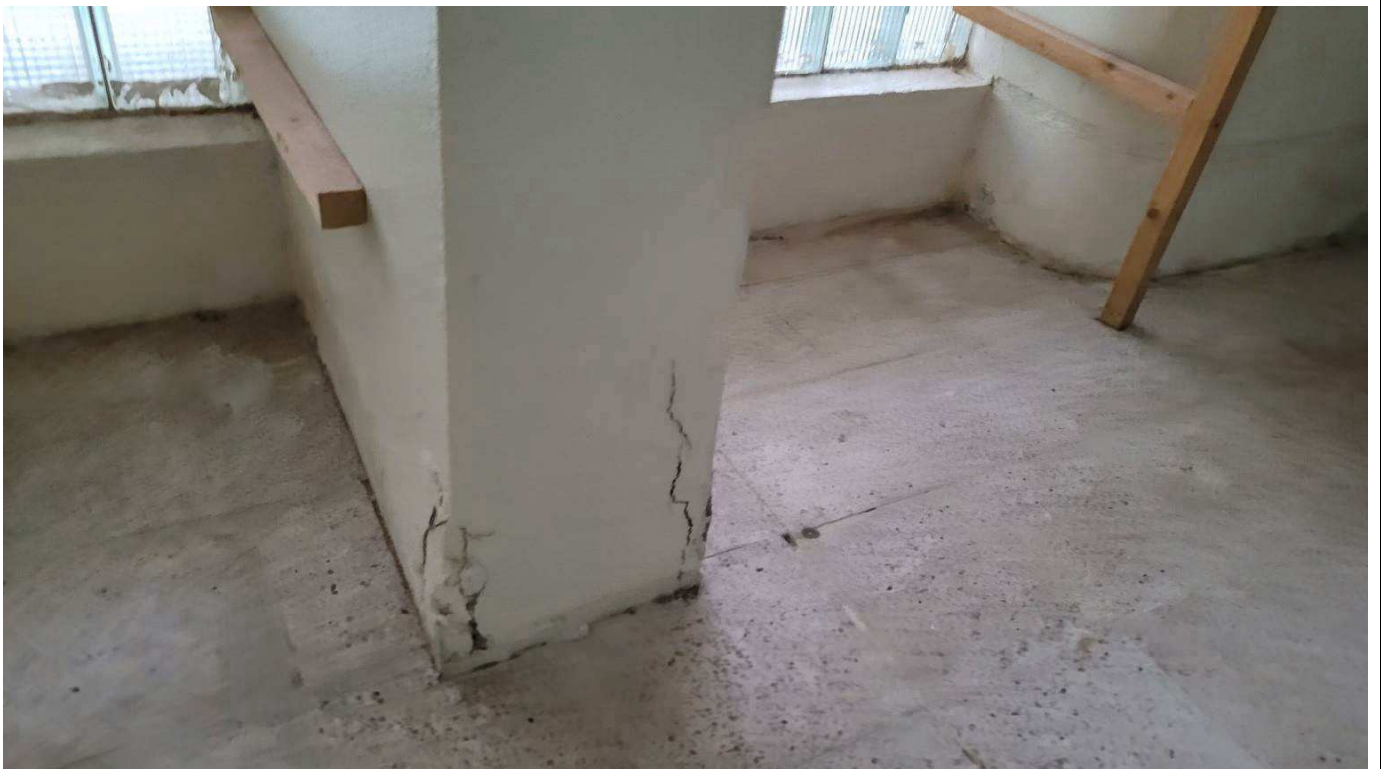
Figure 4-38 delamination in column

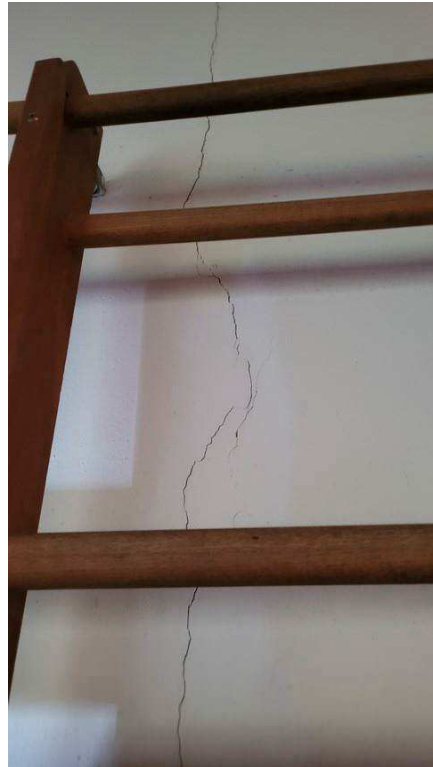
Figure 4-43 cracks in block wall

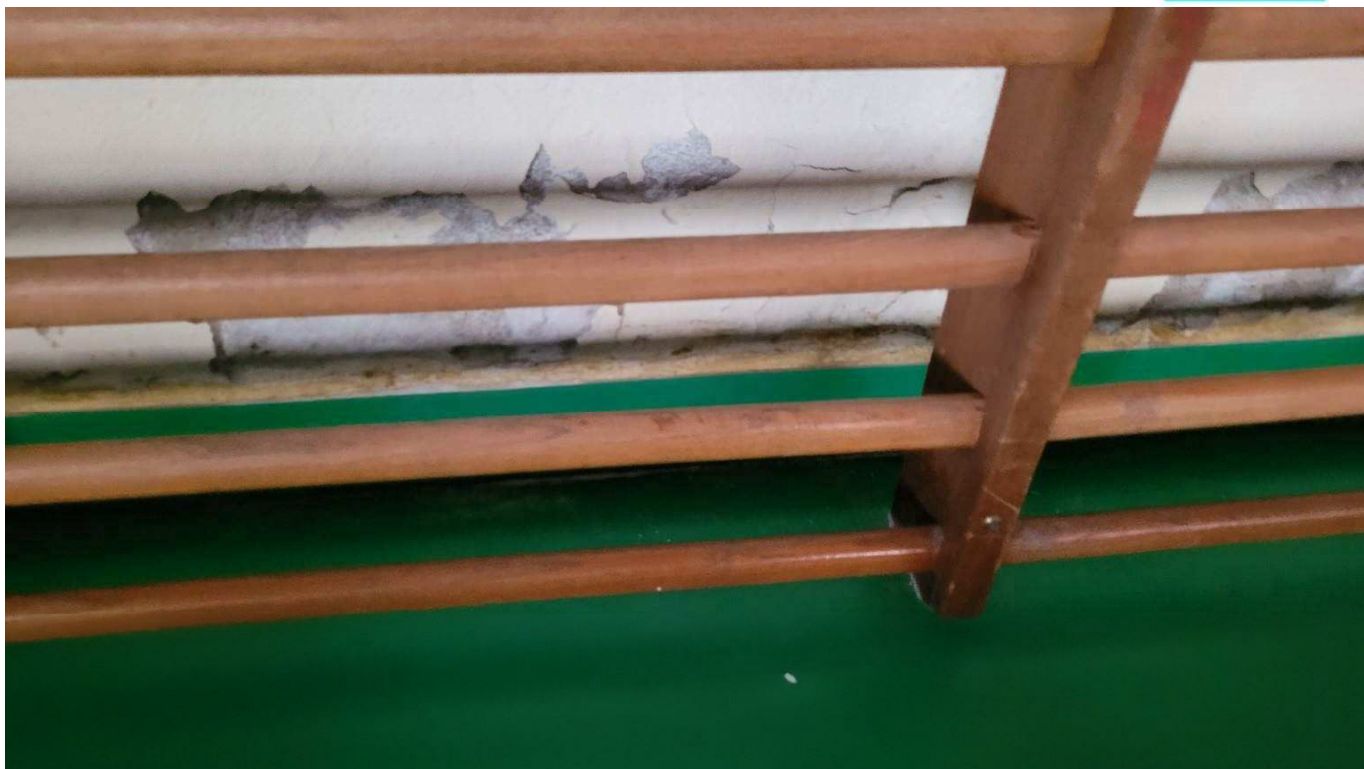
Figure 4-45 Dampness and delamination in ground beam

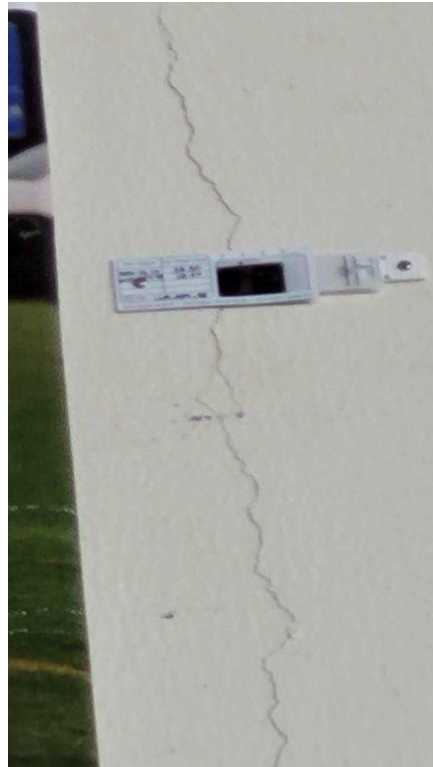
Figure 4-49 Crack in concrete wall

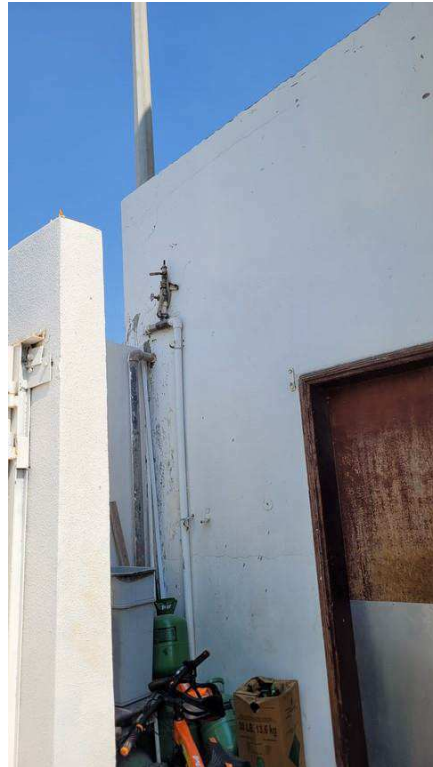
Figure 4-51 Crack in block wall

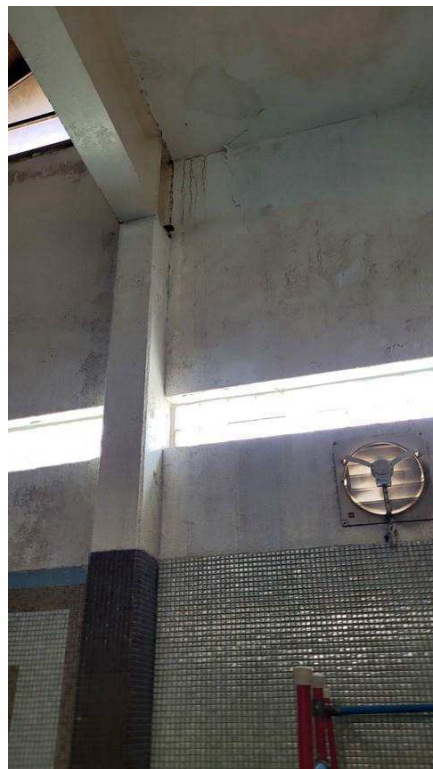
Figure 4-84 dampness in block wall and concrete elements

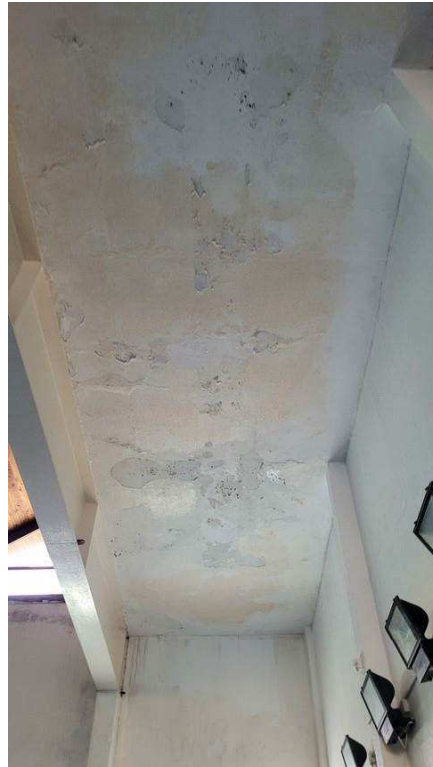
Figure 4-85 Previous leakage in slab soffit
