RENOVATION OF BLOCK B' FOR FRENCH SCHOOL (LYCEE LOUIS MASSIGNON)

CONCRETE REPAIRS AND STRUCTURAL REINFORCEMENT

**VOLUME 5 – Part 4 of 7
M/s eForce Inspection Consultancies
Report eForce/195/2019 dated January 28th, 2020**

**STRUCTURAL STUDY OF EXISTING STRUCTURE OF
THE GYMNASIUM, SWIMMING POOL AND AUDITORIUM
LYCÉE LOUIS MASSIGNON SCHOOL, ABU DHABI, UAE
(Phase 1: Assessment, Pre design and Scenarios)**

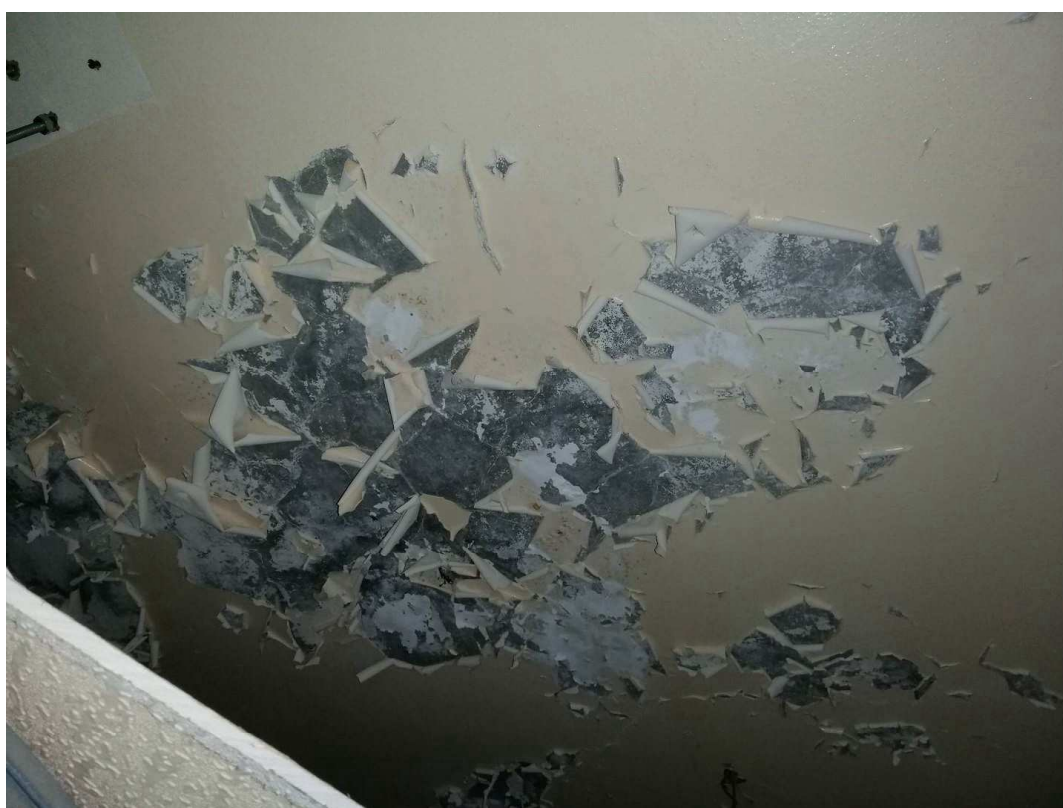
Figure 4-22 previous dampness in slab

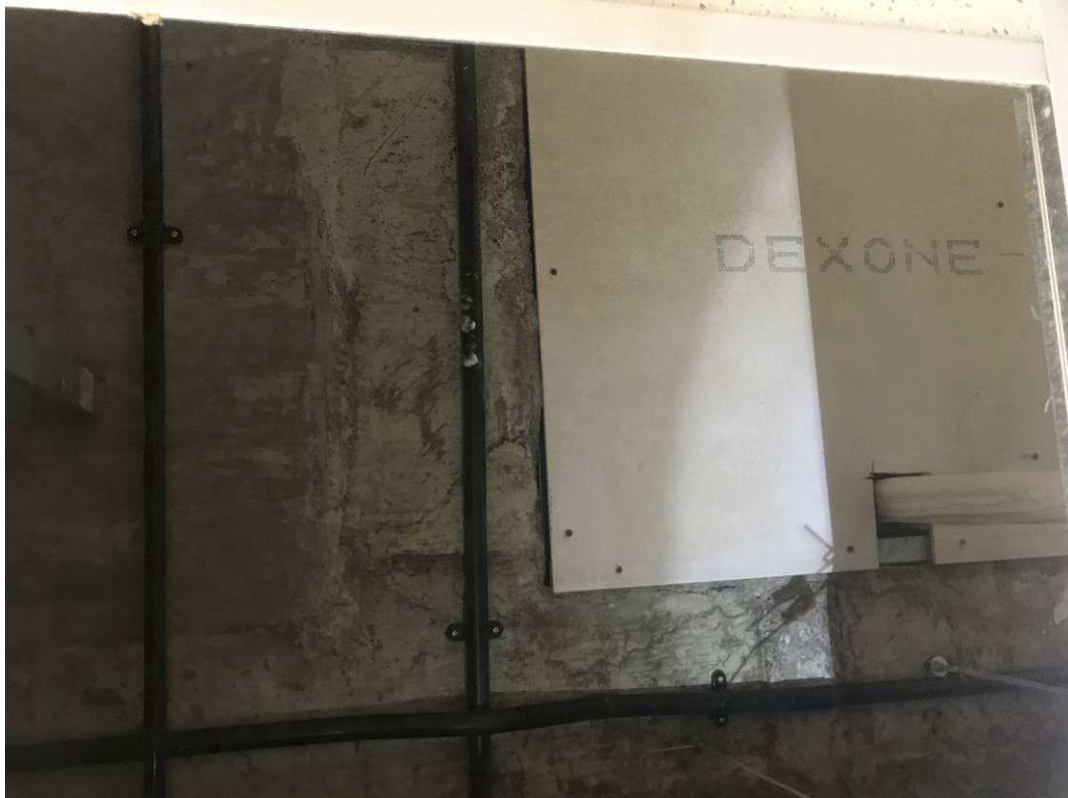
Figure 4-23 slab opening which not closed properly

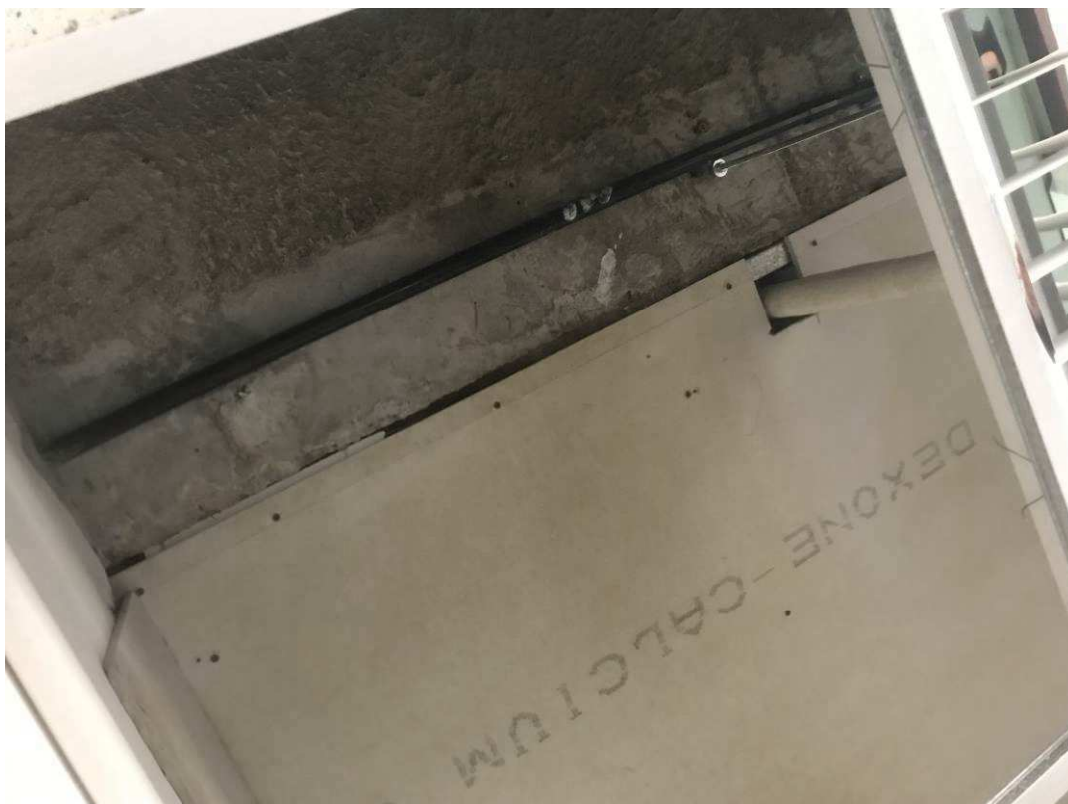
Figure 4-24 slab opening which not closed properly

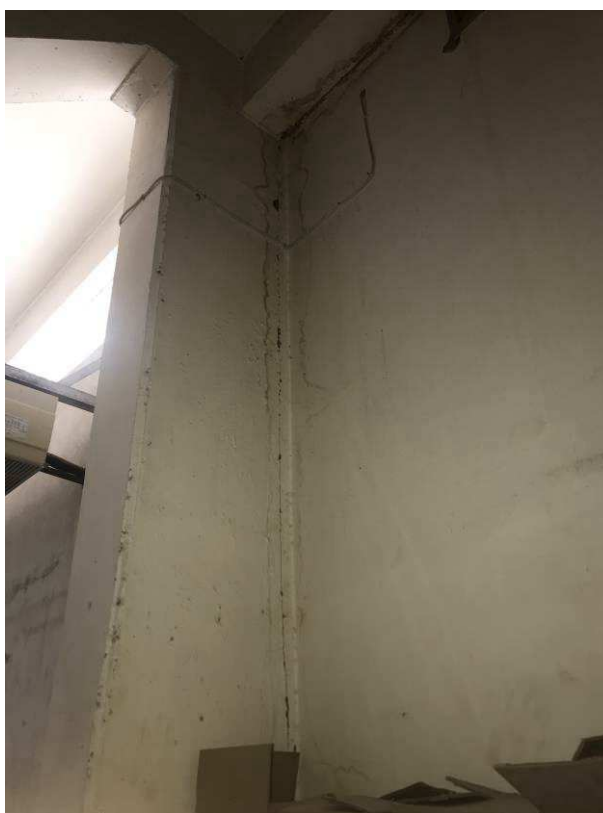
Figure 4-33 Crack between block wall and concrete element.

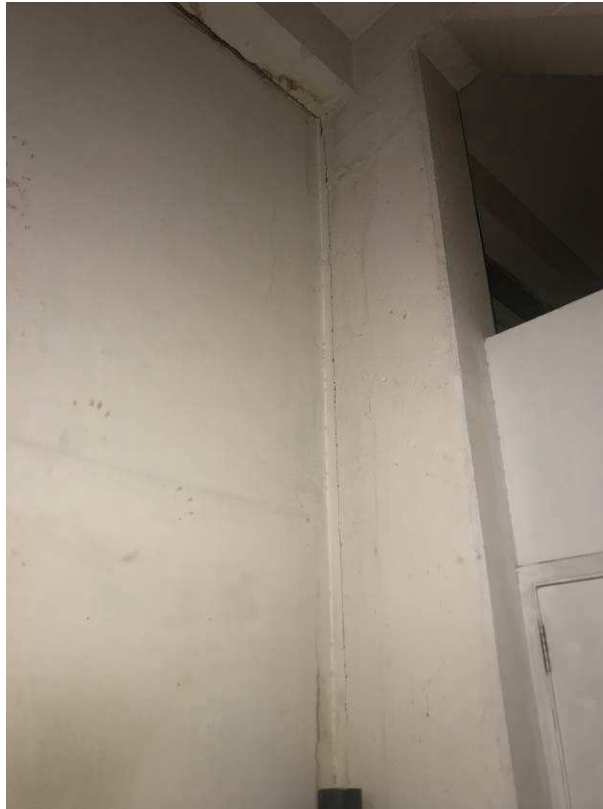
Figure 4-34 Crack between block wall and concrete element.

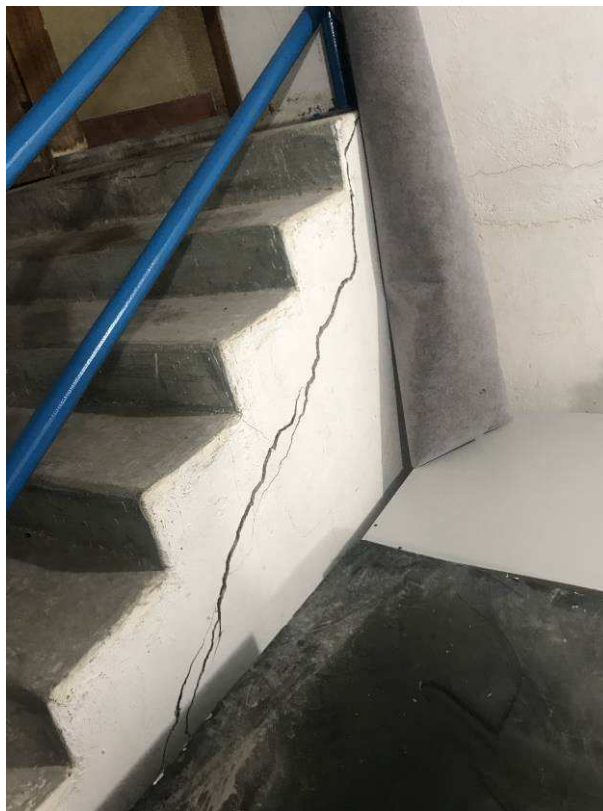
Figure 4-35 crack in staircase

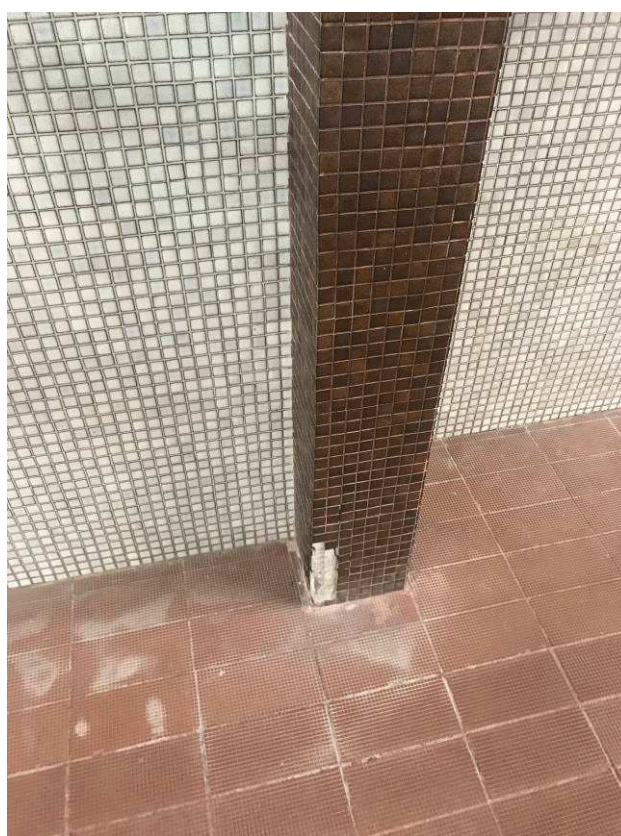
Figure 4-39 delamination in column

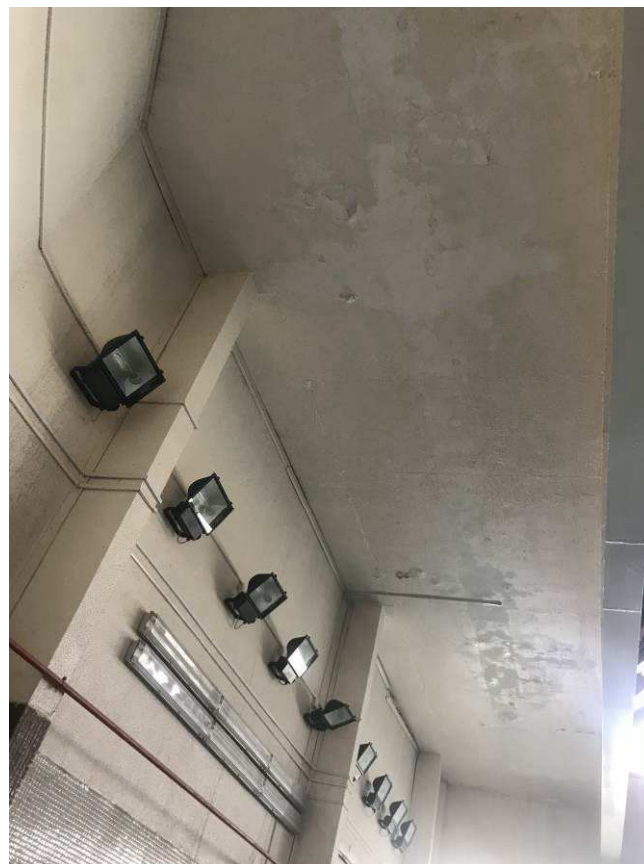
Figure 4-43 Dampness in slab soffit

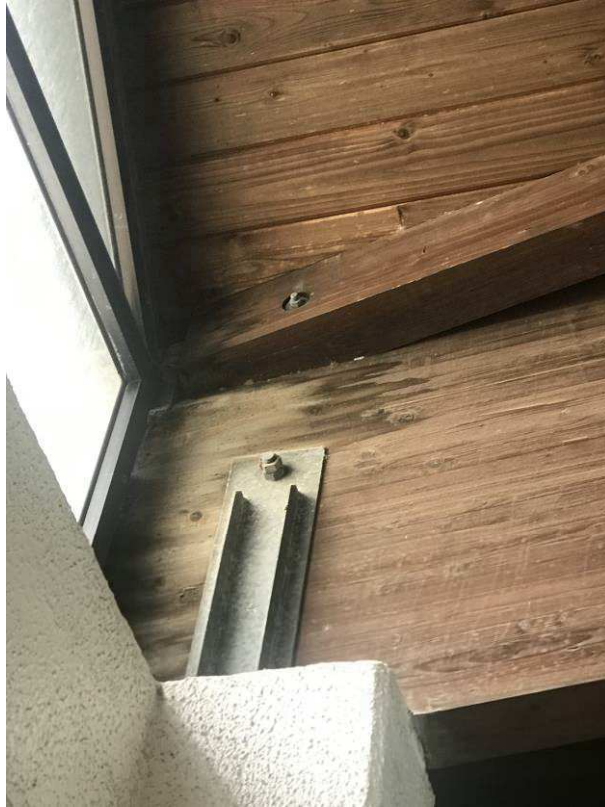
Figure 4-44 Dampness in wooden beam

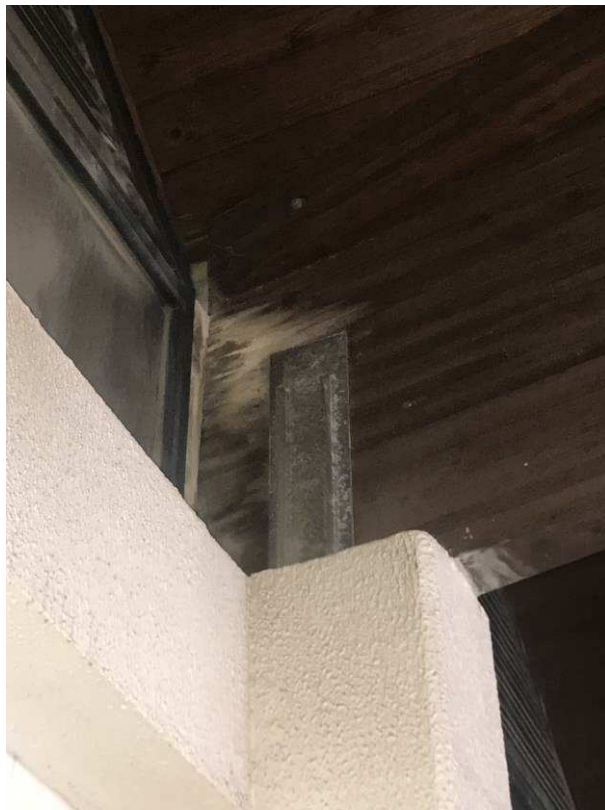
Figure 4-45 Dampness in wooden beam

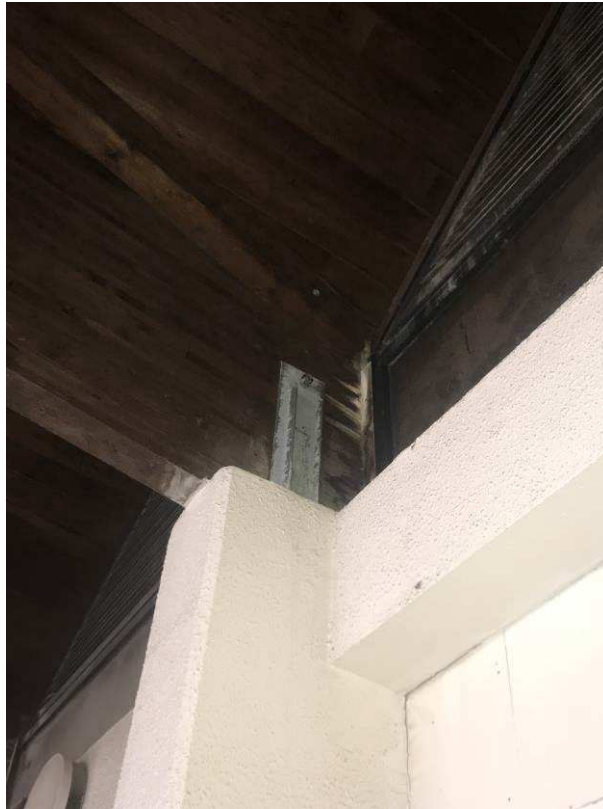
Figure 4-46 Dampness in wooden beam

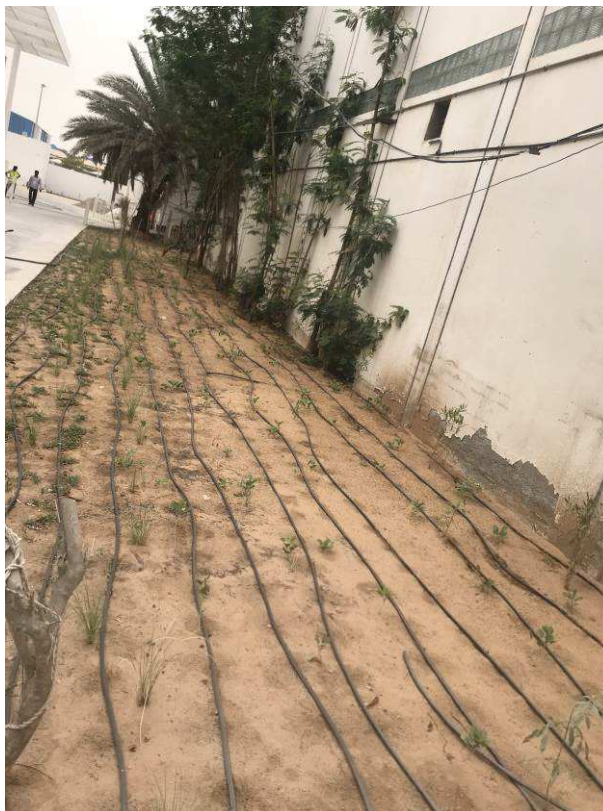
Figure 4-47 landscaping work touching the pool which affect the quality of concrete

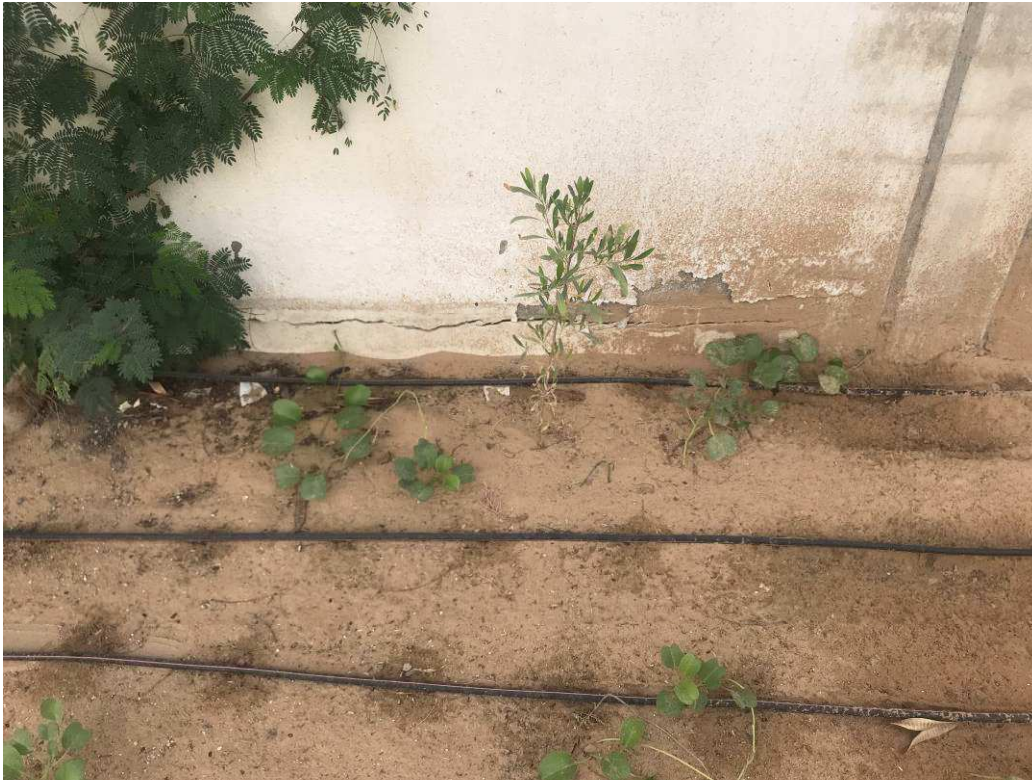
Figure 4-48 landscaping work touching the pool which affect the quality of concrete

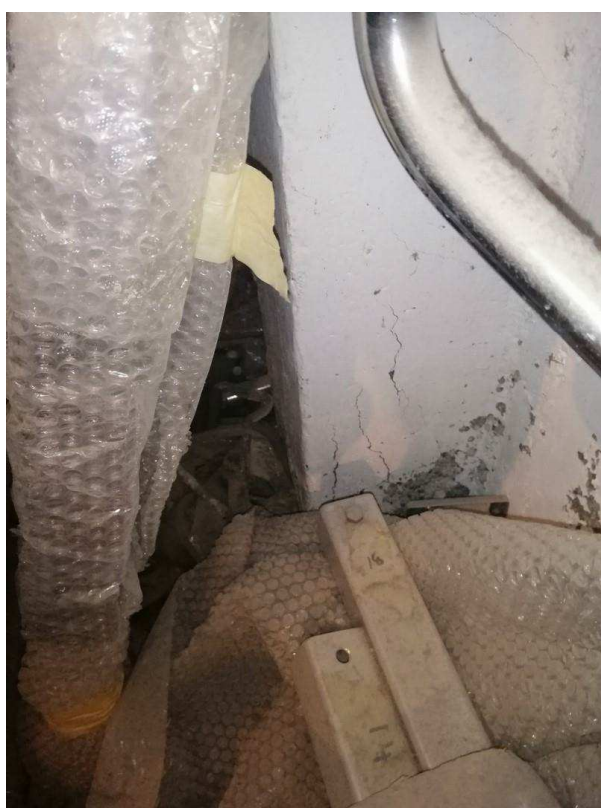
Figure 4-56 Cracks in column

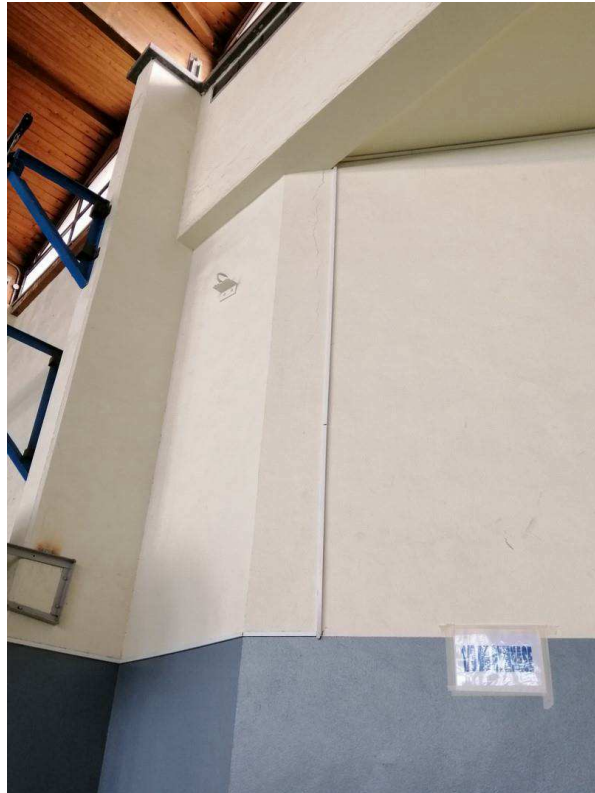
Figure 4-61 Cracks between Block wall and concrete element

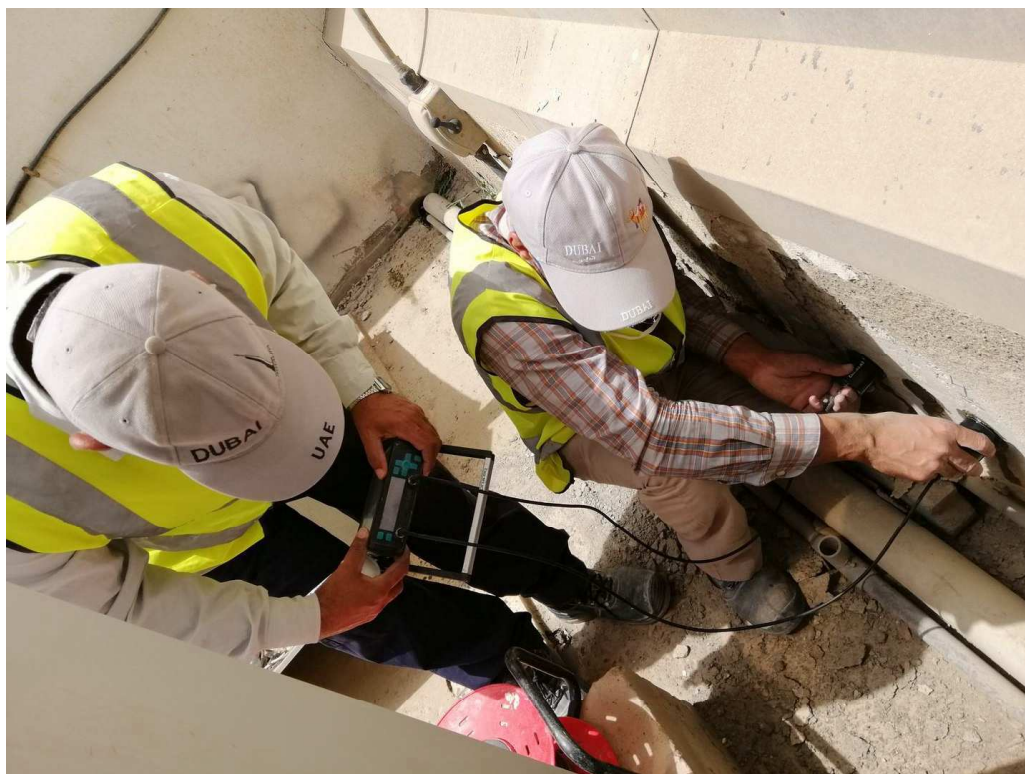
The test results of four (4) tests at different locations are presented in Table 4.5 (Figures 4-70 to 4-72). The ultrasonic pulse velocity of the existing concrete in the building ranged between 421 to 1880 m/s on average 1274 m/s, which is lower than the 1500 m/s. In general, the concrete quality is very poor. The results indicate the bad workmanship of the concrete which require good level of concrete protection.

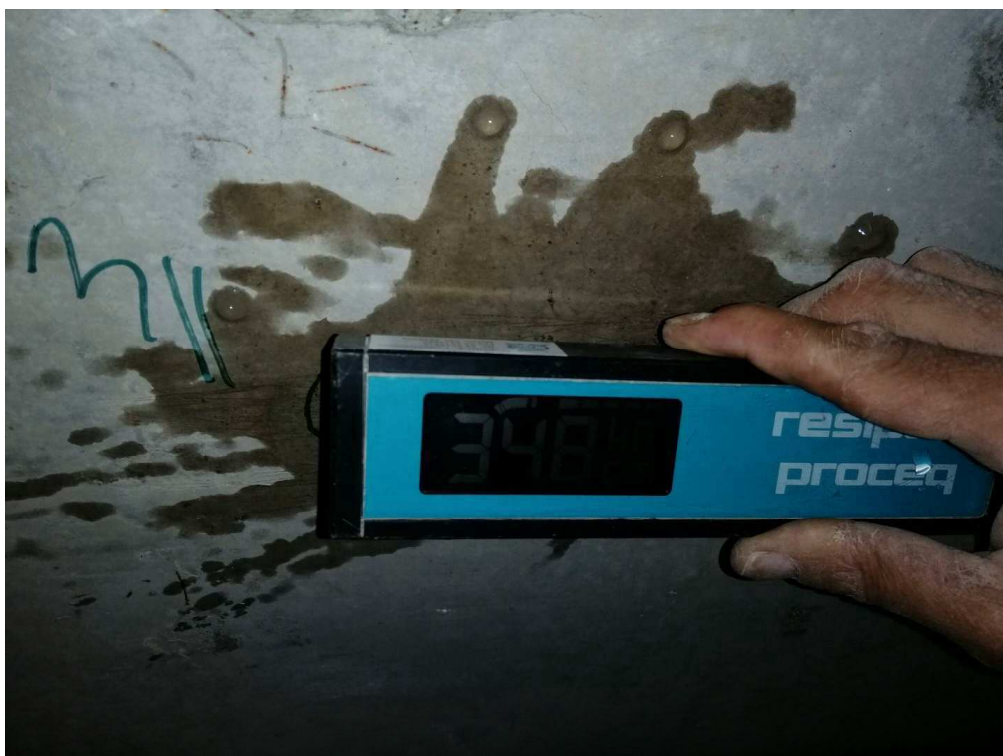
Figure 4-75 During measuring the resistivity

The resistivity tests showed low corrosion rate for all the tested locations, except for point 4 which showed a high corrosion rate.

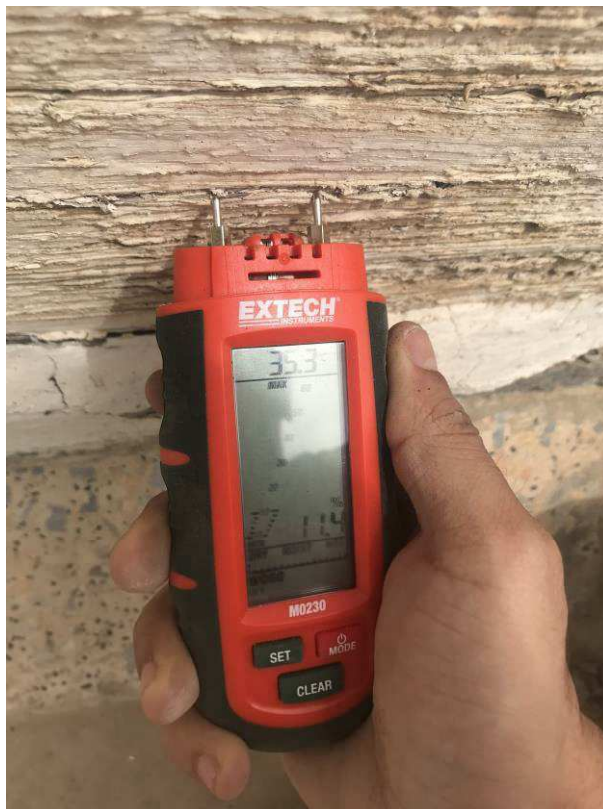
Figure 4-77 during checking the moisture content

No.	Location	Moisture content
1	Auditorium	5.5%
2	Swimming pool	8.9%
3	Swimming pool	11.4%
5	Gymnasium	13.4%
6	Gymnasium	16.6%
7	Swimming pool	18.5%
8	Swimming pool	14.5%

As per **BS 5268** for the average moisture content required of the external uses 20%. All the results are below 20%.

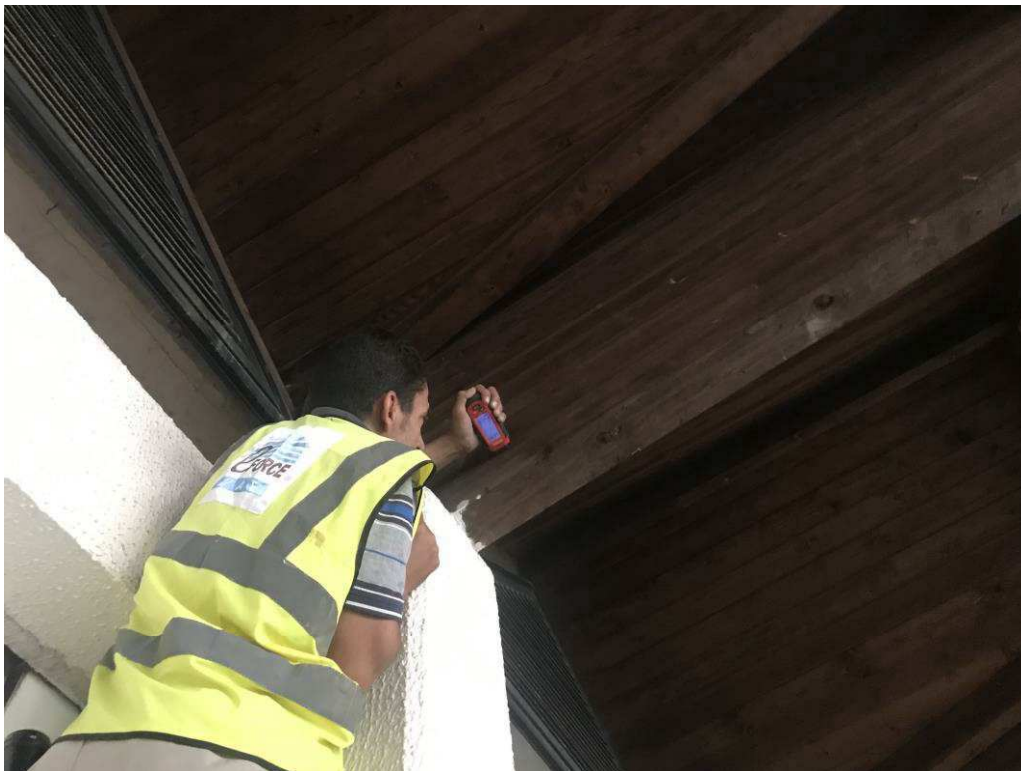
Figure 4-78 during checking the moisture content

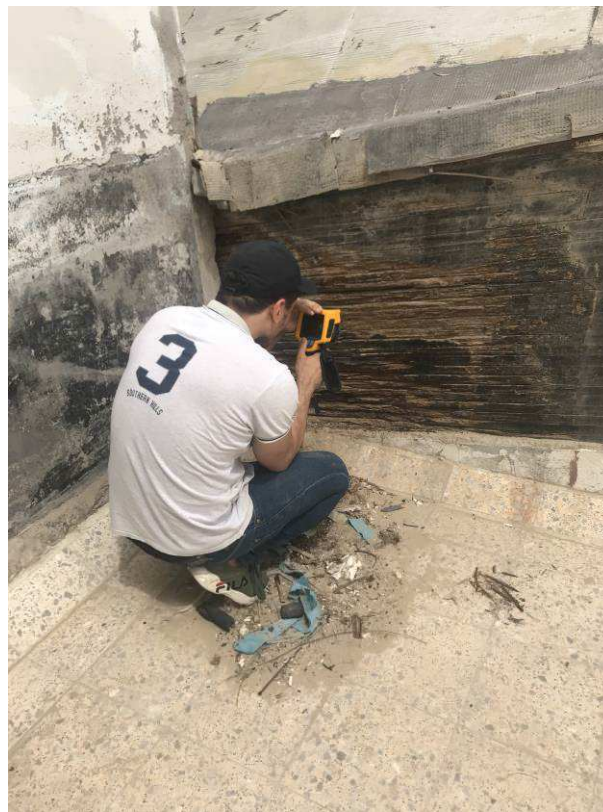
From thermal graphic test (figure 4-82 and figure 4-83) the wooden beam of the swimming pool is fully dried.

Figure 4-82 during conducting thermal image test over the damaged beam
